COASTAL MONITORING REPORT - 02

PROJECT: GULHIFALHU PORT DEVELOPMENT PROJECT PHASE 1: DREDGING, RECLAMATION AND SHORE PROTECTION

May 2020 – November 2020

CMR_25/11/2020 (Rev 1.0)

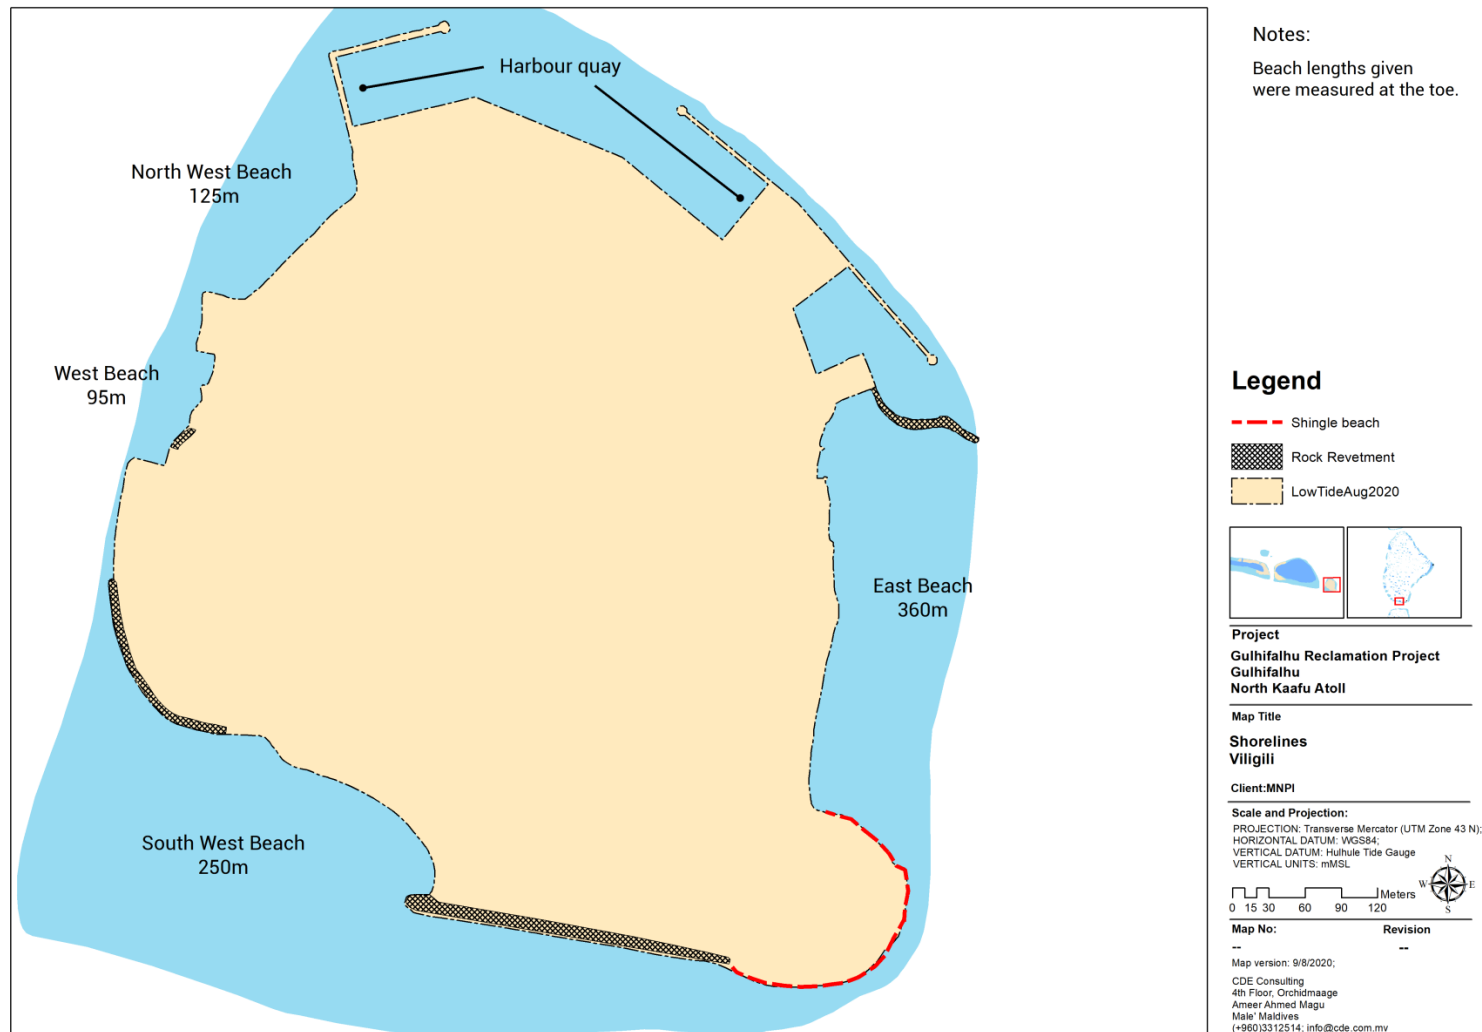
Figure 4-1: Description of Villingili shorelines

From the surveys carried out it can be seen that there have not been any drastic changes to the shorelines of Villingili during the beach surveys of August 2020 and November 2020.

The rate of sediment drift across the South Beach seems to have significantly stabilized compared to the changes observed between May 2020 and August 2020.

High-tide line has moved seawards at the northern end of the North-West Beach. This does not necessarily indicate accretion but the beach acquiring a smoother seaward slope.

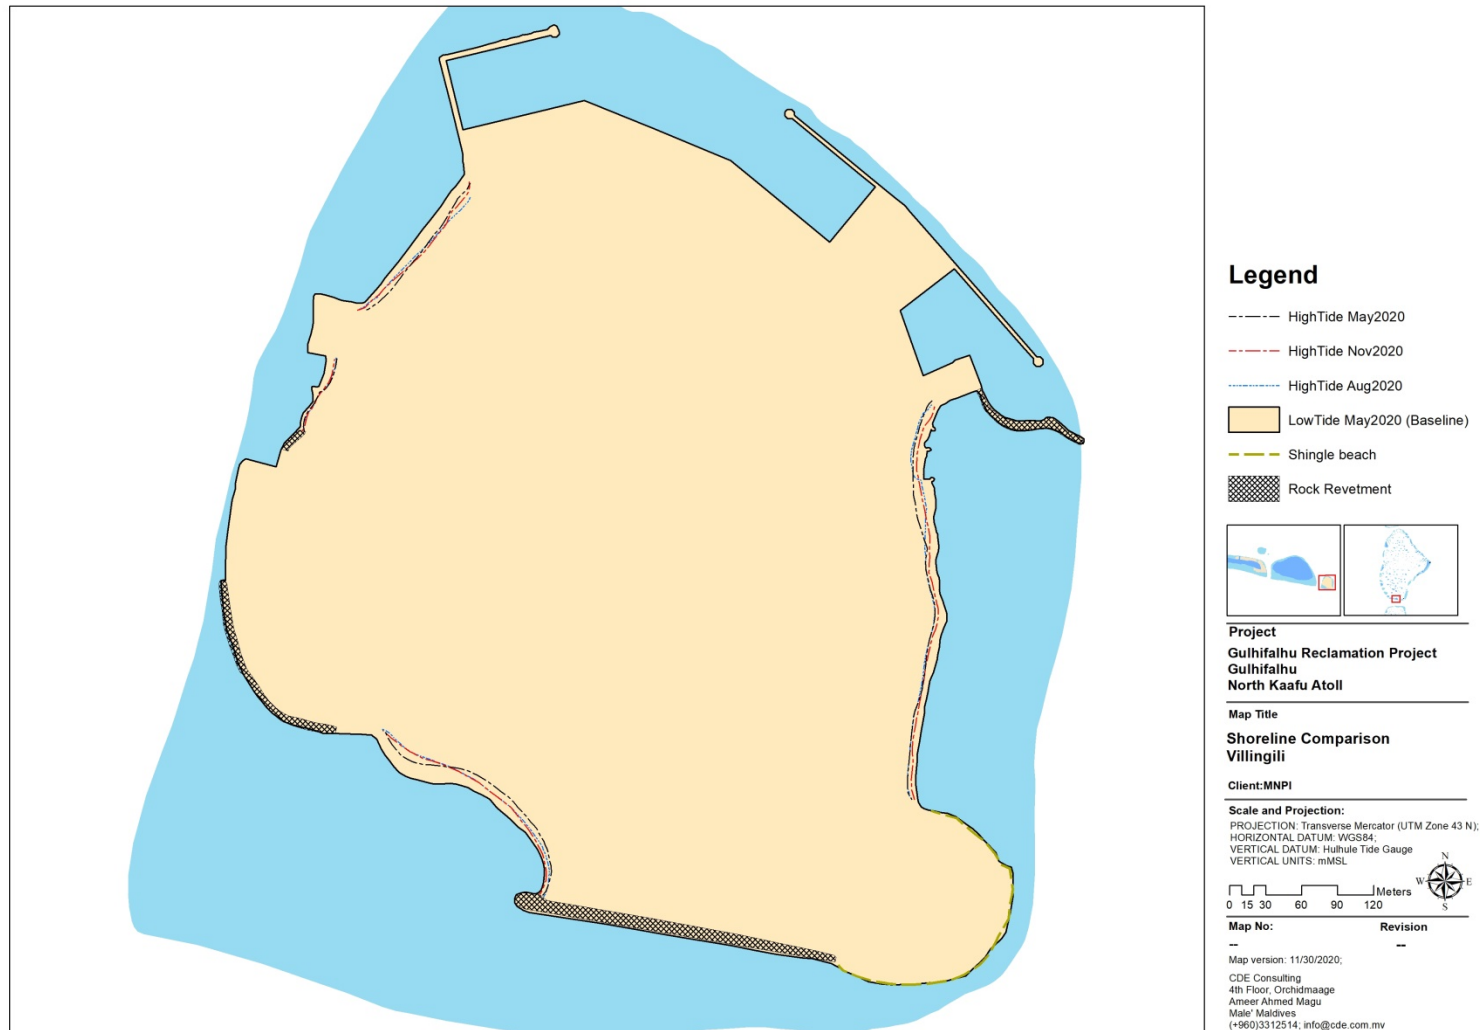
Figure 4-2: Shoreline Comparison

No changes in shorelines were observed at West Beach. The shoreline map has been provided in Appendix A.

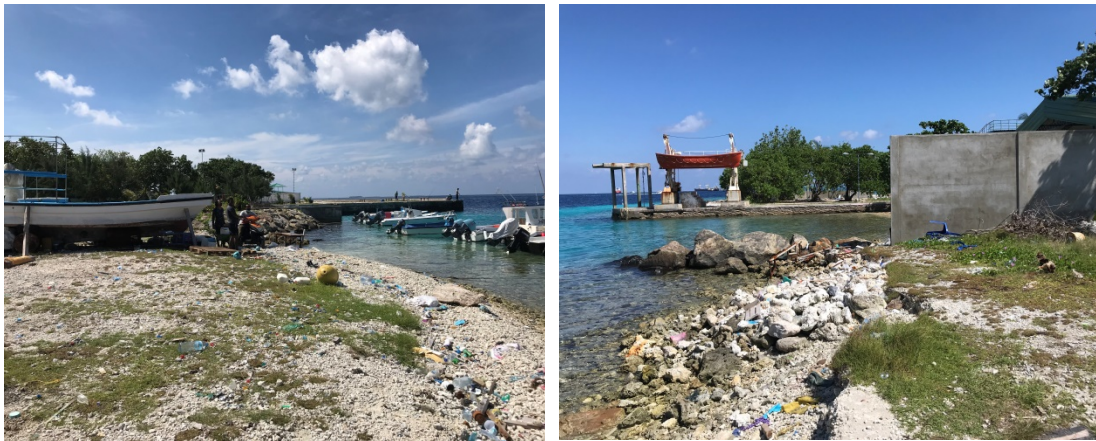
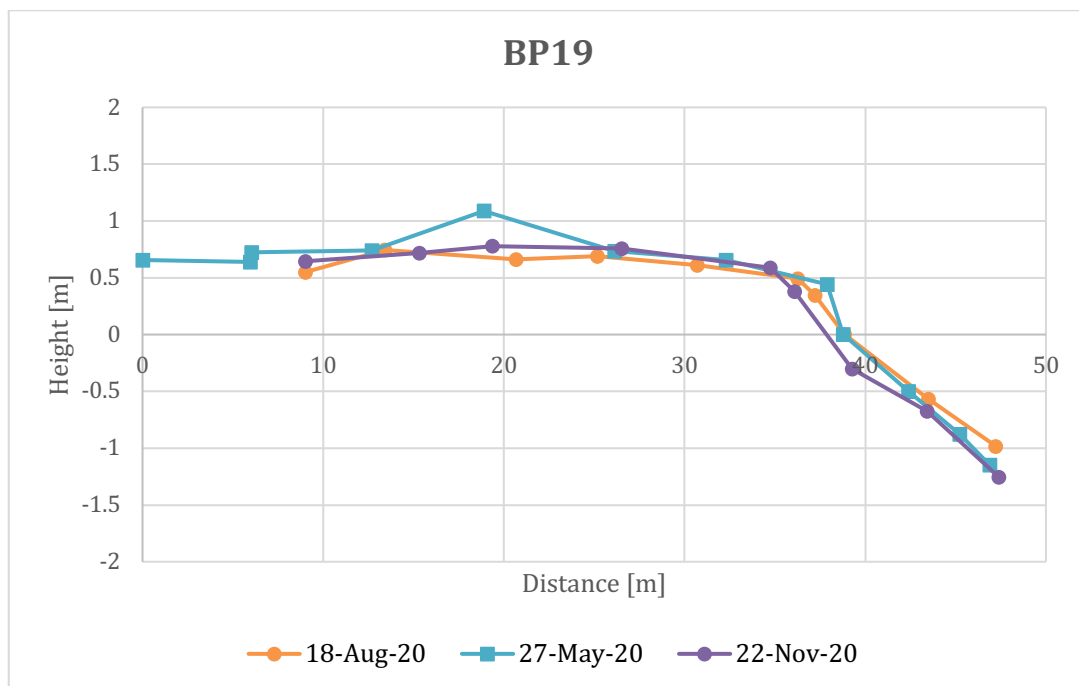
d) Beach Profile ID: BP-19

No changes were observed at P19, located at the West Beach. Despite facing west, absence of changes in shorelines and beach profile may be due to the lack of fine sand, which is more susceptible to drift.

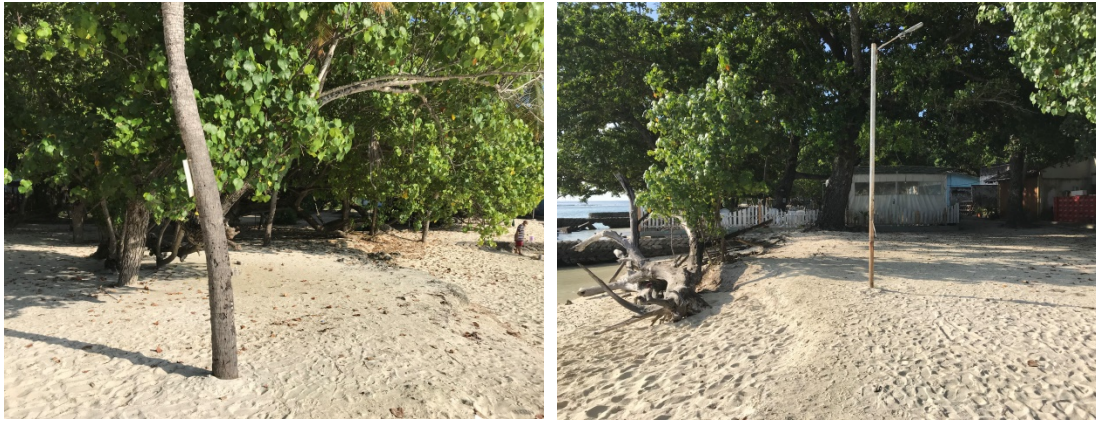
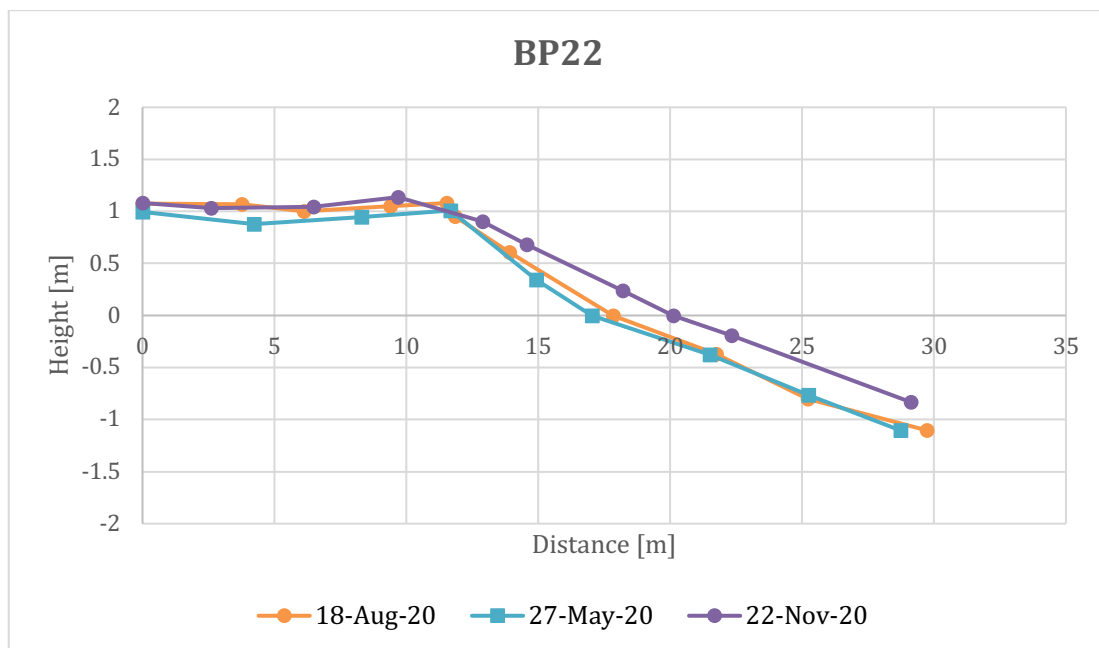
g) Beach Profile ID: BP-22

Little to no changes were observed in the profiles P22, P23 and P24 taken on the East Beach. However, the slope of the beach seems to become less steep, attributable to the absence of high-energy north-eastern wind waves during this period.
