ENVIRONMENTAL IMPACT ASSESSMENT

For the proposed reclamation of 24 hectare at Thimarafushi,
Thaa Atoll, Maldives

Ministry of Housing and Environment

For Water Solutions Pvt. Ltd., Maldives

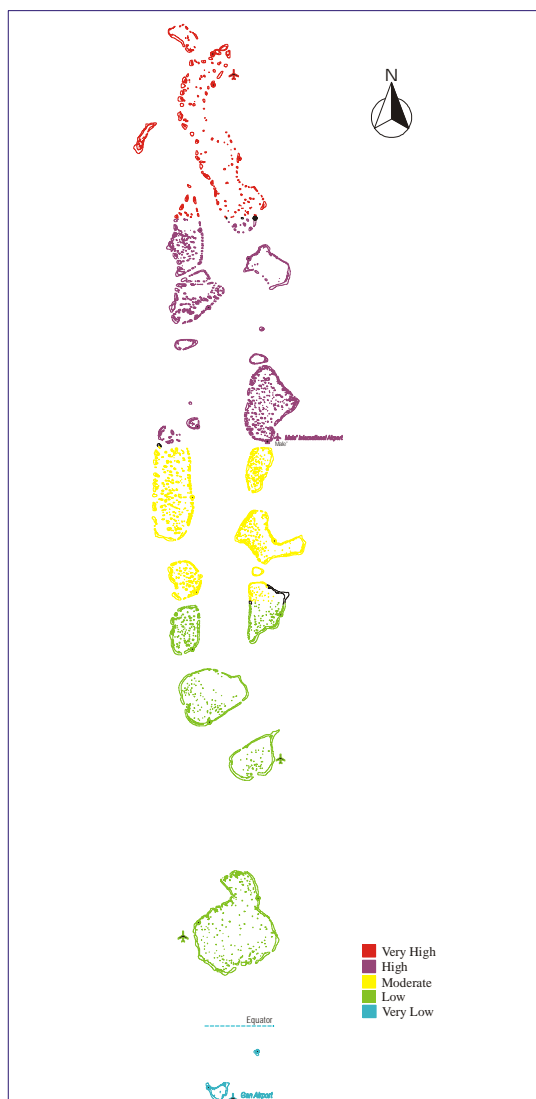
Table 20: Cyclonic Wind Hazard Map (source: UNDP, 2006)

The northern atolls have a greater risk of cyclonic winds and storm surges. This reduces gradually to very low hazard risk in the southern atolls (see **Error! Reference source not found.**). The maximum probable wind speed in Zone 5 is 96.8 knots (180 kilometres per hour) and the cyclonic storm category is a lower Category 3 on Suffir-Simpson scale. At this speed, high damage is expected from wind, rain and storm surge hazards (UNDP, 2006).

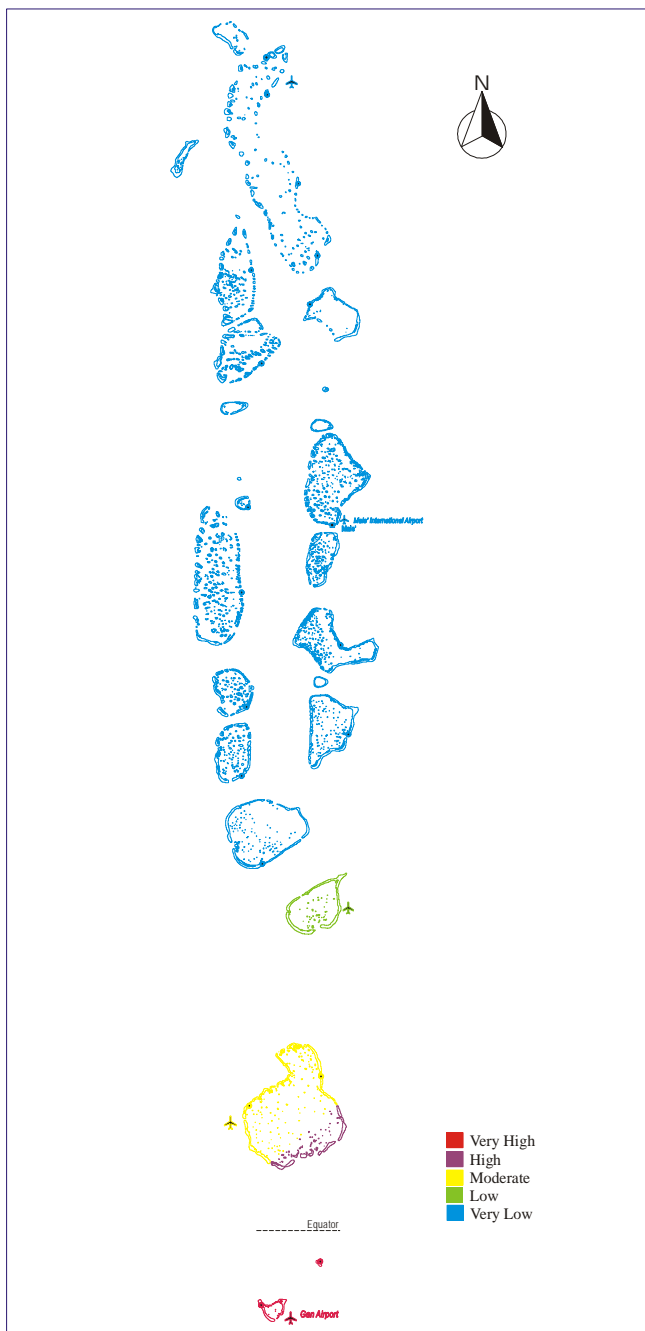
Table 22: Earthquake Hazard Zone (source: UNDP, 2006)

UNDP (2006) identified that hazard risk from earthquake is low for the Maldives and considered as a disaster risk for only islands located in the south of the country. See **Error! Reference source not found..**

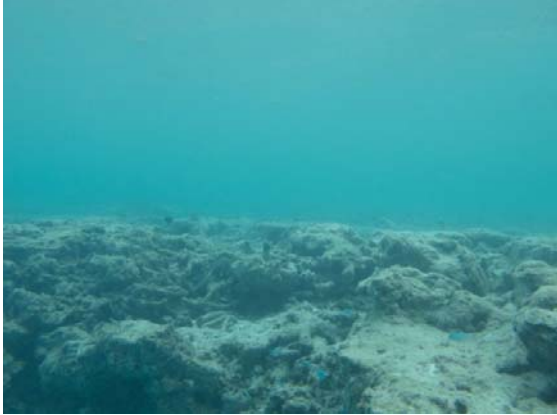
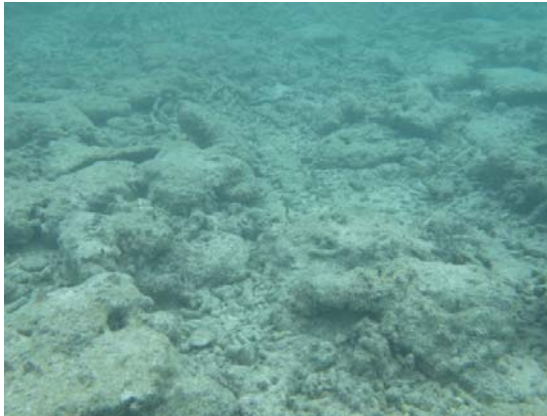
Figure 3: Photos indicating reef status at site 1 (November 2011)

Status of coral reef at site 1

<p>The reef is completely destroyed from reclamation and there are no live corals no any fish species observed during the survey.</p>	<p>The bottom is filled with dead corals, rubble and suspended sediments. The reef will require time for new corals to regenerate.</p>

Site 1 lies in close proximity to the already deepened area from the first phase of reclamation. This is also the location where the second phase of reclamation will dredge for borrow material. There are no live corals in this site as the site has been completely destroyed from dredging. The site has not had time to recover and for new corals to regenerate, it will take some time. As a result, the entire area is filled with sediments. There is also a high degree of suspended sediment in the water column. The following photos illustrate the poor status of the reef at site one. No fish species were also observed during the survey.

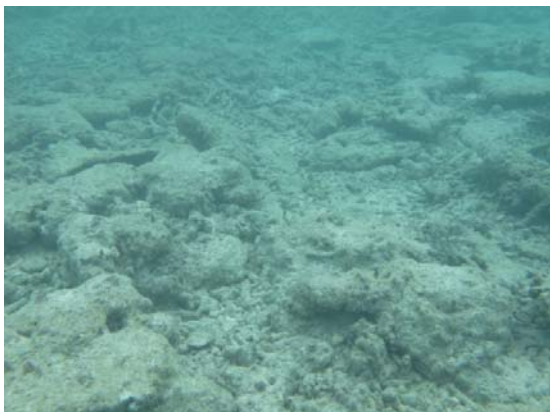
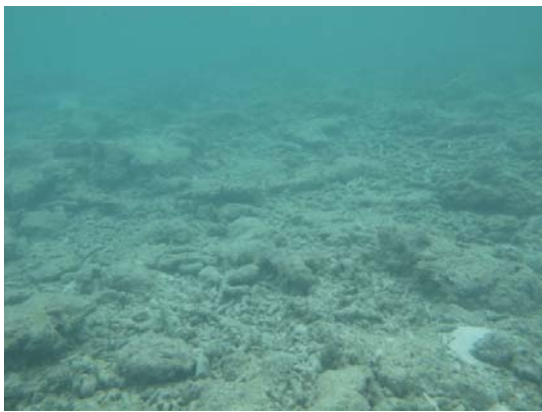
Figure 4: Photos indicating reef status at site 2 (November 2011)

Status of coral reef at site 2

The reef is completely destroyed from reclamation and there are no live corals no any fish species observed during the survey.	The bottom is filled with dead corals, rubble and suspended sediments. The reef will require time for new corals to regenerate. There is also very poor visibility from the high percentage of suspended sediments.

Similar to site 1, site 2 is also completely destroyed and there are no live corals. This is also the location where the second phase of reclamation will dredge for borrow material. There are no live corals in this site as the site has been completely destroyed from dredging. The site has not had time to recover and for new corals to regenerate, it will take few years. The entire area is filled with sediments. There is also a high degree of suspended sediment in the water column. The following photos illustrate the poor status of the reef at site one. No fish species were also observed during the survey. From the scale of the reclamation and the proximity of this site to the borrow area of phase 1, it is no surprise that the reef has been damaged severely.

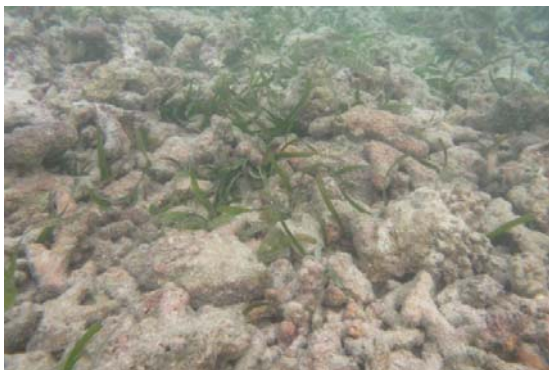
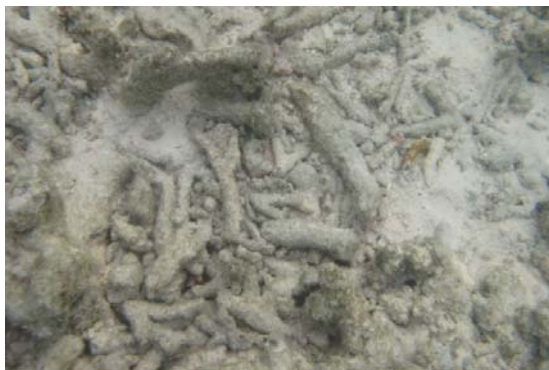
Figure 6: Photos indicating reef status at site 4 (November 2011)

Status of coral reef at site 4

Site 4 is also considered to be very unhealthy and mainly consists of coral rubbles, sand and sea grass. The status of the reef is not considered to be a result of the first phase of reclamation.

Site 4 is also considered dead and does not contain any live corals. There is growth of sea grass to some extent. The coral reef status of this site is not considered to be caused by the first phase of reclamation as the reef slope areas (site 5) has very high coral cover.

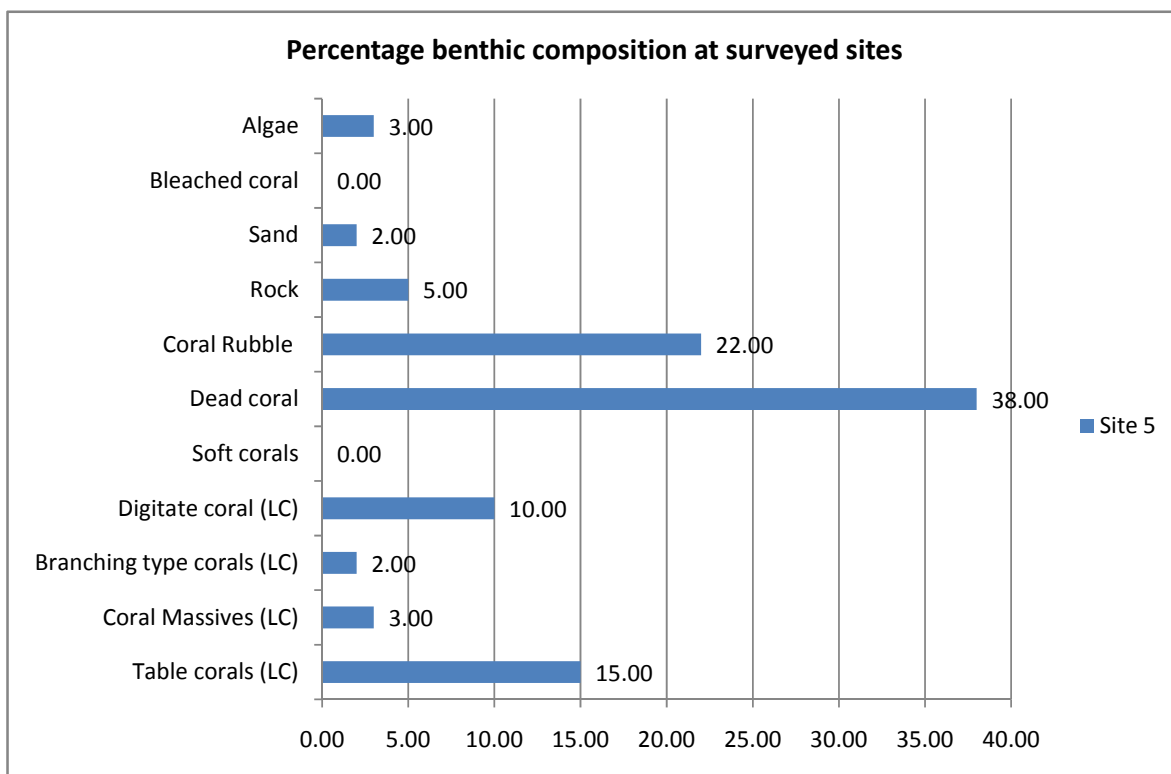
Figure 7: Percentage benthic composition at site 5 (October 2011)

Live coral cover at site 5 was 30%. The dominant type of corals recorded was *Acropora tabular*. Other live coral types recorded were Coral Massives (3%), Coral Branching (2%) and *Acropora Digitate* (10%). Of the non living components, dead rocks dominated this area with 38%. Percentage of rock was 5% and coral rubbles constitute 22%, sand 2% and algae accounting to 3%. No bleached corals were recorded or found.

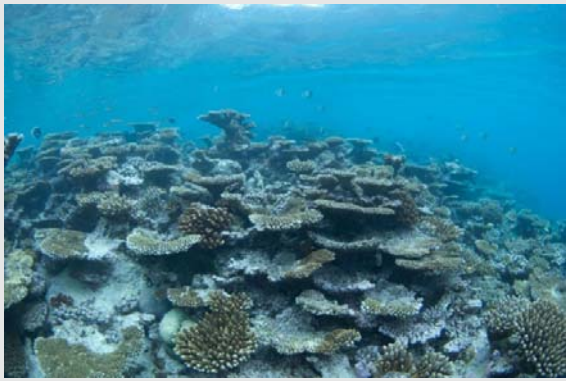
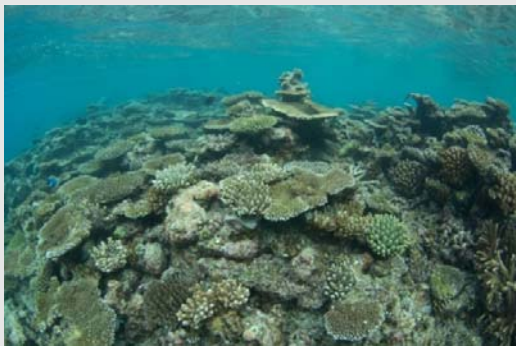
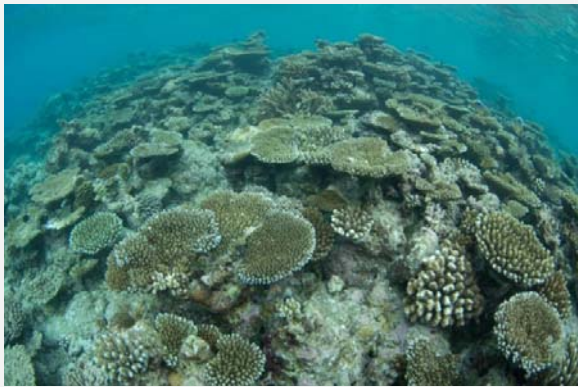
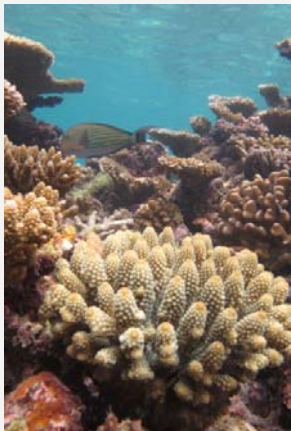
Figure 8: Photos indicating reef status at site 5 (November 2011)

<p>Site 5 has a very high percentage of live corals, mostly table corals as indicated in these photographs.</p>	<p>Most of the reef at this site is covered with hard corals.</p>

<p>The phot illustrates the coral coverage at this site. Despite the reclamation that has been undertaken in Thimarafushi, this site does not seems to have been affected as can be seen with the healthy coral population. However, the second phase of reclamation is going to destroy all or most of these corals.</p>	<p>Digitate coral colony growing among the numerous live corals.</p>

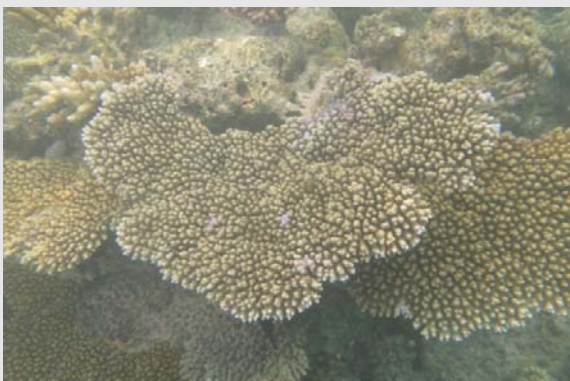
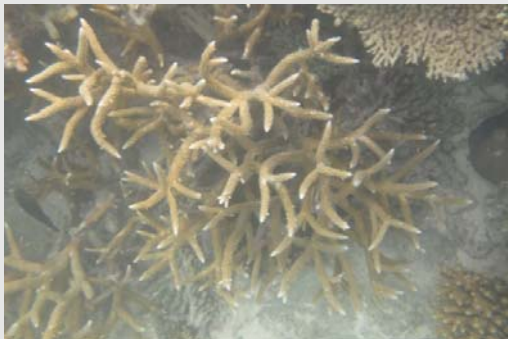
Figure 10: Photos indicating reef status at site 6 (November 2011)

<p>Table coral colonies at site 6. Despite the high coral cover, this area is heavily affected by reclamation mainly through sedimentation. .</p>	<p>Branching coral colony under stress from excessive sedimentation.</p>
