# ENVIRONMENTAL IMPACT ASSESSMENT

## Coastal Protection Works, Ihuru, Kaafu Atoll, Maldives

Proponent: Angsana Hotels and Resorts

September 2012

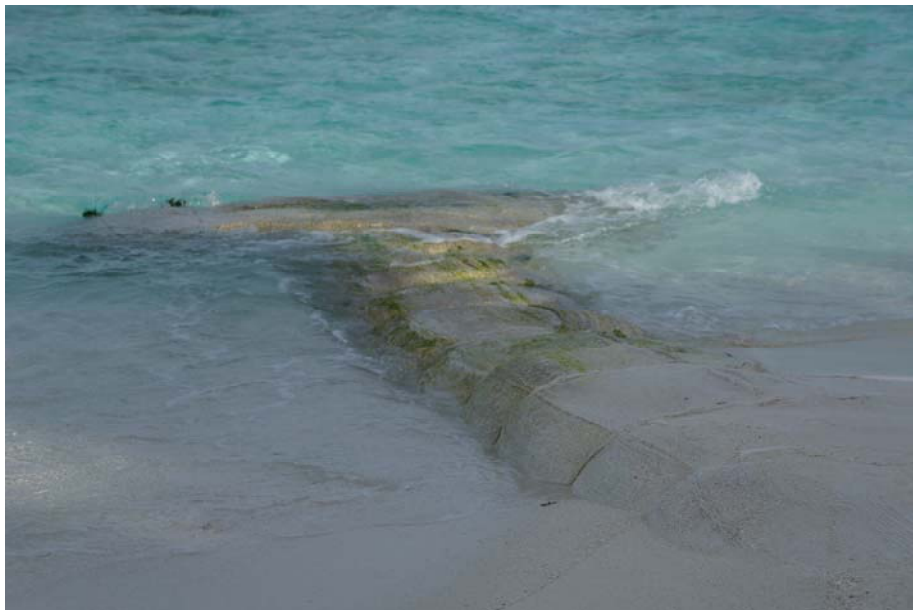
**Figure 4 Sand Bag Groyne constructed in the island**

The other practice for beach maintenance is groyne construction. Temporary groynes are constructed using sand bags laid perpendicular to the shoreline to an average 13 m in length. Sand bags are made from white nylon material that is not very durable. The white colour gives an aesthetic look to the groynes, and the material has to be replaced frequently to

preserve this appeal. A longer lasting material was not chosen, as the operators preferred to have a material that has to be renewed frequently. About 11 groynes are present around the island at any given time as shown in Figure 5. The distance between the groynes are not uniform and ranges from 20 – 30m.

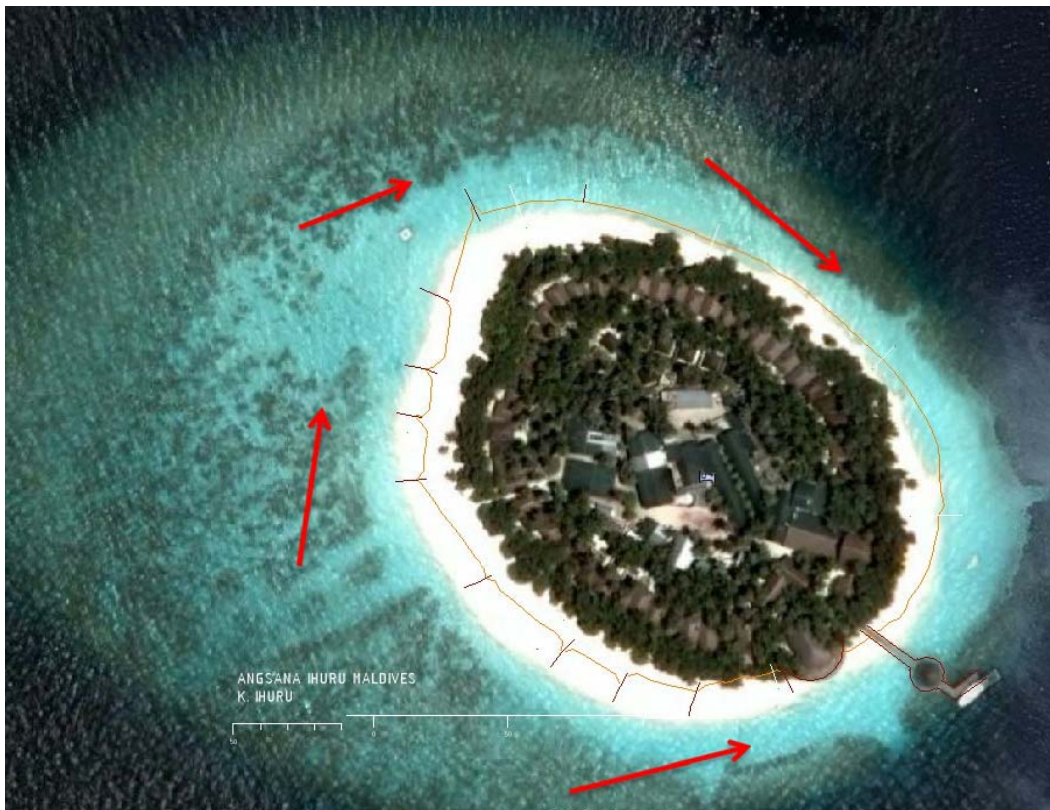
**Figure 6 General current flow direction (June 2012)**

The drogues indicated that at the time of survey, the main component of long-shore current around Ihuru is due to wave-generated currents from the west. On the day of the field visit in June 2012, the wind was in an easterly direction, i.e. from the west. Furthermore, due to wave propagation onto the southwest portion of the reef, it drives the current flow northwards along the western shoreline and eastward along the southern and northern shorelines as shown in Figure 6. Additionally, due to swells from the southeast, it has been observed that the current in a westerly direction is dominant during certain occasions. However, in general the sediment transport and the subsequent erosion and accretion pattern follow the general pattern for similar islands in the Maldives as had been researched in numerous studies including studies by Kench et al. 2003.

Drogue tests were done at different locations around the island in order to assess the movement of the water body around the island and to determine seasonal current movement and sediment transport patterns. The results of the drogue tests done as included in the island map shown in Annex 5.

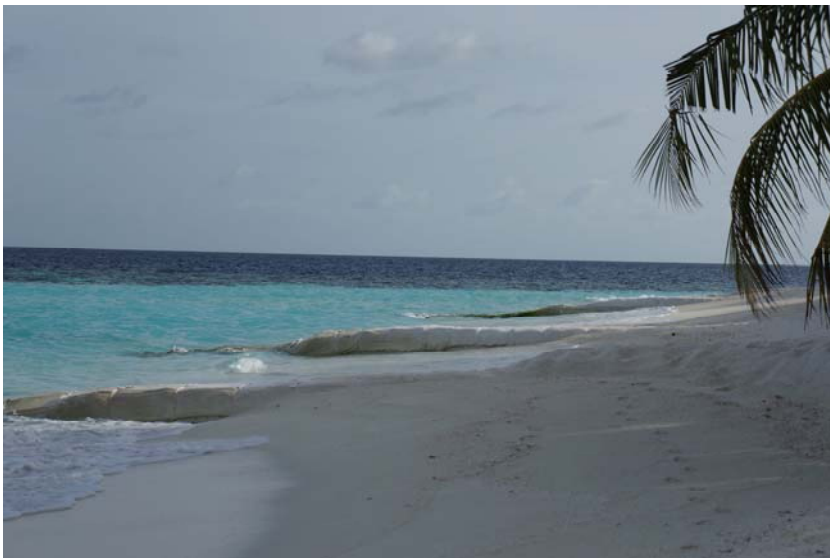
**Figure 7 Groyne Field along the shoreline**

Coastal protection structures are at a minimum at Ihuru mainly for aesthetic reasons. There are no hard engineering structures, which means there is no rock or concrete revetment or breakwater or groyne to be found anywhere in the island. However temporary groynes made from sand bags can be found with significant distances between them, all around the island. They had lengths of approximately 15m. Image of groynes along the shore is shown in Figure 7.

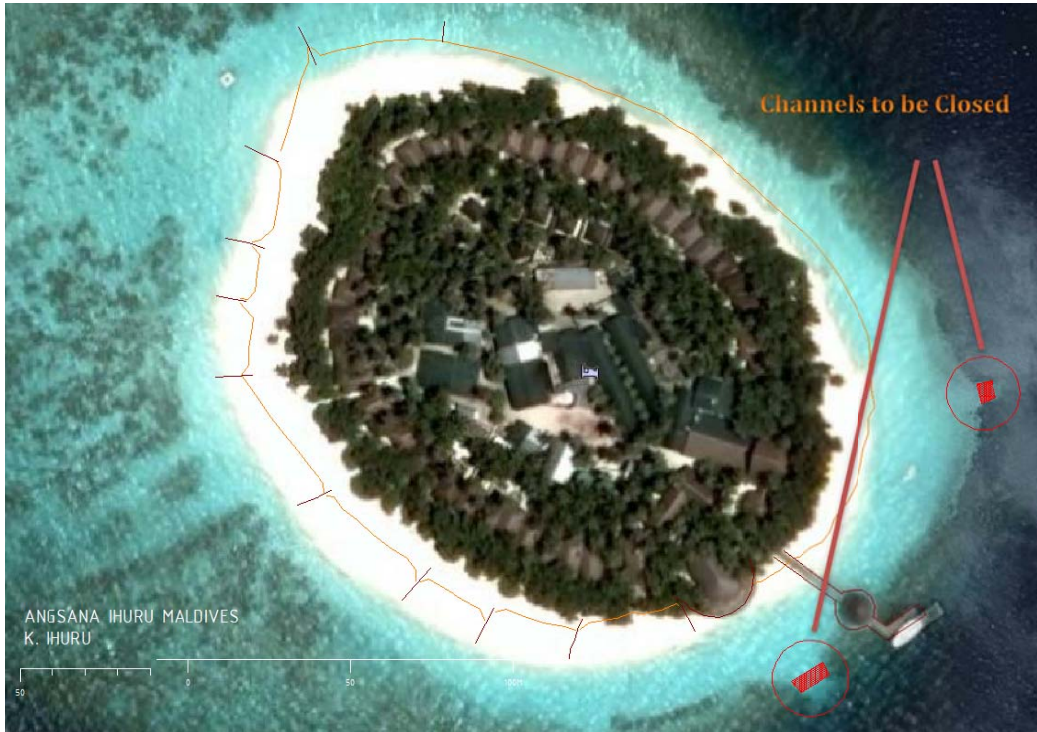
**Figure 13** Two entrance channels that need to be closed

would also allow for better absorption of incoming wave energy. Details of the design are to be investigated with the assistance of a civil or coastal engineer. Locations in which the channels are to be closed are shown in Figure 13.

However, in addition to making it convenient for snorkelers and divers, it also makes it convenient for waves to enter the lagoon without any obstructions. Subsequently, it encourages cross shore transport of sand out of the lagoon. Therefore as a permanent but minor civil works, concrete blocks are recommended to be laid in these two locations. Sulphate resistant cement is recommended to be used to cast these blocks and the surface of the blocks should be smooth so that the channels original purpose can still be fulfilled i.e. guests should still be able to use the pathway. A concrete pyramid shaped block can be made such that there would be steps on both sides and guests would find it easy to climb up and down pass the reef edge. Also these steps
