Addendum to:

# Environmental Impact Assessment for Tourist Resort Development on Malefushi Island – Thaa Atoll

Proposed by  
Investment Venture Pvt. Ltd.

September 2012

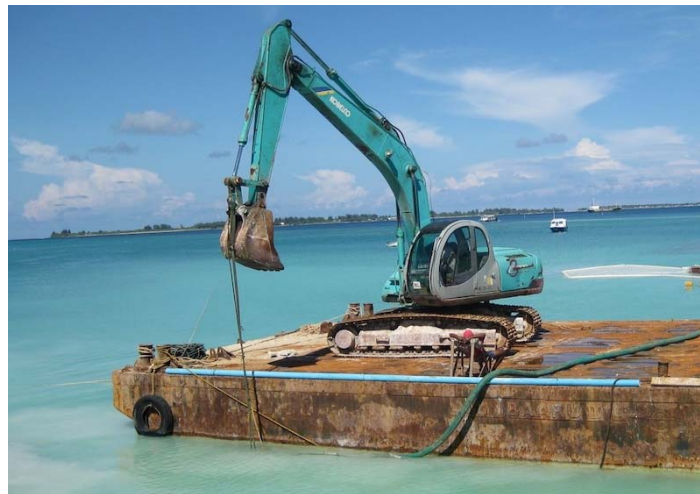
**Figure 1:** An excavator mounted on barge will be used to deploy the concrete footings at the site.

The lagoon area of the proposed development is about 1.5-2.0 m deep and so a hatched-barge will be used as a working platform. An excavator will be mounted on the barge for burrowing (or digging) and deployment of the footings (Figure 1).

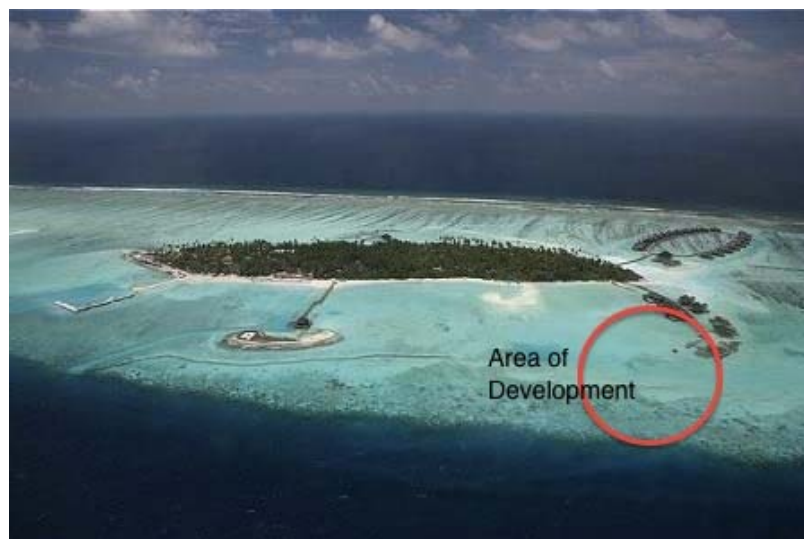
**Figure 3:** Image of the island the surrounding areas to show the lagoon and are where development relating to scope change takes place.

A reef survey was carried out on 06 September 2012. Sequence of underwater photographs in the area marked development in Figure 3 was obtained. As expected the images revealed a substrate of coarse sand devoid of any hard corals. Pieces of broken *Acropora* sp. (branching coral) was founded in some areas. Towards the reef edge, however reef lives coral cover was significant. There were no obvious signs of damage or degradation caused by the construction activity.

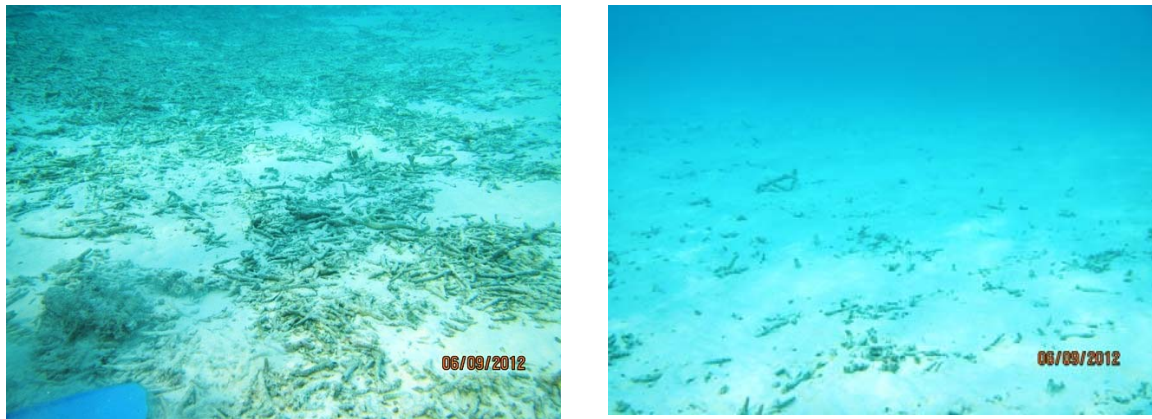
**Lagoon Substrate:** The lagoon area marked in Figure 3 has a substrate of coarse sand. Areas closer to the existing over-water bungalows is completely devoid of corals except in few area where broken pieces of Acropora (Figure 4 right). The sand is soft and so it is likely to cause to some amount of sediment suspension and turbidity during placement of concrete footings. In areas closer to the reef the amount of broken Acropora on the substrate is significantly increased (Figure 4 left).

**Figure 4:** Sample images of lagoon – the area where the new over-water bungalows will be built.

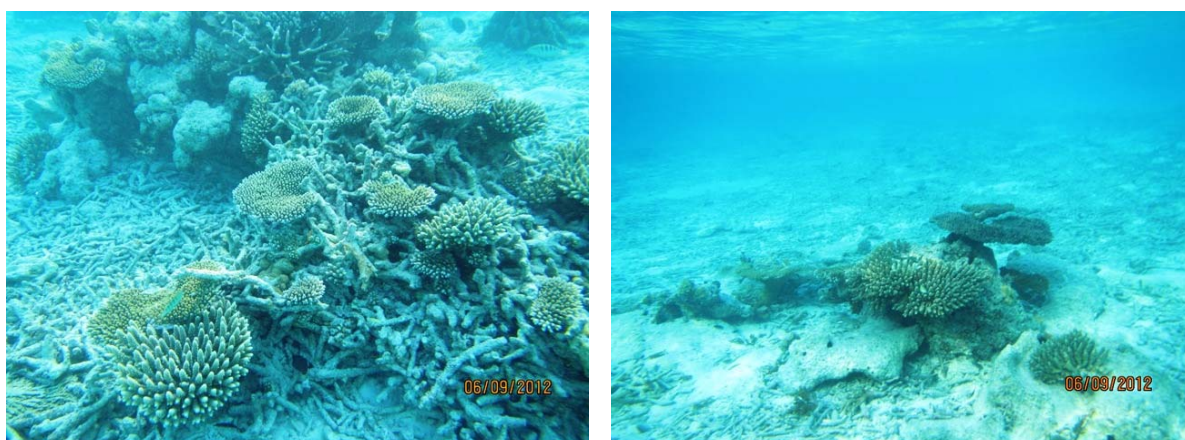
**Figure 5:** Sample images from the reef close to the sandy lagoon just in front of the proposed development area.

**Coral Reef:** The EIA reported average live coral cover of 15% consisting mainly Acropora, table corals, digitate and missives (porite heads). Close to 40% of the cover was estimated to be dead corals covered with algae and around 15% unconsolidated rubble and 32-35% sandy bottom. These results were in general agreement with what was observed on survey of the area (Figure 5 and Figure 6).

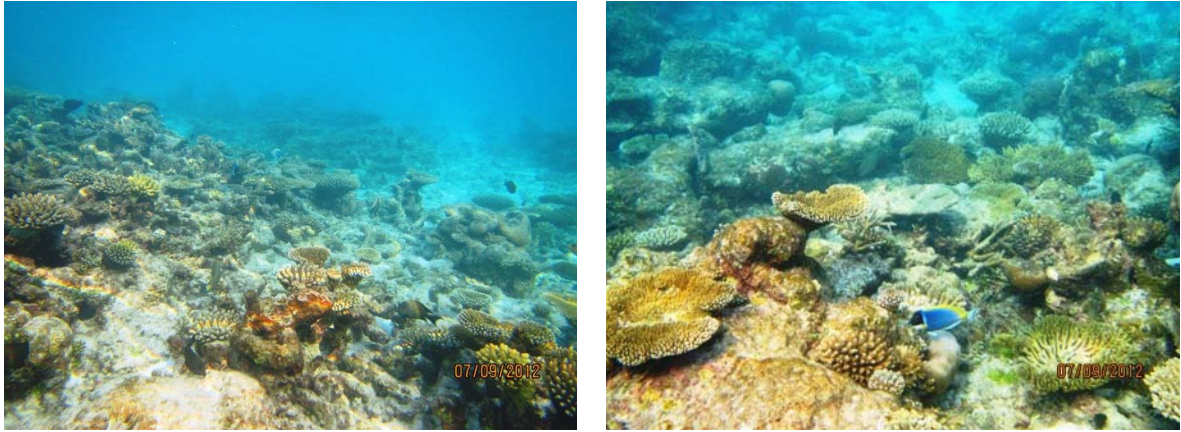
**Figure 6:** Typical images form reef top in front of the proposed development.

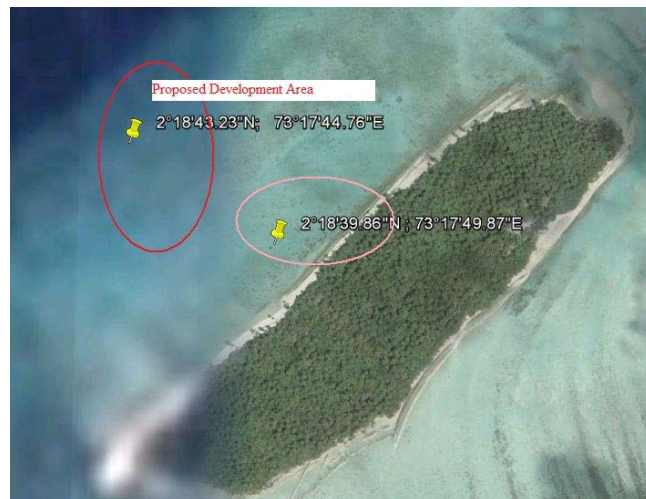
**Figure 7:** Area to show the water sampling location; Sample #1: Proposed Development Area; Sample #2: General lagoon area.

**Water Quality:** Water samples were taken from two locations, one in the general lagoon area and other from the area of the development (Figure 7). The test results show that water quality is normal. The water was clear and with no traces of turbid conditions. The water quality results are given in Annex 3.
