# **Environmental Impact Assessment for Coastal Works** at Reethi Beach Resort

**July 2010**

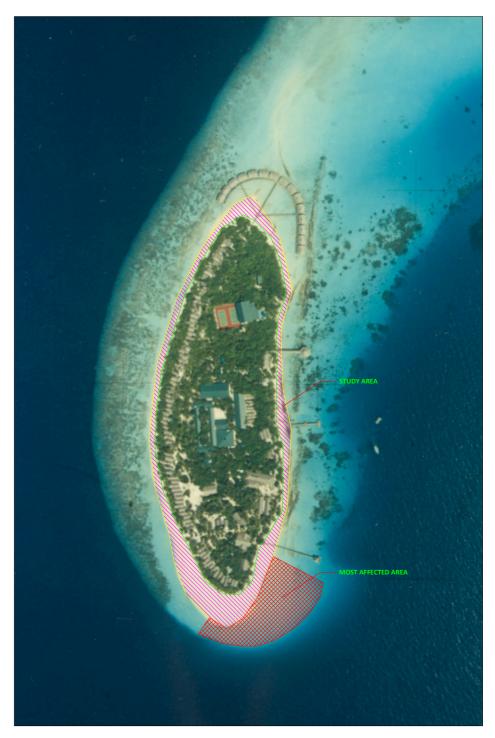
Figure 2: Survey Boundary Area

affect negatively other reefs or islands outside the reef system. The boundaries of the survey area are shown in the figure below (Fig. 2)

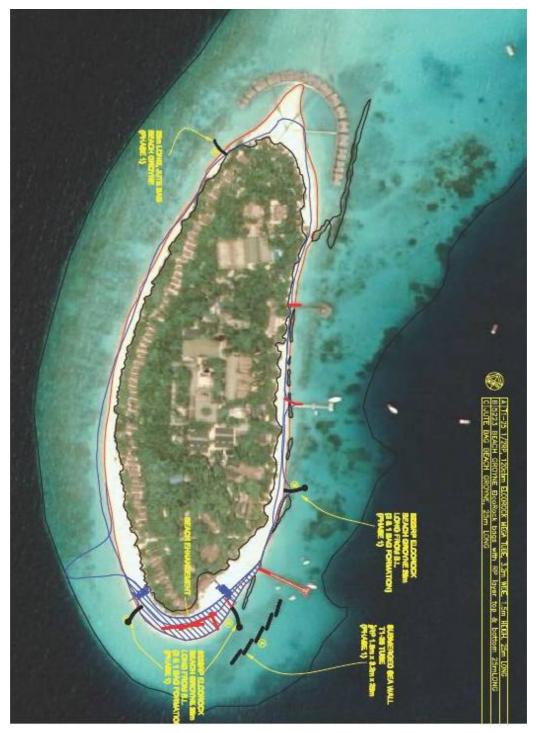
Figure 3: coastal structure designs at B. Fonimagoodhoo, the proposed structures are in black

Following is a site plan of the island with the proposed coastal protection envisaged to secure the southern part of the island (Fig. 3)

Previously a number of different options have been adopted, which have proved not very long lasting, these included sand bags on the shoreline, cement bag revetments, groynes of various shapes and designs, coir mesh to retain bags, etc... The present project is looking at more permanent solutions to ensure the aesthetics of the beach and the satisfaction of the guests. Based on previous observations, a combination of shore perpendicular and off shore parallel structures has been opted for drawn in black (Fig. 3).

On the site plan, the structures drawn in red already exist, which were implemented after the Tsunami, and will be maintained as last resort coastal protections.

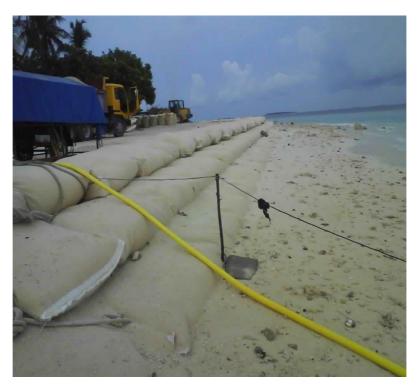
Figure 4: A beach protection revetment installed in R. Maduvvari using Elcorock containers

The new structures will be made of Elcorock Beach Protection systems (Fig 4). These consist of containers made of perforated geotextile allowing the sediment to stay inside the container, while the water is drained through the small openings. Once filled, the smaller bags (5 tons) will be placed using excavator. Geotubes, made with of the same fabric are placed in situ and sand pumped from the sandbarge directly. These are very durable and will be installed to create the different groynes and breakwater as highlighted in the drawing. The northern groyne will be built out of jute bags containing a mix of cement and sand as is done in many islands around the Maldives.

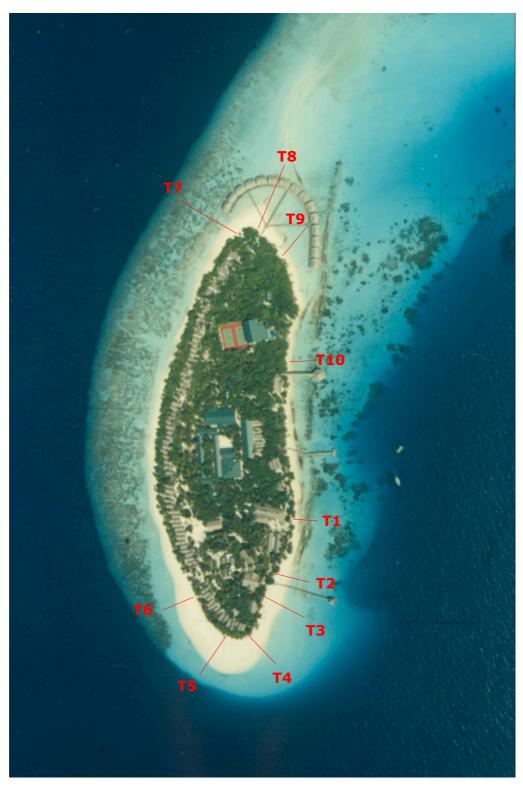
Figure 21: Beach Profiles

All the beach profiles were taken from the areas, where the current project is predicted to have most effect.

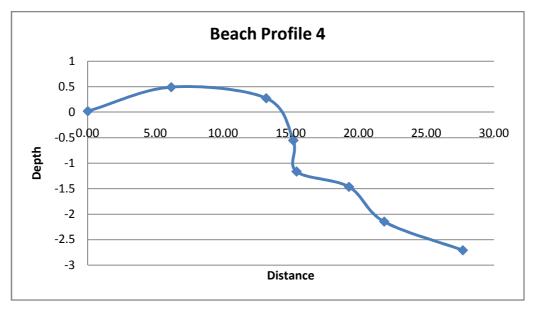
Figure 25: Southern tip of the island

Sand has been pumped inside some geo-textile pockets to retain the sand. The swells coming and pounding on the beach are very strong since this area is exposed to the ocean side. The sudden dip in the graph is where the containers end, also we can see from the graph that it gets deeper just after 5 meters from the containers. This area is the most affected area from the waves.

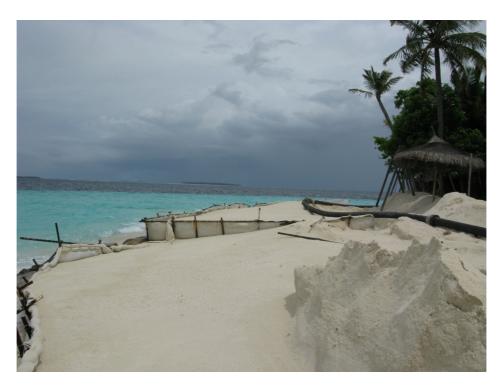
Figure 26: Geo-textile pockets retaining the sand on the south-western corner of the island

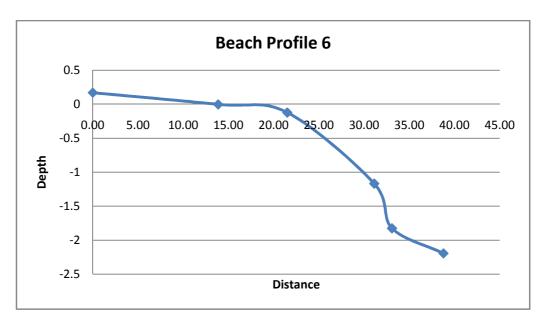
Figure 28: Western side near the refreshment hut

The beach is getting closer to the reef and from the graph we can see the sudden trough in the beach profile where it reaches up to depths 2.5m before reaching the reef flat. In general the beach is in good condition.

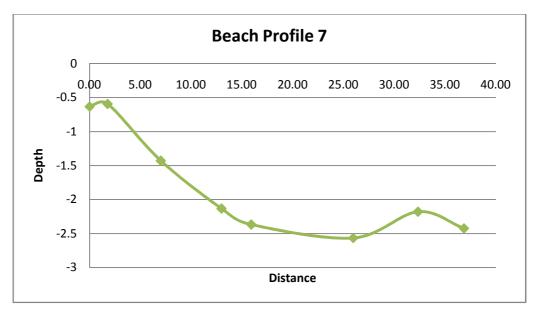
Figure 29: Near to the western end of the water villas

The rise in the graph is at 32m from the start of the profile is due to the presence of beach rock, which probably denotes a larger island in that area. This part of the island is exposed the swell refracted around the Vandhoomaa faru.

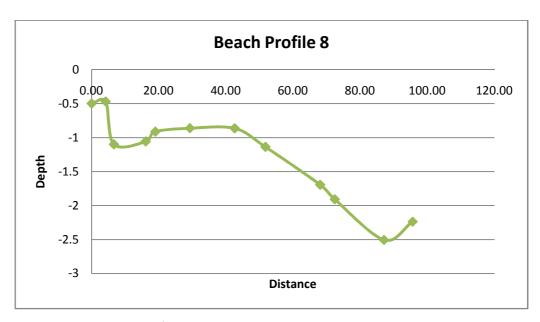
Figure 30: Near the walk way of the water villas

Profile 8 is along the northern sandy tip extending north of the island. The crest consists in a micro cliff at about 4 meters into the profile which marks the maximum of erosion and vegetation loss noticed previously. Further into the profile, the sand level is rising thanks to some structures made of jute bags filled with a cement and sand mix implemented by the management to hold back the sand. At the end of the profile, beach rock is present, denoting a more northward position of the island in the past.

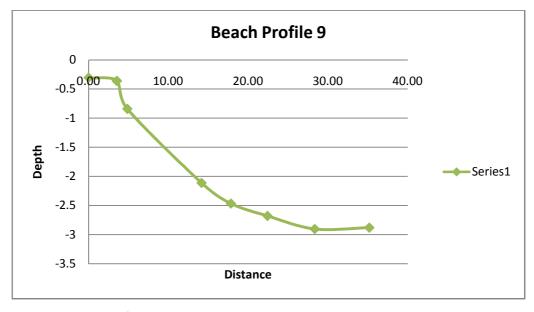
Figure 31: near the end of the water villas to the east

The beach starts to get steadier from this profile onwards towards the south again. Lots of small rocks were observed in this profile. In this part, a micro cliff is still present due to scouring during the northeast monsoon. The beach face is accumulating sediment during the southwest monsoon.

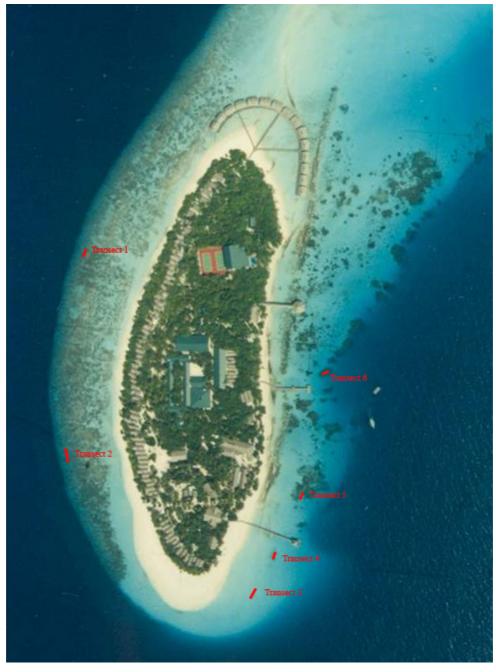
The coral reef environment was surveyed on 16th June 2010. To assess the benthic cover 6 photographic transects were carried out on the reef. The areas surveyed have been chosen to serve as a baseline to assess anticipated impacts occurring during the construction and operational stage. The fish life was visually assessed around the island.

Figure 33: survey site plan showing the different transects around the island

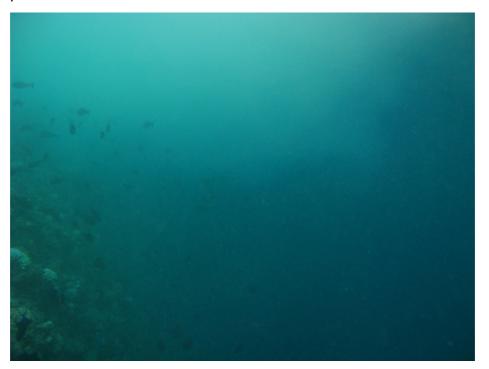
Figure 36: The sediment plume originating from the reef flat contrasts with the deeper less turbid waters.

It is also possible that corals do not grow on the western side due to high turbidity and sedimentation. This is due to the presence of sediment on the western reef flat, in particular on its southern side, which causes the sediment to be resuspended by wave action. Due to the coastal modification brought about to tackle the erosion problem on the southern side, the sandy tip in that area has been moved northwards and westwards to the edge of the reef. The sediment resuspension is illustrated in the following figure (Fig 35) where the sediment plume from the reef flat is highly very visible.
