**ENVIRONMENTAL IMPACT ASSESSMENT
FOR THE EXTENSION OF SERVICE JETTY,
MALÉ AERATED WATER COMPANY, MAWC,
THULUSHDHOO – K MALÉ**

APRIL 2010

**M. S. ADAM (EIA 01/07)
A. NASEER**

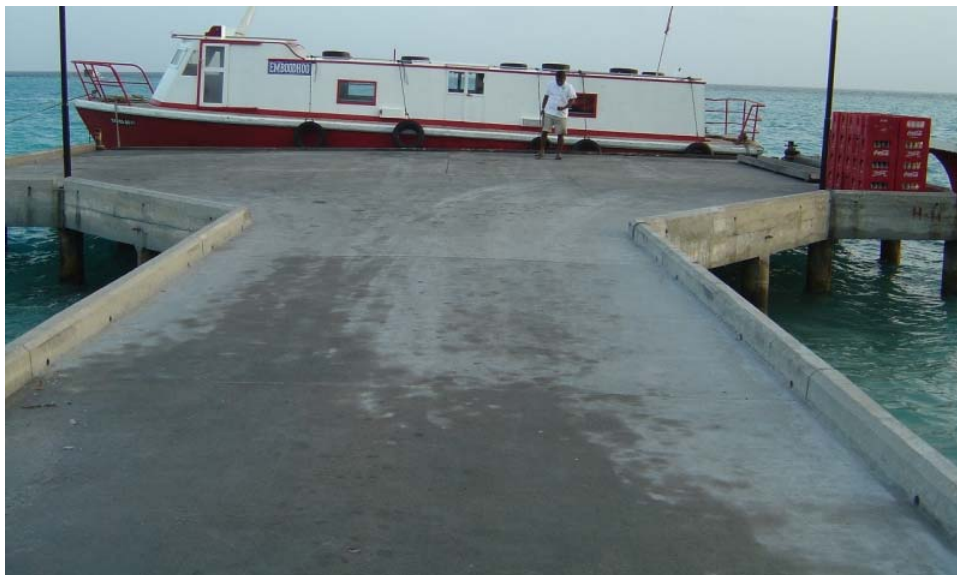
Figure 2: Existing Service Jetty looking towards the lagoon. The jetty head is of hexagonal shape to increase the length of the 'quay-wall'.

The existing service jetty was constructed in 2000. At the time it was anticipated the volume of the bottled products would not increase much and so the jetty size was kept to a minimum. In order to obtain the maximum quay wall space the jetty was constructed in the shape of the pentagon which allowed more than one boat to be served at any given time.

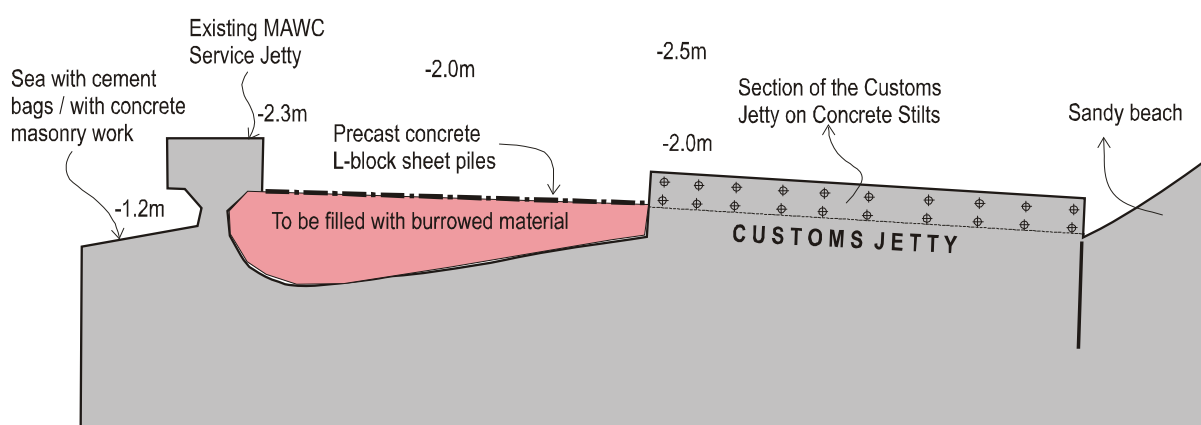
Figure 4: Detailed plan view of the project area. The area will be filled with the material borrowed from the adjacent areas

The major development activity would be to dredge the immediate area and to build the quay wall. Concrete slabs of the type described in Figure 4(a) and Figure 13 will be placed along a straight line starting from the Customs Jetty to the corner of the existing MAWC jetty as shown in Figure 4 (b). The point at which the concrete sheets touch the Customs Jetty is important. Customs jetty has two sections; a section constructed on stilts on the front and a filled section at the back. It is proposed that MAWC's extensions should be aligned to Customs Jetty at the point intersection as identified in Figure 4. A total of 22 such concrete slabs would be required. They are available for sale (Rf, 28,000/-) at Maldives Works Corporation.

It is estimated that about 2,300 cubic meters of material would be required to fill the area to the level of the island. Fill material may be excavated around the area. At present the area is shallow about -0.5m and would require excavate to a depth of -2.0 m to be able to be used as jetty. Once levelled capping may be required before the quay wall can be constructed.

1. *Dredging and deepening of the proposed area (Figure 3, 7 & 10)*
2. *Construction of the quay wall (Figures 3 and 4)*
3. *Infilling and reclamation of the quay wall with dredged material*

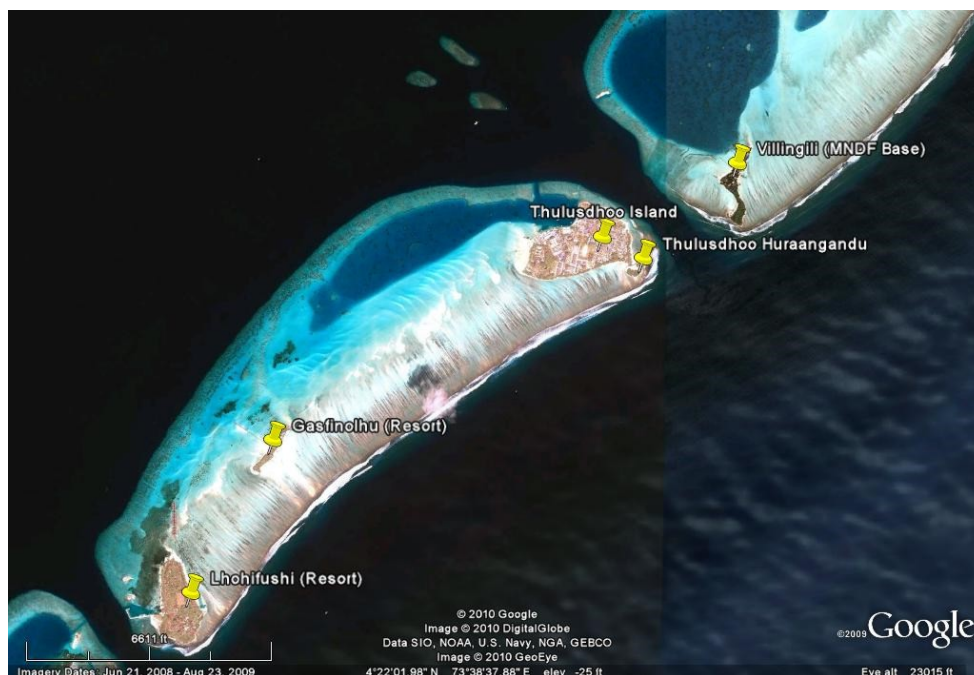
Thulusdhoo Island is located at the north eastern tip of a large rim reef on the south western side of North Malé Atoll. The reef is about 6 km in length and has a width of about 2 km. The total area of the reef is about 15 sq km (Figure 7). The reef houses two other islands namely Gasfinolhu and Lhohifushi. Both are popular tourist resorts.

Figure 7: Island of Thulusdhoo and the adjacent area.

It is predicted that the stability of the beach to the north-east of the development depends on the “bay-effect” created by shape of the shoreline (Figure 7). The development proposed here does not alter the shoreline significantly to produce a major change in shoreline and will not alter the “bay-effect” of the area.

Major sedimentary movements and processes are evident towards the western side of Thulusdhoo Island. Major accretion processes are also observed to the west of the island (Figure 7). These movements appear to be the net result of the SE swells and the SW monsoon winds reaching the reef of Thulusdhoo. The movement of sand around the west end of the island towards north and east means that the quay side will have to be deepened up periodically.

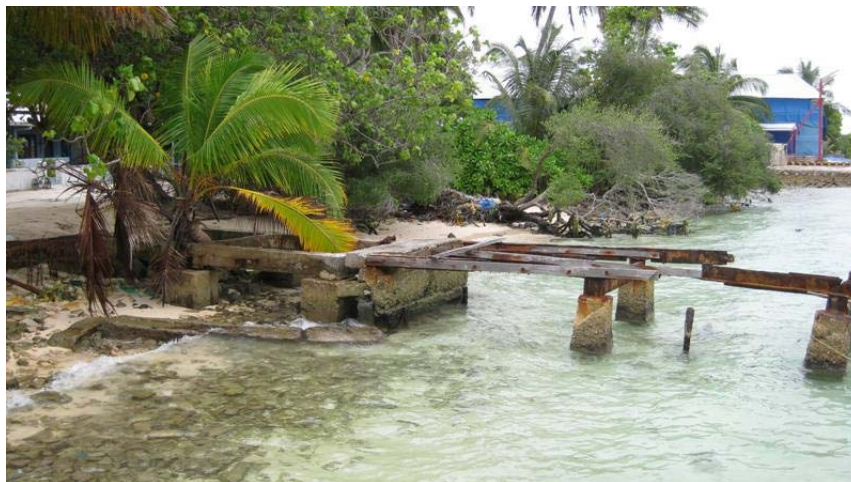
Figure 8: Project site looking from Customs Jetty with the broken jetty in the foreground.

This short stretch of coastal area is devoid of sandy beach . Rubble and coastal vegetation dominate the area. A jetty built on stilts with iron struts lie broken one third of the way from the Customs Jetty. The concrete stilts have been shattered exposing its reinforced deformed bars. The struts are rusted and corroded heavily. The rocky beach is littered with construction waste of masonry origin.

The area to be developed is currently an eyesore (Figure 8, Figure 9). The development activity will result in improved beach and shoreline conditions and present a more aesthetically appealing look overall. The jetty is expected to improve the production capacity and transport, and marketing of MAWC beverage products possibly leading to job opportunities and more income to the community.

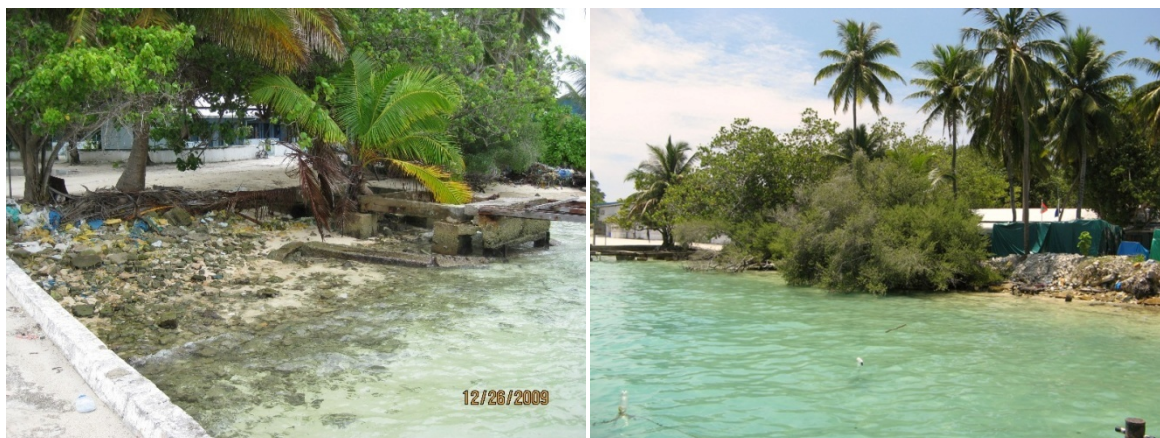
Figure 9: Project site; looking from north towards to Coal Jetty (left) and looking from south towards Customs Jetty (right).

Two dhigaa trees (*Hibiscus tiliaceus*) and five coconut palms (*Cocos nucifera*) exists in the area. At the southern section close the Coca Cola Jetty, a small area of the kuredhi (*Pemphis acudula*) exist. Here a large rubble mound of masonry origin has been dumped presumably in effort to arrest the scouring and erosion taking place. Diagonally starting from the main Coca Cola Jetty a sand-bagged seawall/breakwater has been erected to prevent erosion.

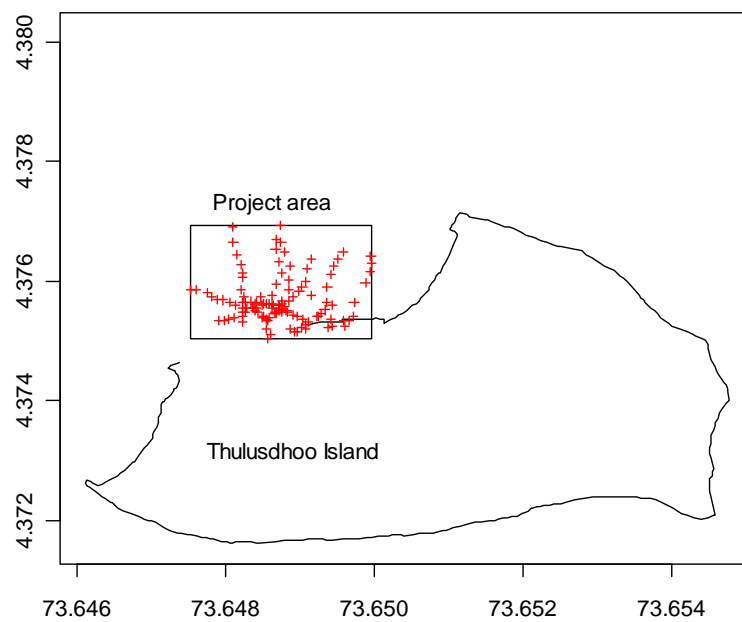
Figure 10: Schematic Section of the Thulusdhoo showing the project area and the area where depth measurements were taken. The crosses represent individual depth measurements.

measured along the quay wall from MAWC jetty to the Customs jetty at 6 points replicating the baseline depth measurements collected as part of this assessment.

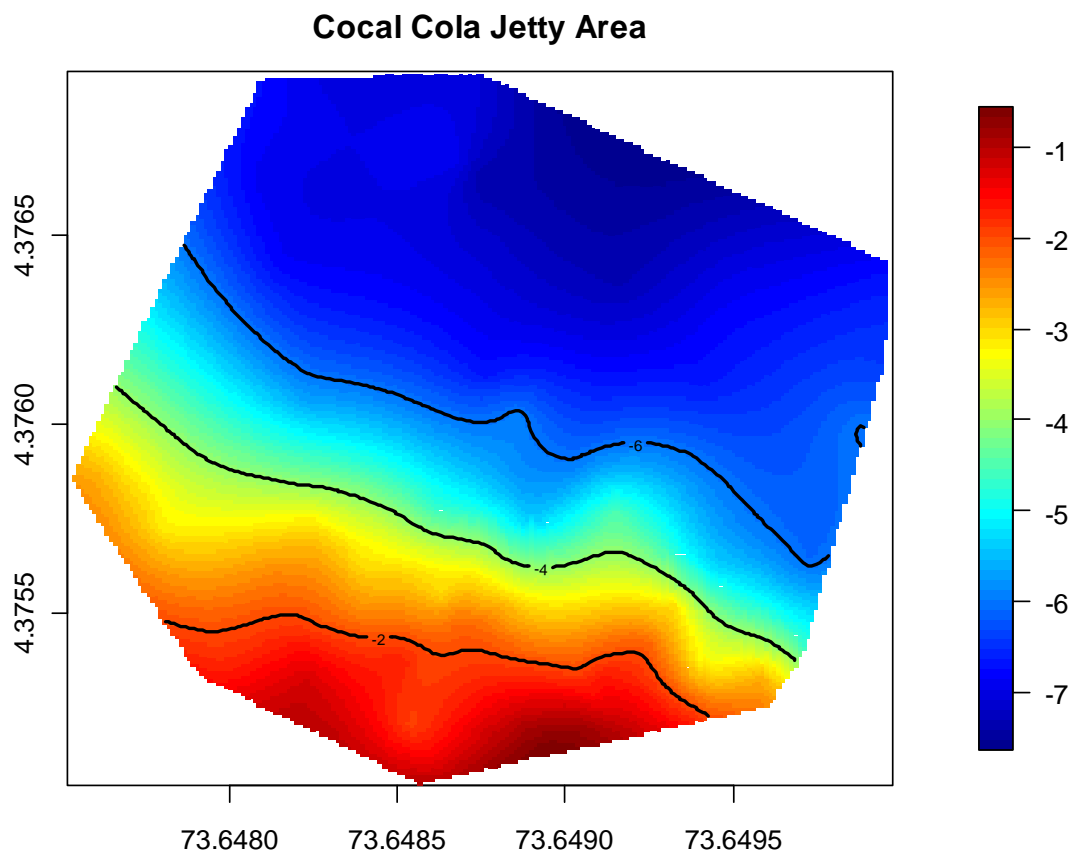
Figure 11: Depth contours of the project depicted using kriging function in R-statistical Package. Close to the jetty it is quite shallow ranging from 1.0 m and gradually going to 7.0m.

The surrounding marine area was studied extensively during the 2004 when an IEE conducted to protect coastal area between the Coca Cola Jetty and Precision Marine's yard. Over 100 depth measurements and its GPS positions were taken using a handheld GPS (Figure 10). The results indicated that near-shore areas were about 0.8-7.0 m (Figure 11). Close the jetty the depth is around 1.0 which is sufficient for the supply vessels used by the MAWC.

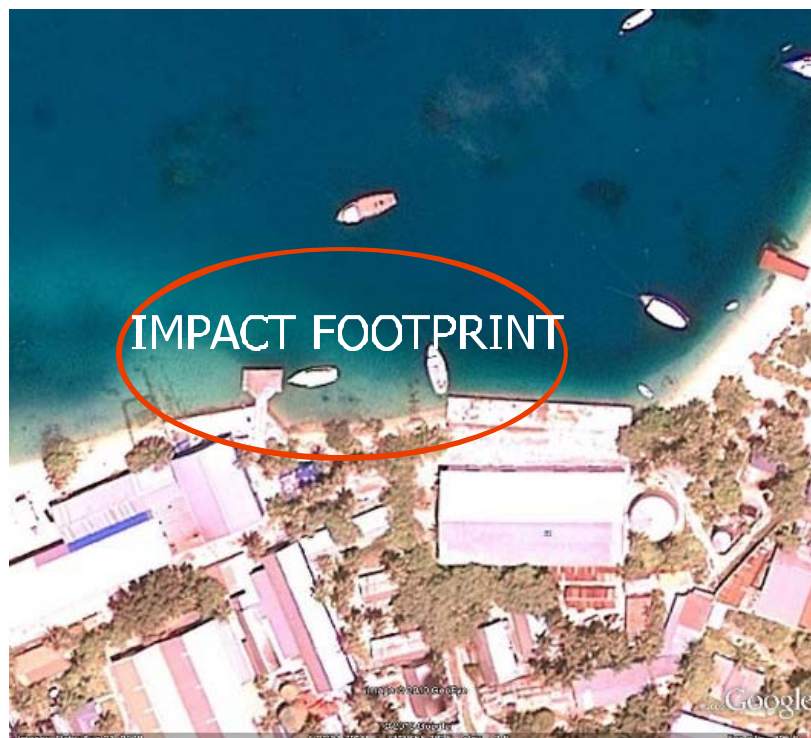
Figure 12: Coca Cola Factory area to show the impact footprint. The foot print will be limited to the surrounding areas immediate to the project activities.

As described earlier the actual area of project and its impact footprint is relatively small (Figure 12). It occupies an area of only 745 sqm (58m linear length) between the Customs Jetty and the present Coca Cola Jetty (Figure 8 and Figure 9).

This section describes the development impacts of the extension of the jetty (Figure 12). Impacts from the proposed method of the construction and back-filling are discussed. Major Impacts from the extension of the jetty proposed in this development relates to the following activities:

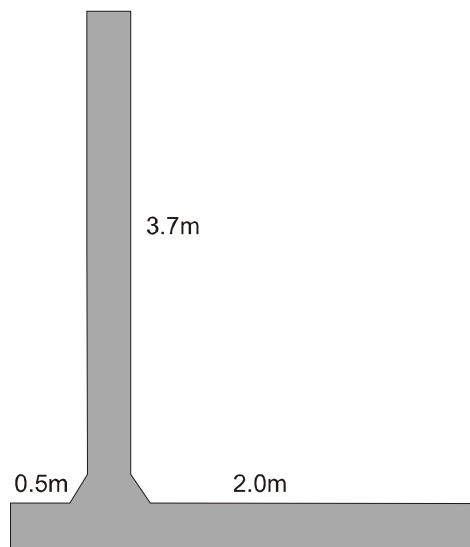
Figure 13: Example of how pre-cast concrete slabs can be used alternative to sheet piling of the breakwater and quay wall. The technique is commonly used in the Maldives instead of cement-bagged breakwaters.

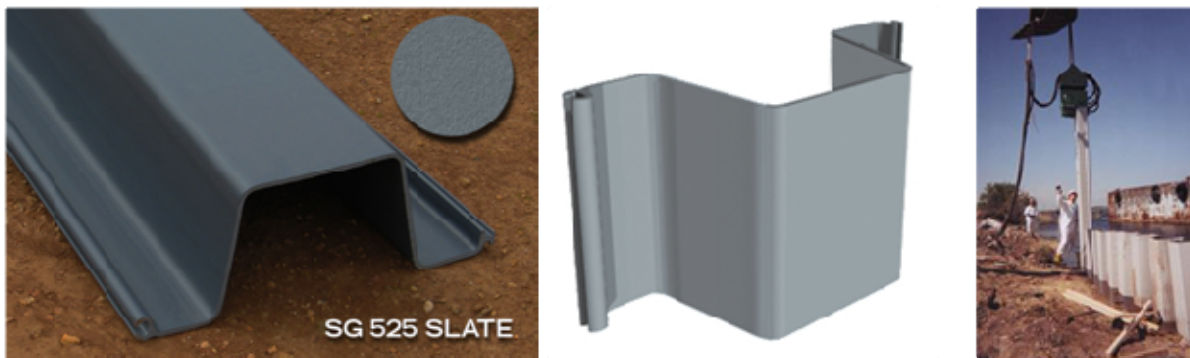
Figure 14: Example of the metal sheet piling. Both the material and the construction is expensive.

3. **Sheet piling:** (Figure 14): Construction of the quay wall by piling in metal sheets is commonly called sheet piling. This has been the preferred methods in large development projects. It is expensive and unnecessary for a small project of this nature.
