Project: EIA for the proposed development of a senior football ground, access road and water sports area
INSA PVT LTD H.Dhooriha, 5th Floor, Kalaafaanu Hingun, Male', 20076, Maldives.

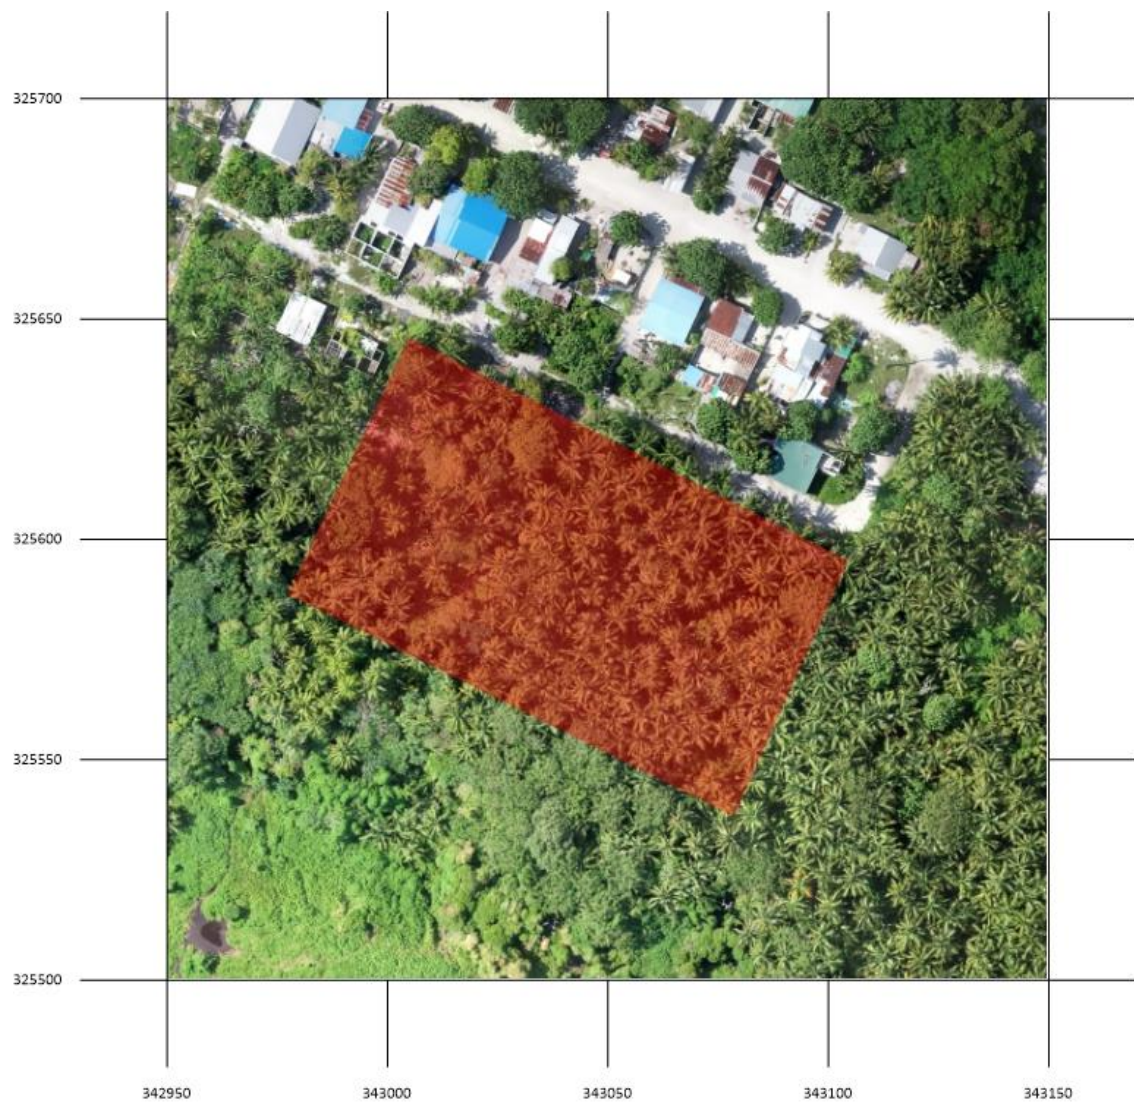
Figure 2 Project boundary and site football ground (reduced version)

Football area map

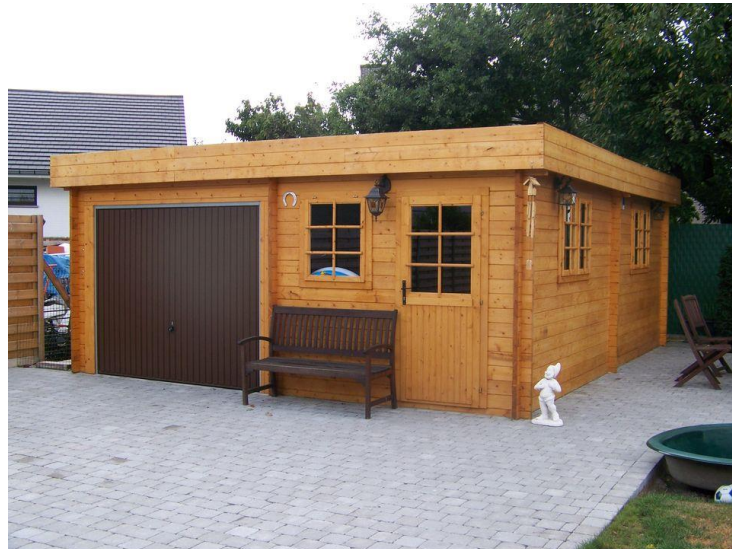
The beach huts will be prefabricated and put together on site. The site will have a minimum excavation as it is just in the periphery of the buffer zone. A pad footing foundation may be included if in the design.

Figure 5 Prefabricated hut (source: <https://logcabins.co.uk/products/mr-hancocks-workshop/>)

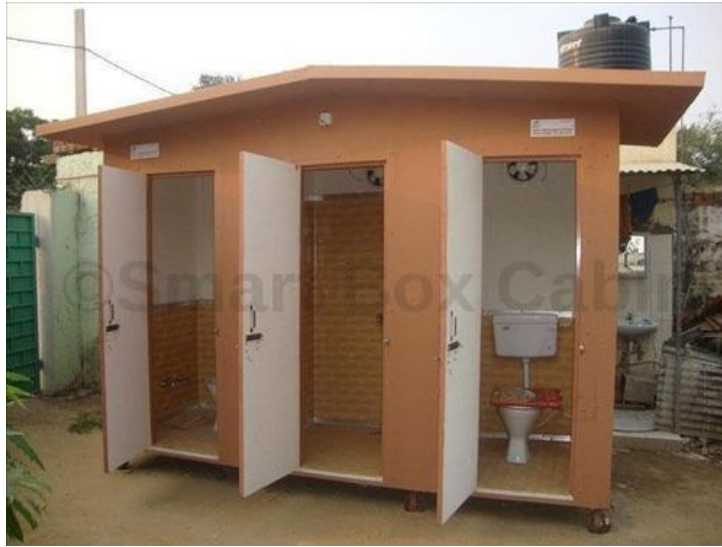
The beach hut will be behind the riparian vegetation. The beach hut will be of dimensions. The 3 shower areas will be placed behind the beach hut covered by a fencing.

Figure 6 utility hu prefab (source: <https://www.indiamart.com/proddetail/prefabricated-toilet-block-12599495112.html>)

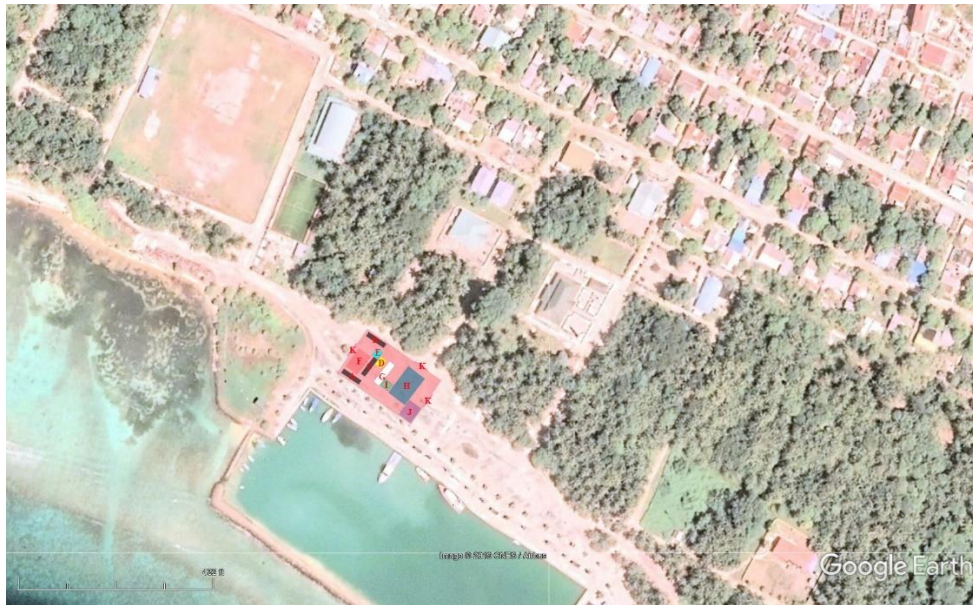
Temporary housing will be created in the work camp. The proponent is required to request for the work camp area prior to mobilization. The most optimal work camp area is on the harbor in the coordinates 2.945907° 73.582883 °.

Figure 12 The location of the work camp on the harbor

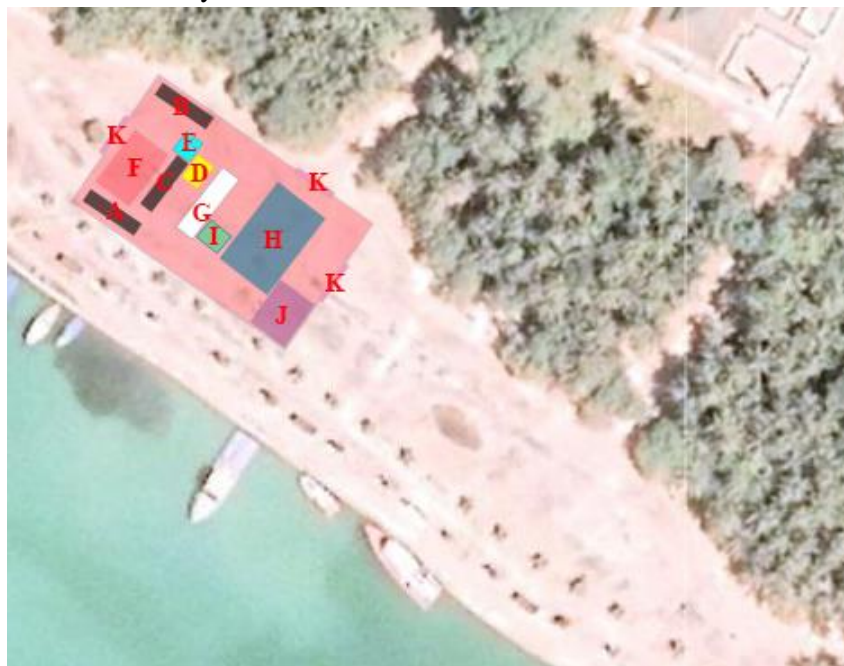
Figure 13 Tentative components of the work area

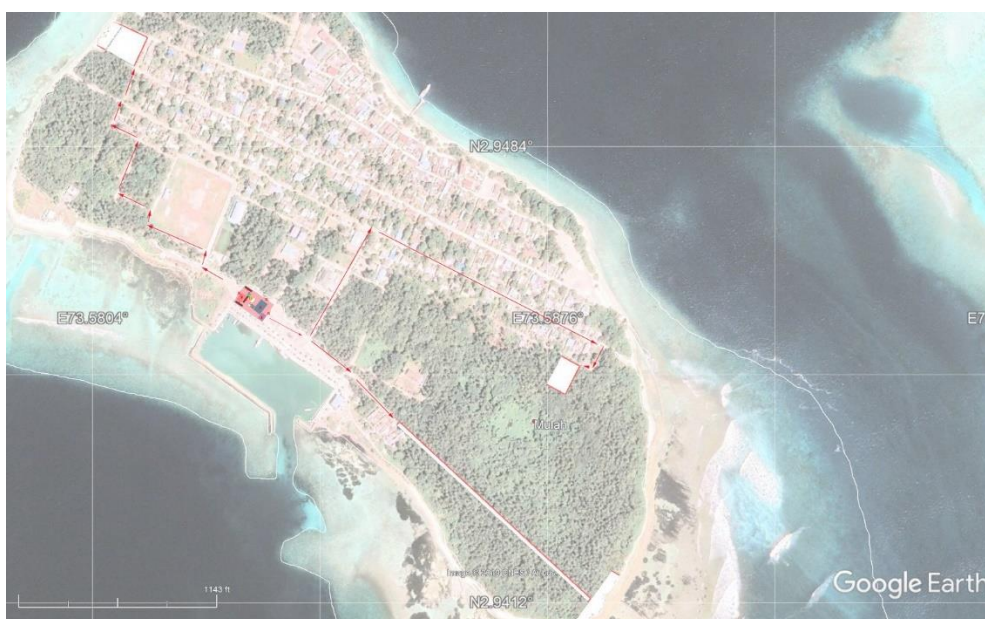
The path that leads to the senior football ground area is a packed residential zone, and the road floods during rainy season. although not ideal, the football ground is proposed at the current location and access is necessary. The road to the waste management area is direct hence is the least problematic path in the process. the water sports area is the most difficult area to reach with heavy machinery. The beach path should be avoided and saved as the last option.

Figure 14 Optimal drive path advised

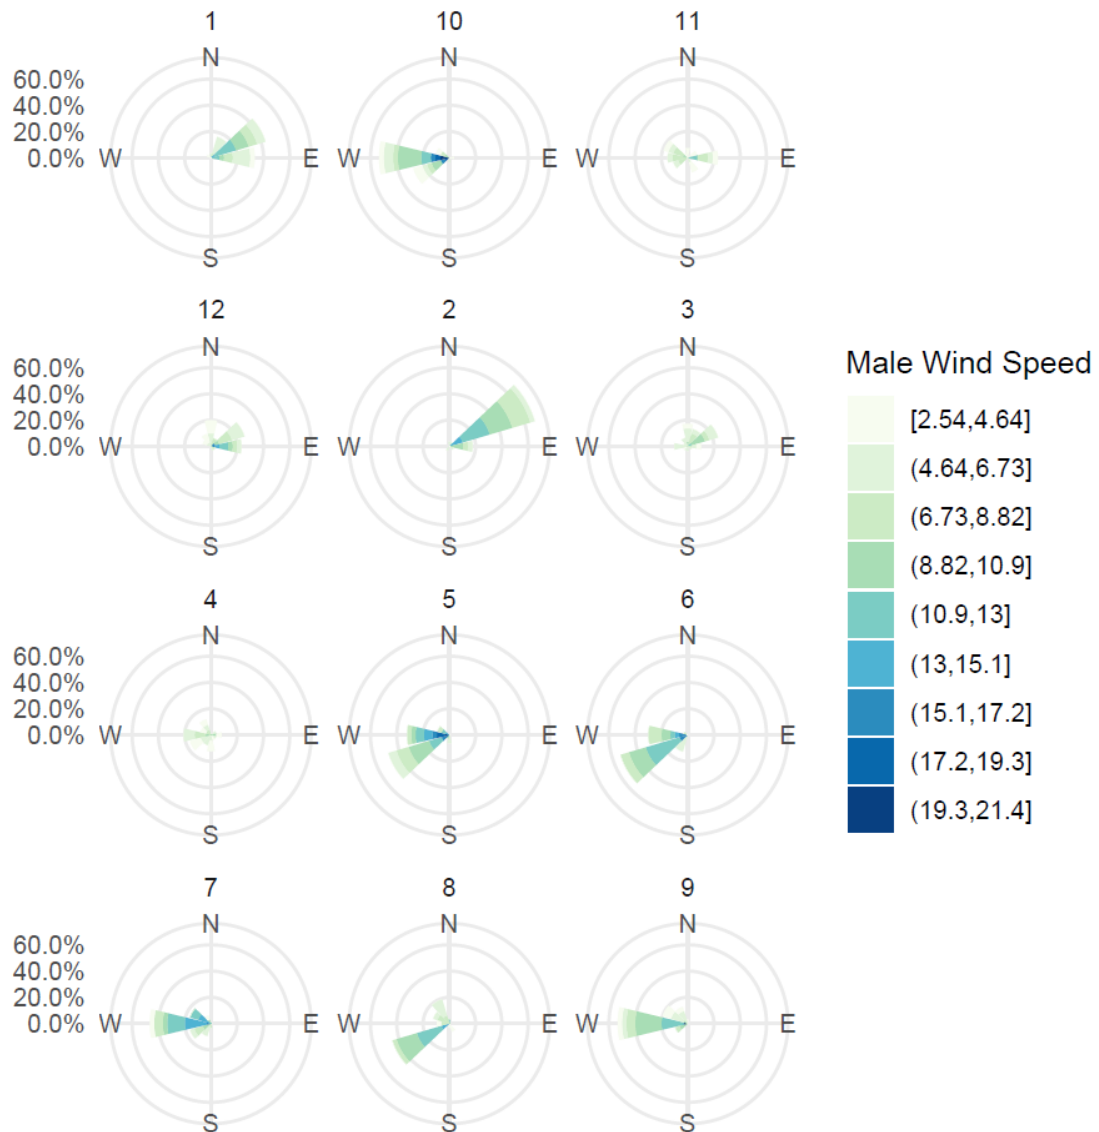
Figure 24 Average wind speed and direction 2018 (Maldives Meteorological Service, 2019)

The wind data for Male' from January 1985 till March 2019 are shown in Figure 24 and Figure 25 respectively.

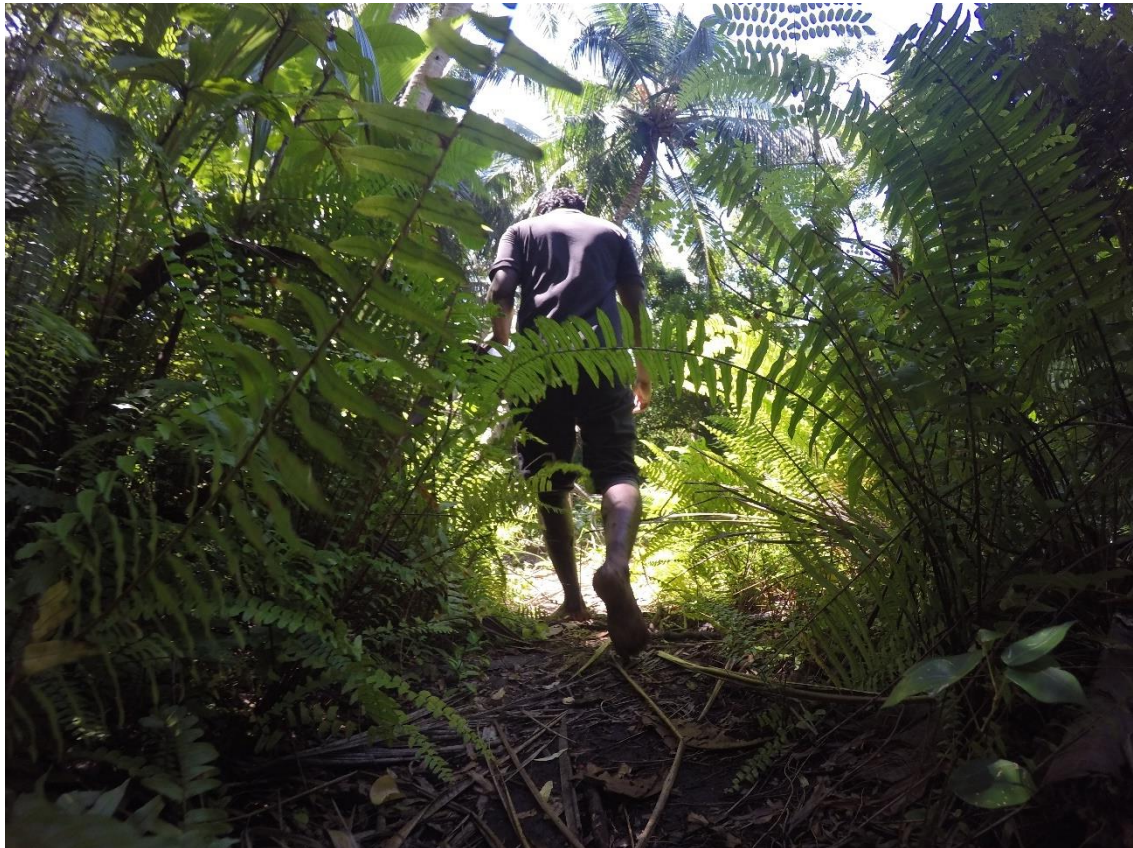
Figure 27 A photo from the foot path on the northern side of the mangrove footprint.

surrounding the mangrove area. For the most part, the footpath shows signs of farming attempts of the locals to harvest banana and yam. At points of access at the southern tip of the island, the footpath has little to no buffer zone before the wet zone and cuts across the wet zone. It must also be noted that the lack of a buffer in some cases is due to the foot path being an old road which predates protection of the mangrove areas. The footpath seems to be elevated from the mangrove area, according to the accompanying guides, the footpath does not flood during rainy season. However, it is our assumption that in the south of the island, the footpath will flood but may drain faster than the mud path.

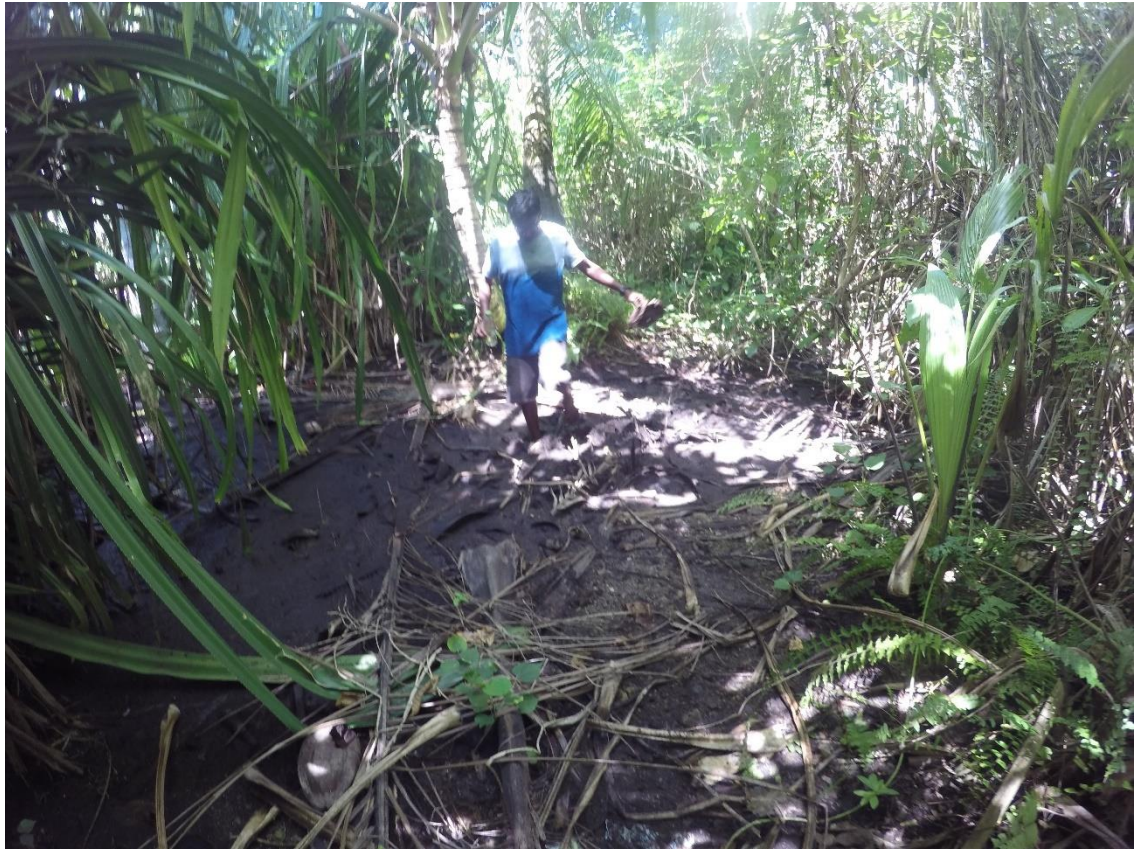
Figure 28 inside the mangrove area; the wet path.

The inner section marked in orange is the mangrove area. The footprint of the section is approximately 52573.48m². The area does not have a definite access road, and is distinguished by large vegetation and a waterbody that is mostly filled with leaf matter, and topsoil or sediment that sinks to about 0.5m deep. The vegetation of the area is mostly mixed dominated by screw pines and coconut palms.

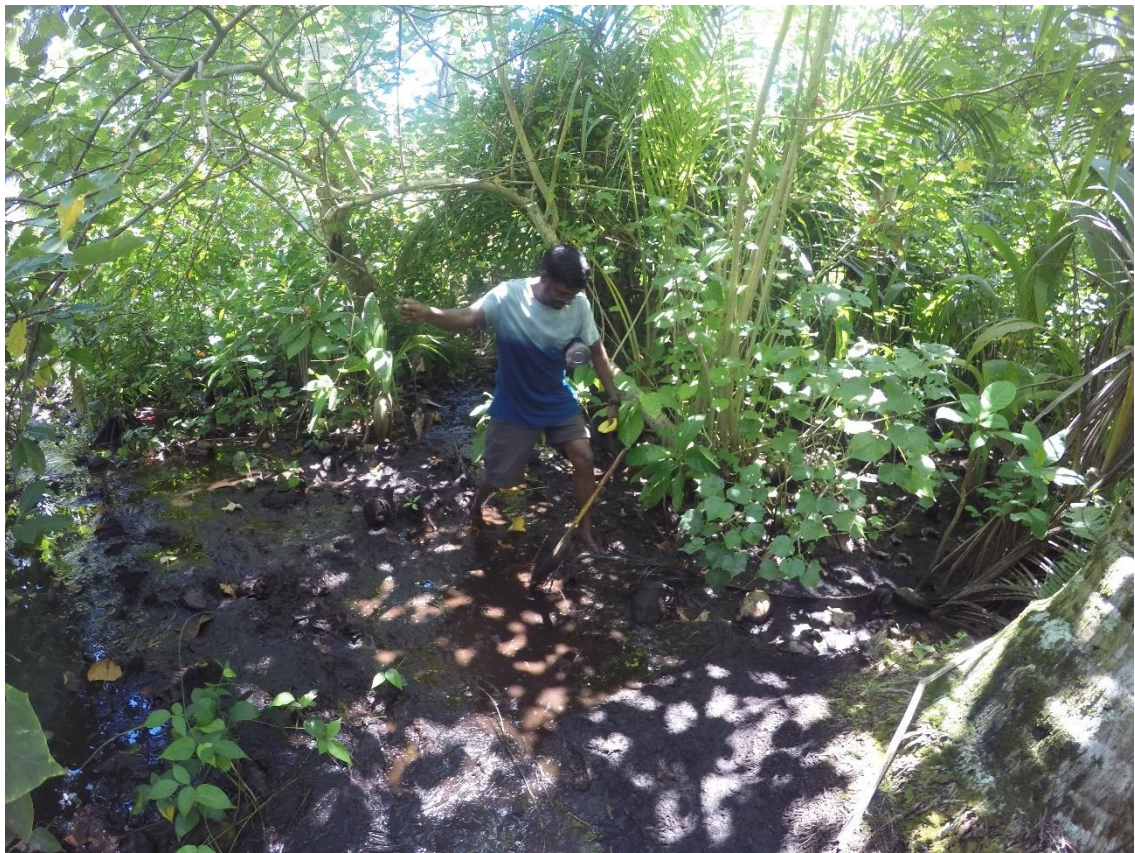
Figure 29 inside the mangrove area wet path

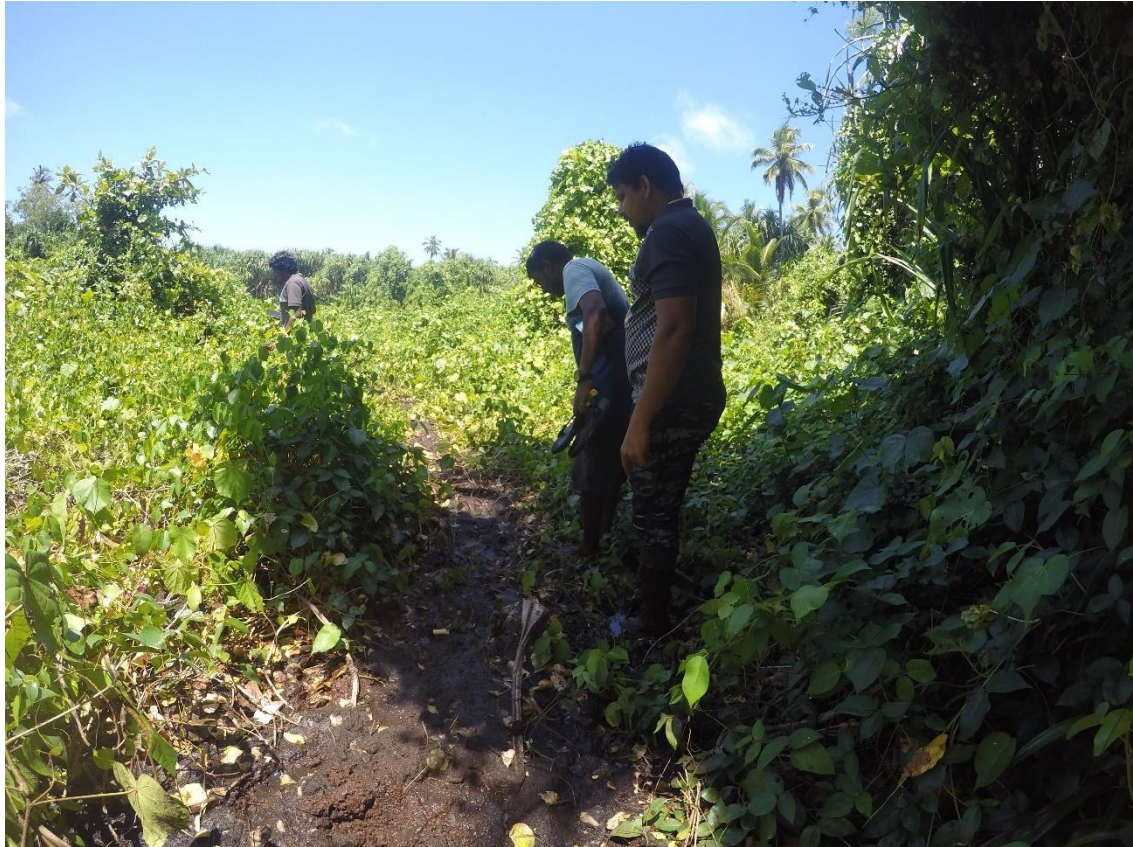
Figure 30 Inner mangrove area opening

Through the mangrove area road leads to the open area. The open area is a unique feature of the island. Mostly consisting of low levels of water covered with vines that spread across the entire area the footprint of the area is approximately 3824.11m². The rare path taken while traversing through the mangrove is seen exposed as a footpath of approximately 354.28m². . The inner area is elevated due to the abovementioned woody vines.

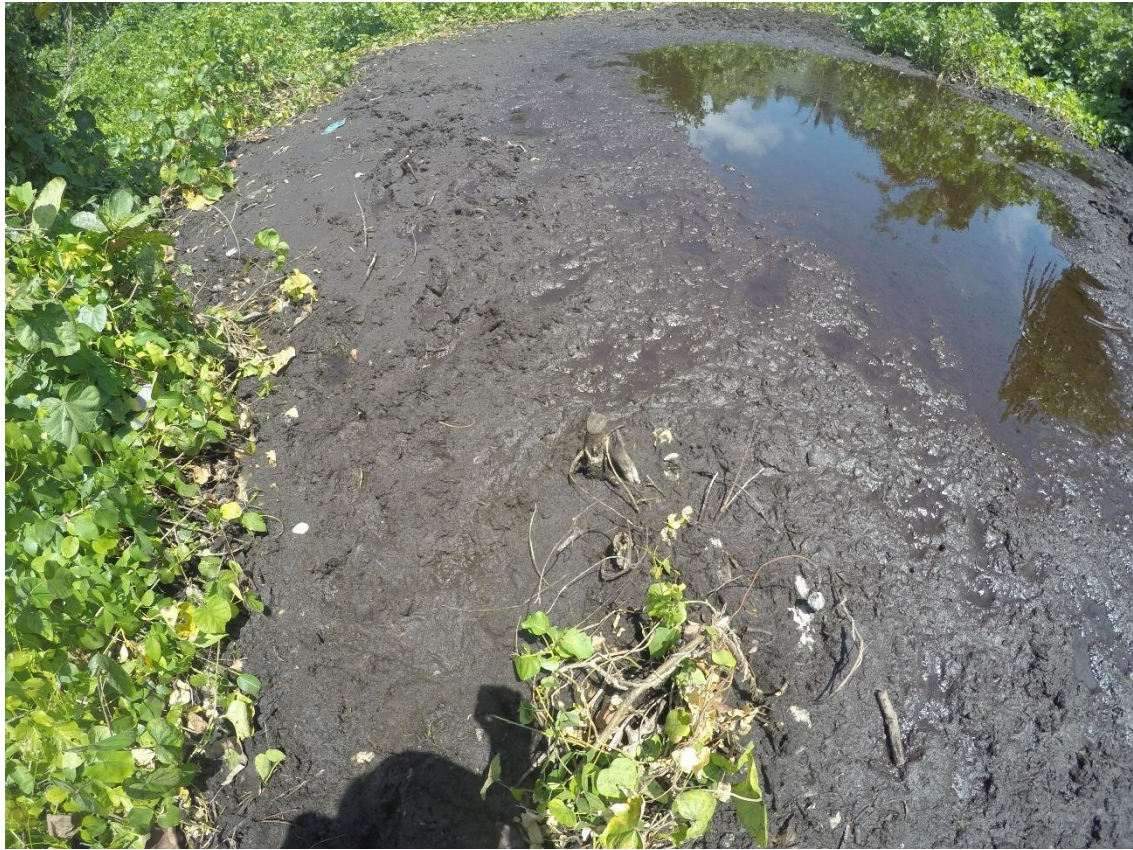
Figure 31 Known for its mud baths, the area has shrunk in size due to the spread of vines

According to the locals the area is known for its mud baths. However, in the recent years the usage of the area has declined and as a result has led to an overgrowth of the vines on location. During the visit, the council staff guiding the team commented that the existing gap is smaller in comparison to the recent past.

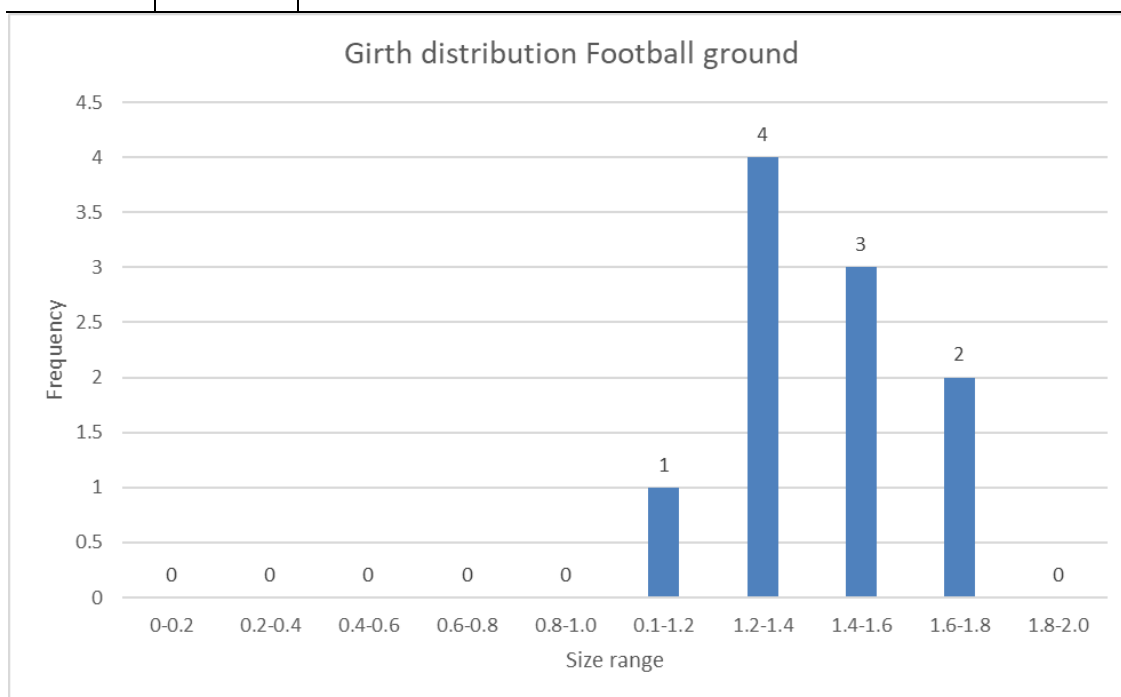
Figure 33 Distribution of plants according to the size range

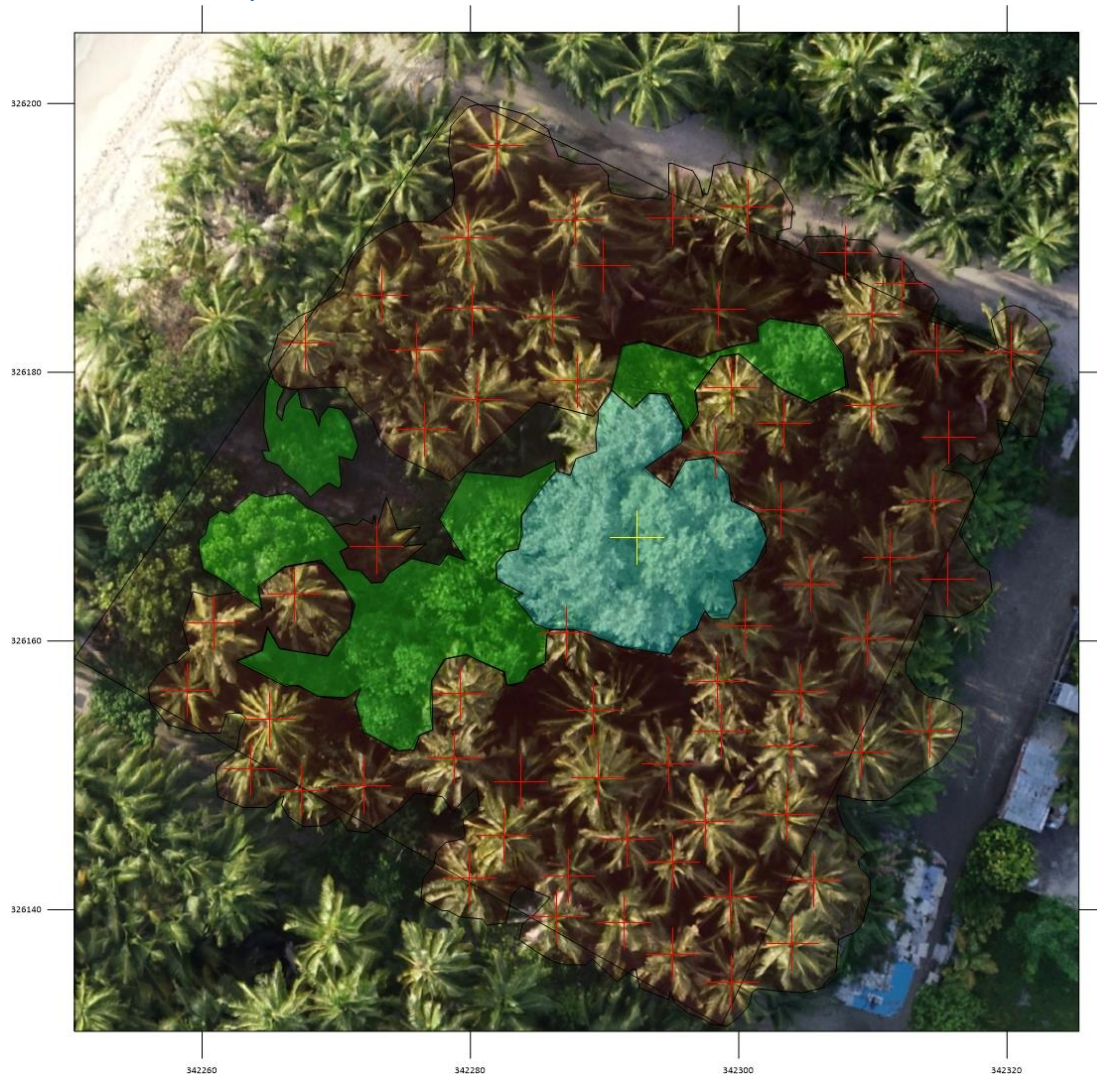
Figure 34 ATS Tree count Sports area (reduced)

ATS images of the tree count in the sports are shows that the area has a total of 74 trees. As this method proves impossible to count the canopy cover, on site survey was carried out.

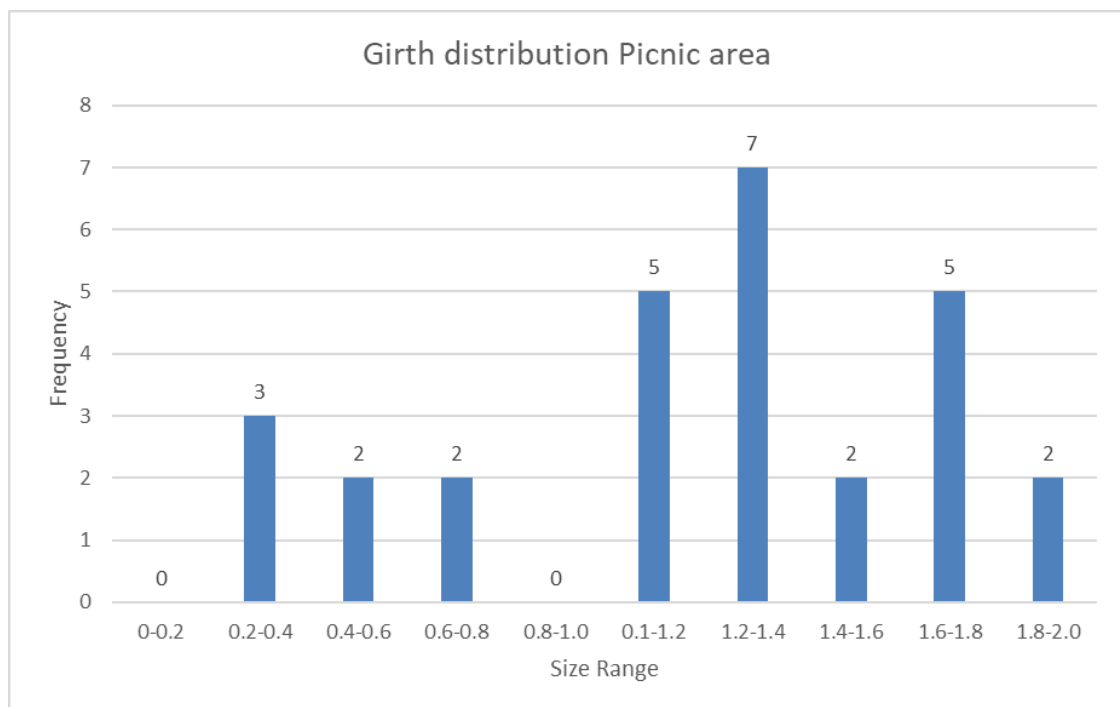
Figure 35 Distribution of plants according to size range

With the variation of the species in the plot, the size varied drastically. The highest occupied girth range was 7 plants at 1.2 to 1.6m. Uniform distribution of sizes can be seen as expected in such an infiltrated plot.

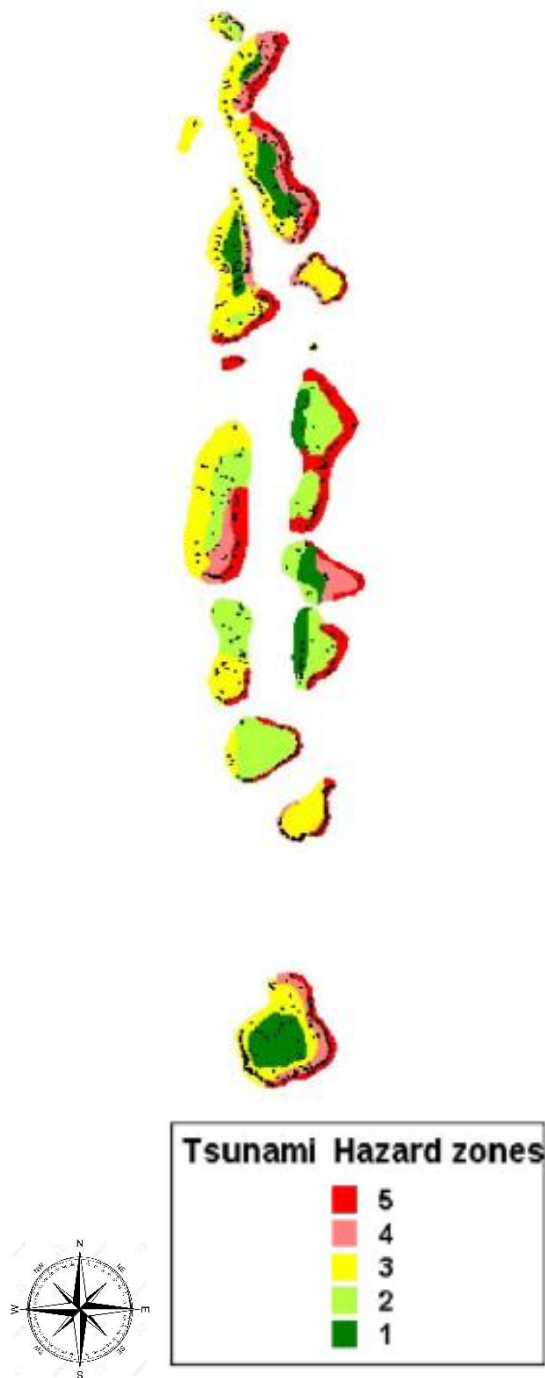
Hazard Zone	Range of probable maximum wave height
1	<30 cm
2	30-80 cm
3	80-250 cm
4	250-320 cm
5	320-450 cm

Figure 36 Tsunami hazard zones, (UNISDR-ADRRN, 2005)

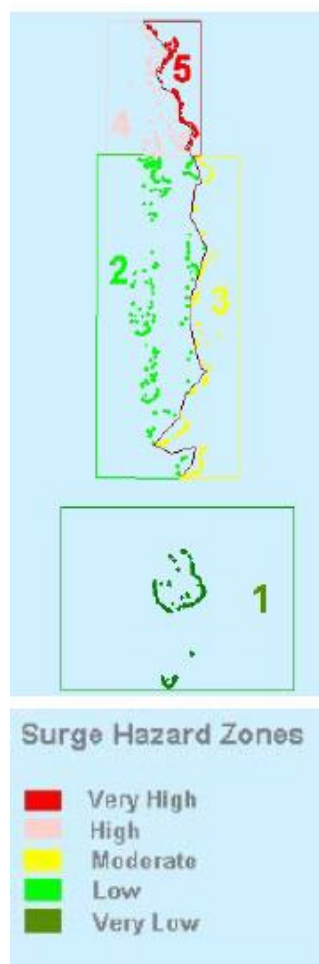
Figure 38 Surge hazard zones, (UNISDR-ADRRN, 2005)

Local storms are high in the Maldives. Usually accompanied by rainfall and high waves. In general, the southern parts of the islands are mostly affected during April and December, which is the interim period between northeast and southwest monsoon season. (Figure 38), (UNISDR-ADRRN, 2005).

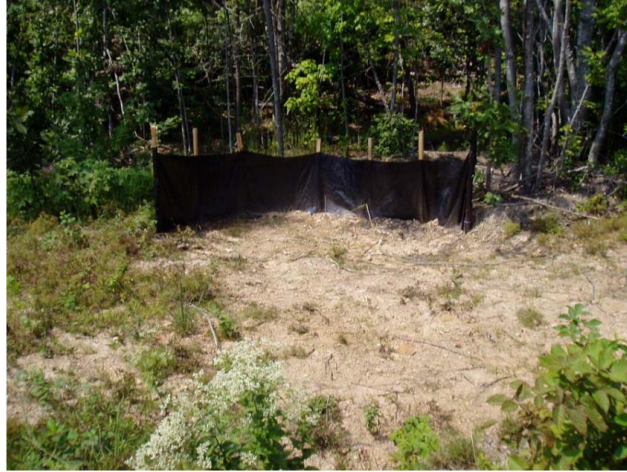
Figure 42 Successful establishment of silt fence near the riparian vegetation on a upper water shed (Lakel, et al., 2019)

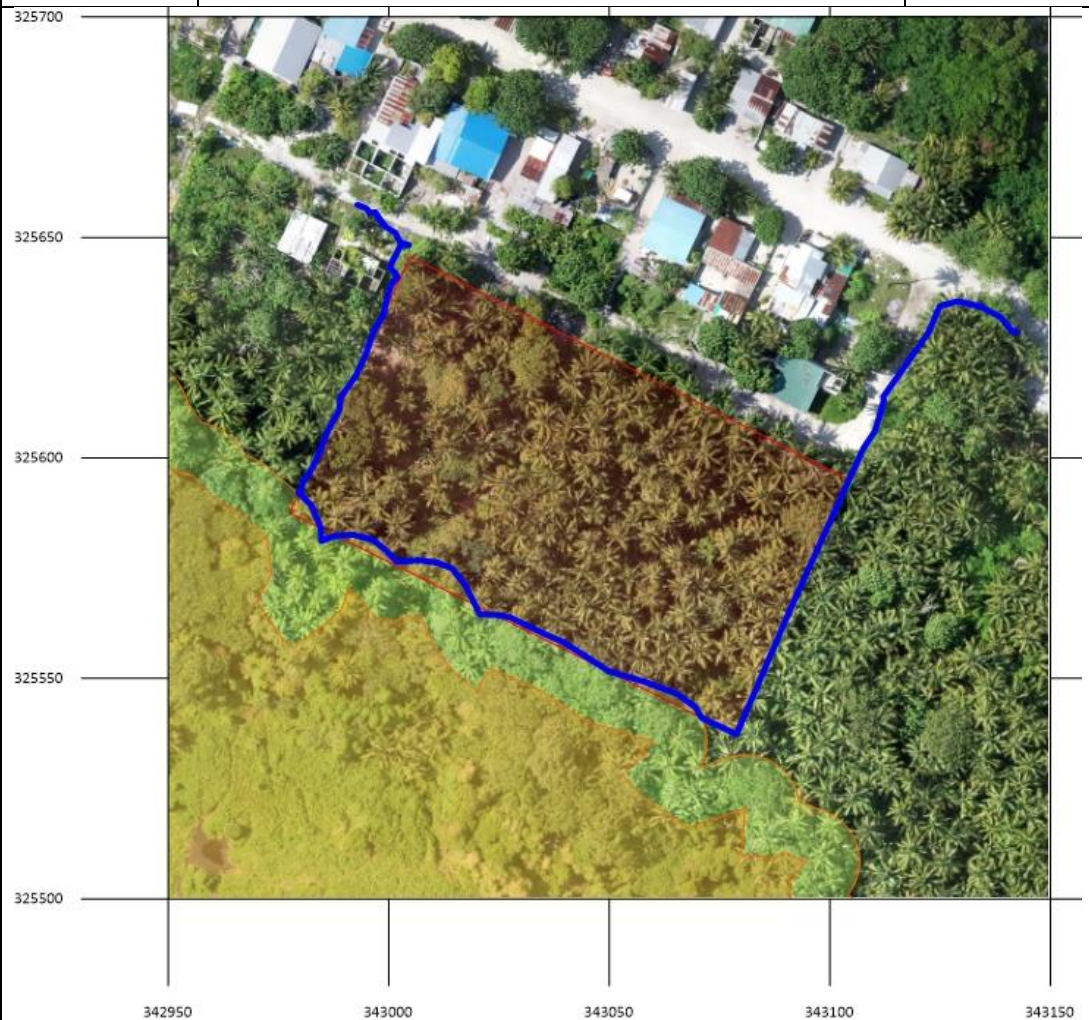
Figure 43 silt fence path proposed wetland area

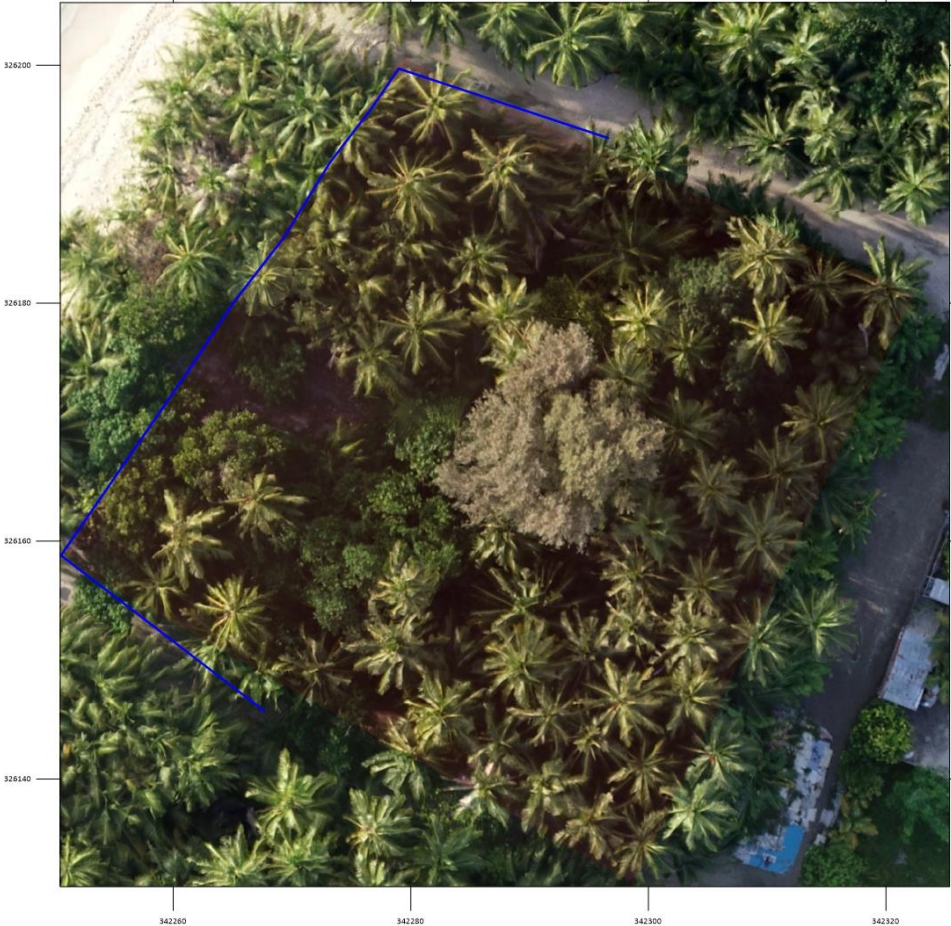
<p style="text-align: center;"><i>Figure 44 silt fence sea spots area</i></p>		
	Increased ambient noise	All construction should be carried out during daytime to minimise noise pollution. Provide ear muffs for construction workers while using machinery	1,000.00 MVR
	Loss of terrestrial flora	All plants will be relocated to desired locations	120,000.00 MVR
Work site related hazards	Movement of vehicles and ditching of the roads	Set roads must be planned, and agreed upon prior to movement of vehicles If a road proves too soft for movement of heavy vehicles, alternatives must be found and roads must be repaired.	70,000.00 MVR
