**ENVIRONMENTAL IMPACT ASSESSMENT
FOR THE
ADDITIONAL WORKS REQUIRED DUE TO A CHANGE IN
SCOPE OF EMBOODHOOFUSHI-OLHUVELI RESORT
DEVELOPMENT PROJECT, DHAALU ATOLL**

SEPTEMBER 2010

O & E HOLDINGS PVT LTD.

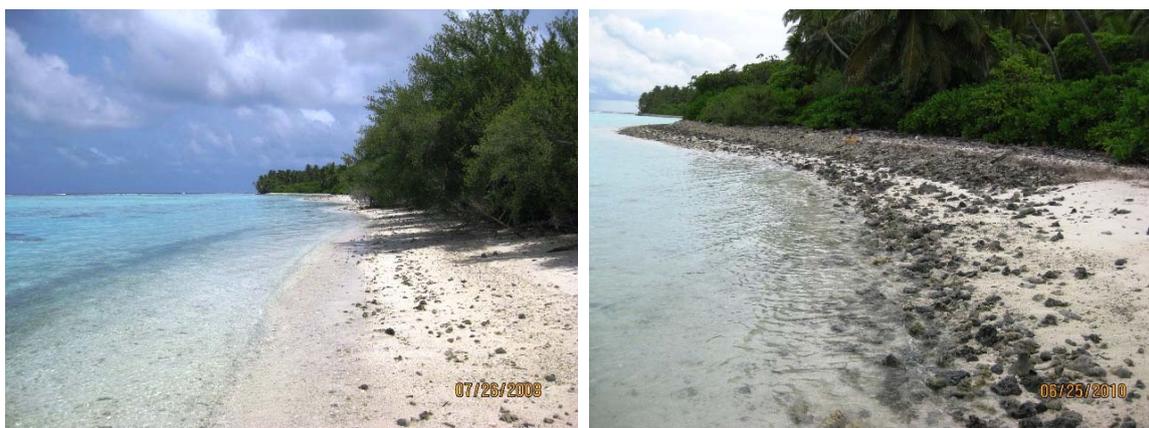
Figure 3: Eastern beach of Emboodhoofushi; image taken in 2008 (left) and image taken on 25 June 2010.

The dredged material will be used to enrich the beach on the eastern side of Emboodhoofushi. The beaches there are not so well developed, particularly on south eastern section of the island. The beach widths on the eastern side of Emboodhoofushi range 2-4 meters, with some exposed rocks, some of them loosely embedded on the sand. This is a common feature on the north-eastern end. Moving towards the south eastern side, the beach is poorly developed. Beach width is narrow with compacted beach rock (Figure 3). A complete description of the beach environment of the islands including the beach profiles were given in the EIA, section 6.5.3, pages 51-56.

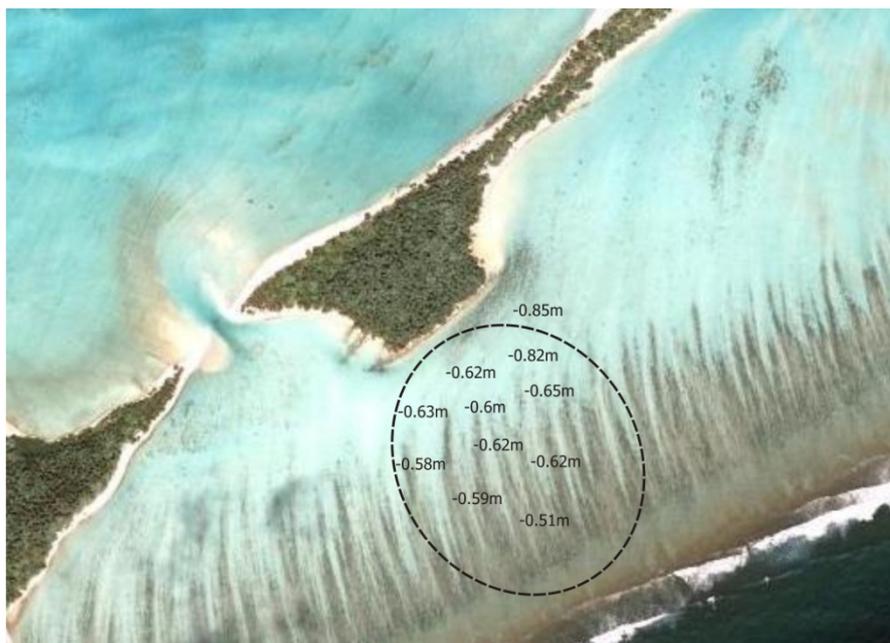
Figure 6: Approximate depth measurements at low tide in the proposed development area (circled).

Depth measurements were taken manually (using a stick and measuring the depth) at random. On average the depth of the area is between 0.5 - 0.6 m at low tide. Summary of depth measurements are given in Figure 6. It is obvious that area is relatively flat.

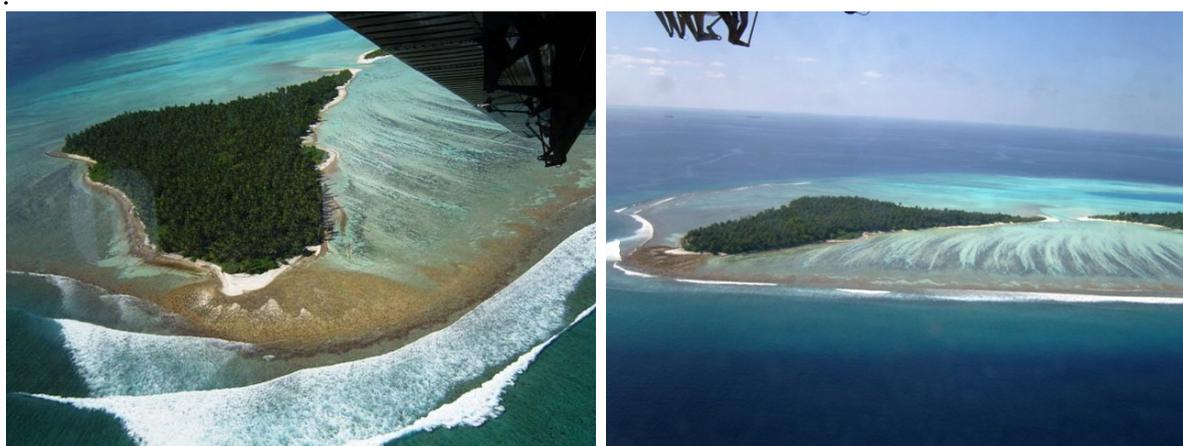
Figure 8: Images of Emboodhoofushi southern corner (left) and Emboodhoofushi and a section of Olhuveli (right) to show features (well developed ridge and spur and groove formations) on reef flat that shows the levels of wave energy experienced on the beach (images taken in February 2008 by the Proponent)

The eastern side of the Emboodhoofushi is quite dynamic owing to the high energy waves reaching the beach. The wave energy is stronger as one move further south and south western corner. A well developed ridge on the southern side of the Emboodhoofushi is evident followed spur and groove formations moving along the north (Figure 8). These are features that are effective in dissipating the wave energy reaching the beaches.
