ENVIRONMENTAL IMPACT ASSESSMENT

Existing Powerhouse and Desalination Plant

Banyan Tree Maldives Vabbinfaru, Kaafu Atoll, Maldives

Environmental Audit Report 2010

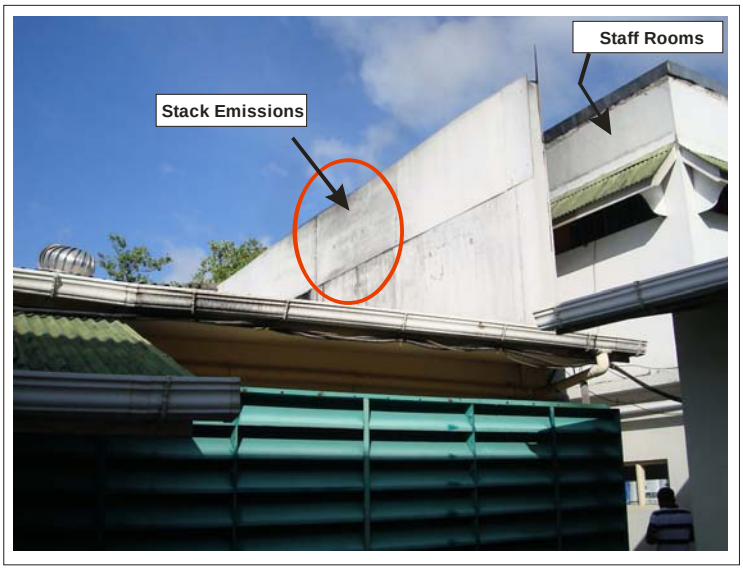
The emission stack is about 5-6m tall with the emission stack located just opposite the staff accommodation unit. Therefore, an 8m tall wall has been erected in the area to reduce the impact of the emissions especially the thermal flume and particulates. Yet, smoke emissions from the stack were directed to some of the staff rooms. It was reported that these rooms get smoke and particulate emissions from the stacks.

Figure 4-1: Low stack causes stack emissions to get into the neighbouring staff quarters

While it is not acceptable to have exhaust stack just next to residential units, it must be noted that the emission levels from the powerhouse is quite low. Estimates using fuel data provided by the Engineering Department indicate an hourly average of 0.69ug/m3 of particulate emissions. This is equivalent to an annual average of 0.5ug/m3, which is well below USEPA standard of 60ug/m3 annual average for particulates. Similarly, SO2 emissions (assuming marine diesel oil with average sulphur content of 0.9% sulphur) are estimated to be at an hourly average of 1.04ug/m3, which is only a fraction of the USEPA standard of 260ug/m3. Therefore, it can be safely concluded that the powerhouse emissions are well within acceptable emission standards.

- Consider changes to the emission stack such as increasing the stack height so that smoke emissions cannot reach adjoining staff quarters.
- Consider urgent repairs to the desalination plants. These include replacing the broken pressure gauges, cleaning the plant and checking the functioning of the high pressure pumps.
