2ND ADDENDUM TO THE EIA REPORT RESORT DEVELOPMENT, MAAGAU, DHAALU ATOLL MALDIVES

**Prepared for
New Mood Resorts Pvt. Ltd**

**Prepared by:
Dr. Mahmood Riyaz (EIA P03/2007)**

September 2020

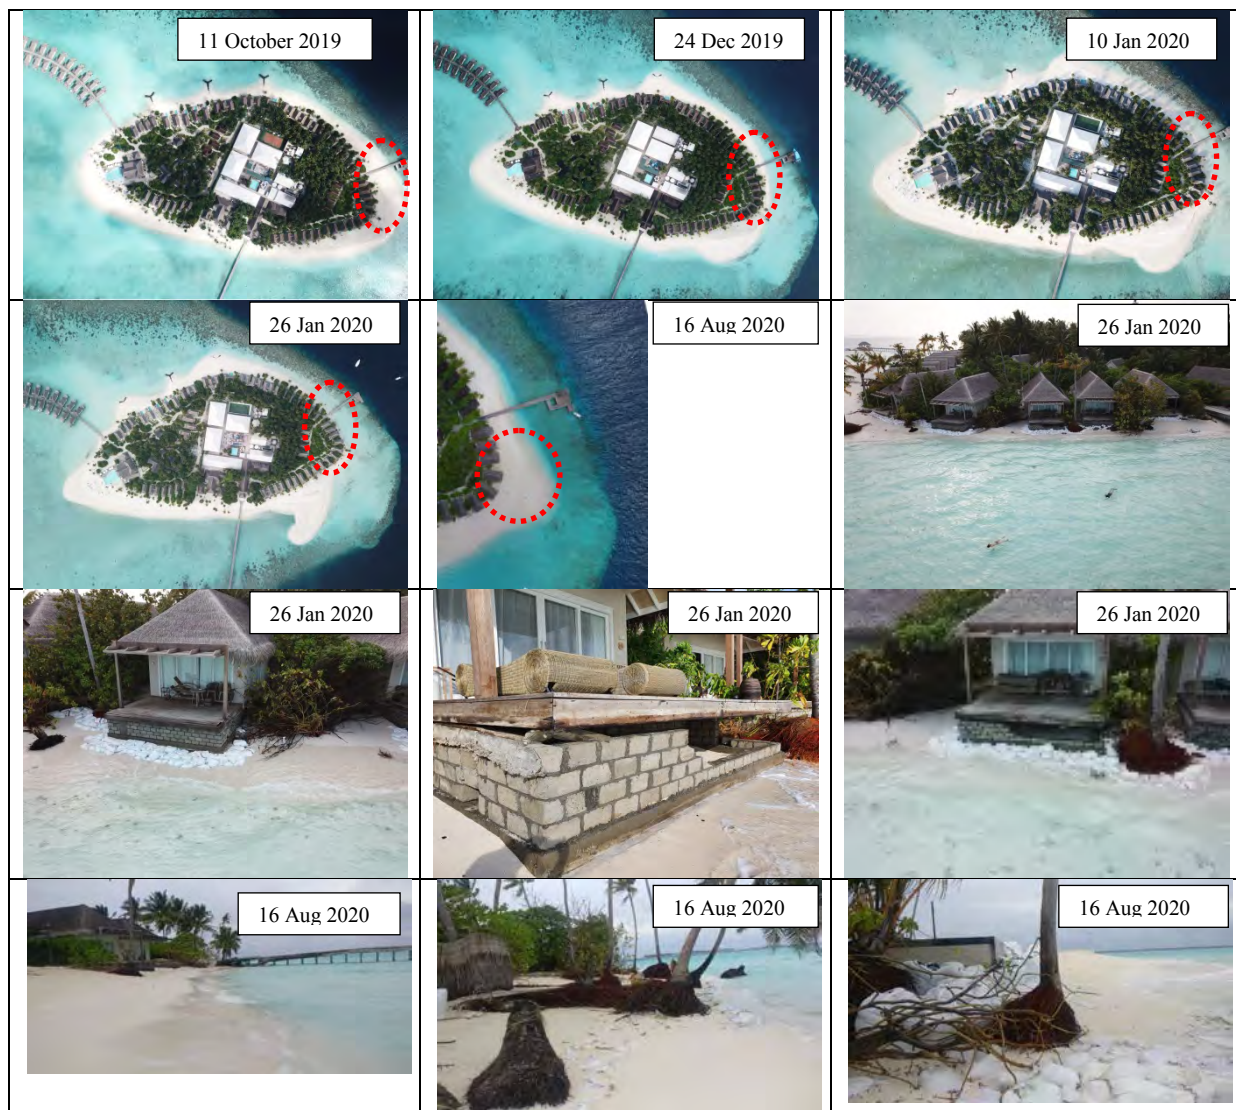
Figure 6. Most recent erosion Magau: time laps photos showing the eastern end beach sand movement and the structural damages near the service jetty area

The island has been under severe erosion for over three years in three different areas of the island; western side between the main jetty and the water villas; coastal erosion and scouring on the base of Water Villa Jetty; the eastern tip of the island which get very severe exposing beach villas near the service jetty area for direct impacts to structures causing uninhabitable damages *Figure 6-Figure 8*. Based on the several assessments in the past it was found that:

- In this process beach sand is sifting various parts of the island seasonally causing sediment accumulation and erosion in alternative parts of the island.
- During this process sediment deficit is in some areas are exposing the structure, particularly those near the beach due to direct impact and exposure to waves and causing damage to resort infrastructure.
- Unusually strong bad weather condition in the Maldives from November 2019 to February 2020 has caused complete shifting of sand spit on the eastern side of Maagau (near the service jetty) westwardly exposing the rooms 141 - 146 for direct hit from waves and un usable.

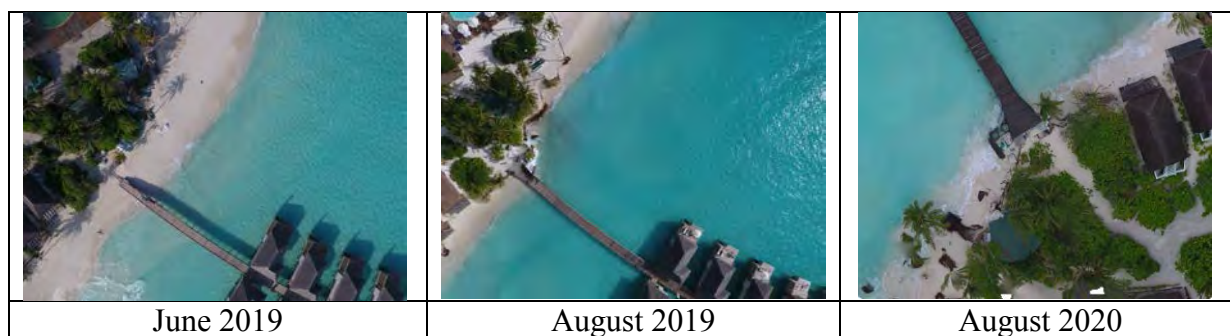
Figure 7. Erosion water villa jetty area in August 2019

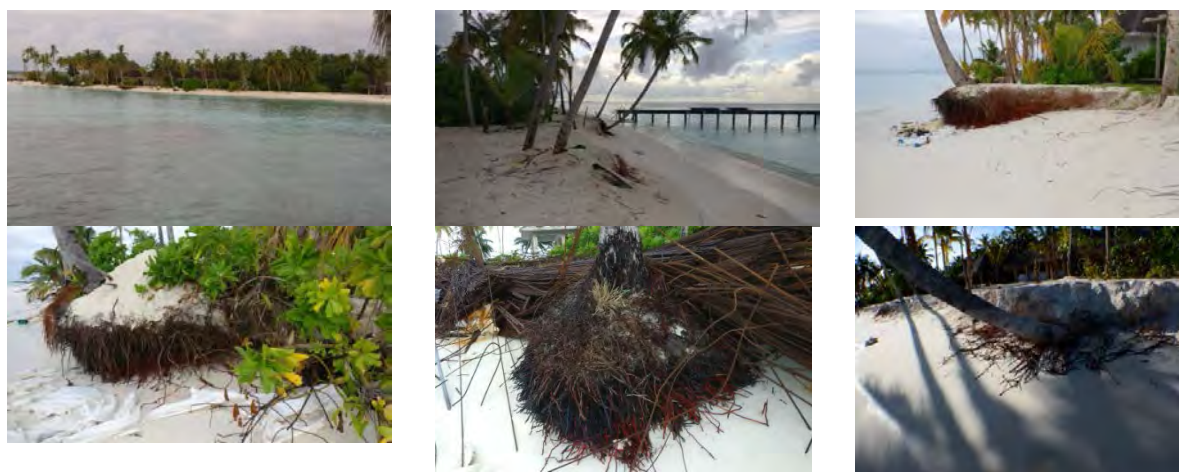
Figure 8. Erosion on the South western side (between the Main Jetty and Water Villa Jetty) July 2018

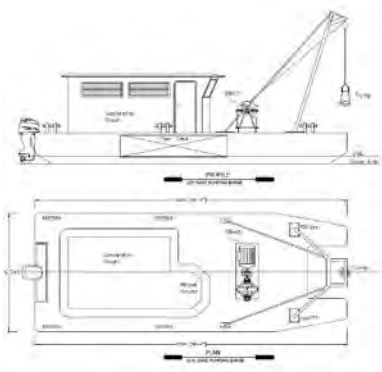
Specification	Photo
<p>12 M Steel Barge (Length Over All) LOA: 12 m (Breadth Over All) BOA: 4.5 m (Depth Over All) DOA: 1.2 m Draft: 0.4 m Water storage capacity: 1 T Fuel storage capacity: 4000 L</p>

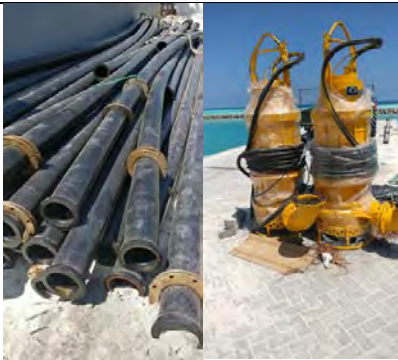
<p>Sand Pump Toyo Submersible Agitator Sand Pump (Chinese Brand) Model: DP-100B-1, Bore (mm): 200, Head (m): 30, capacity (m³/min): 6.0, Solid size (mm): 60, Output (kW): 75, Voltage (V): 200, Pole (P): 8, Weight (kg):2300, Cabaltyre cable 10m(symbol x mm2 x core) :3PNCT×100#×3C·14#×1C Sand Discharge Dredging Pipe Pipe floater Generator set 150KvA</p>

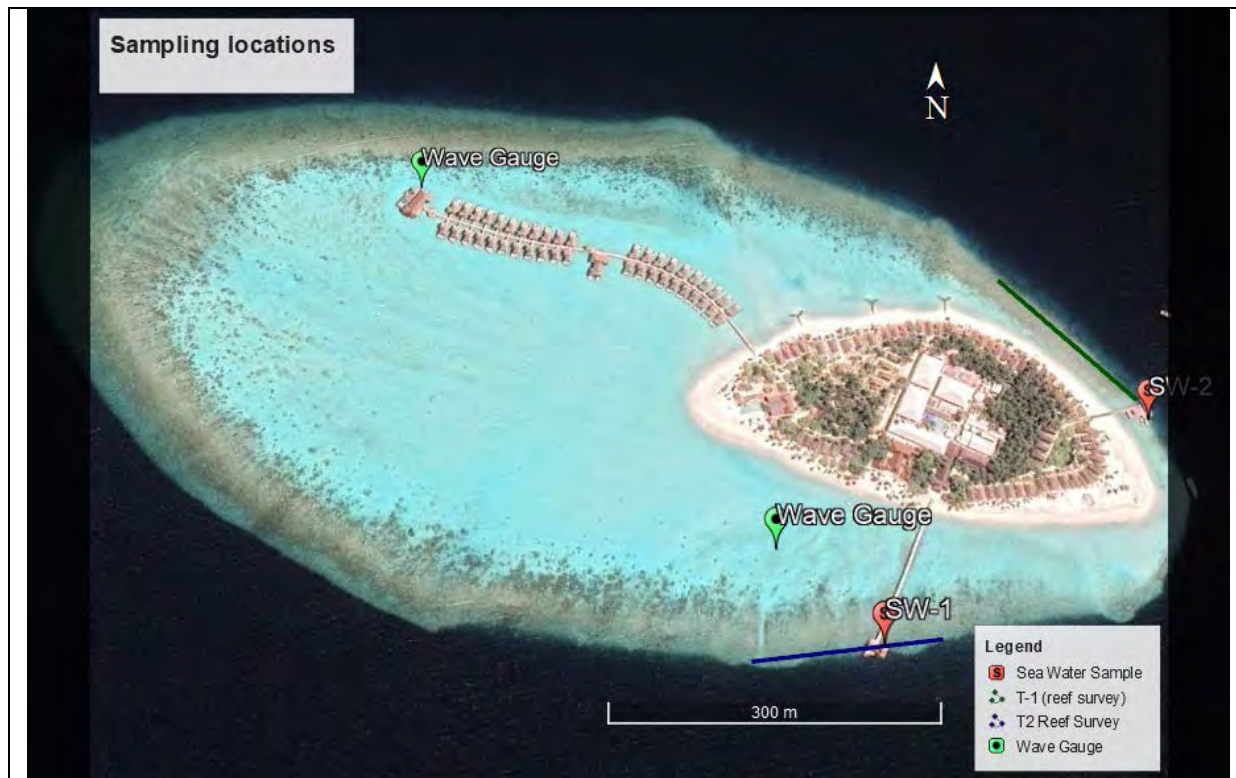
Figure 11. Map showing, wave gauge, reef transact and sea water sampling location

The following map shows the water sampling locations and reef survey areas in the Lagoon plot. Result of the seawater analysis was compared with the results of initial EIA 1st addendum and the monitoring report.

Site specific wave measurement was conducted in two locations in Maagau island during July 2018 and August 2020. In each location the wave gauge (RBR Solo wave gauge) was deployed for 2-3 days in the locations shown in Maagau Falhu, (*Figure 11 Error! Reference source not found.*). Over 300 samples with a burst rate of 2Hz at 0.05 minutes interval were taken from each location. General specification and wave statistics and wave height in each location is shown in (*Figure 11*).

Water quality was tested at two locations one on the southern end of the island and another on the northern end of the island. These can be used as reference during the project monitoring period. The locations are shown in *Figure 11 Error! Reference source not found.* and the results in **Table 6** Water sample analysis for the baseline assessment and the results of sample taken in July 2020. Comparison of the results of the laboratory analysis of water sample show minor changes in various parameters, which means there is no significant changes or alteration in the sea water quality around Maagau Island

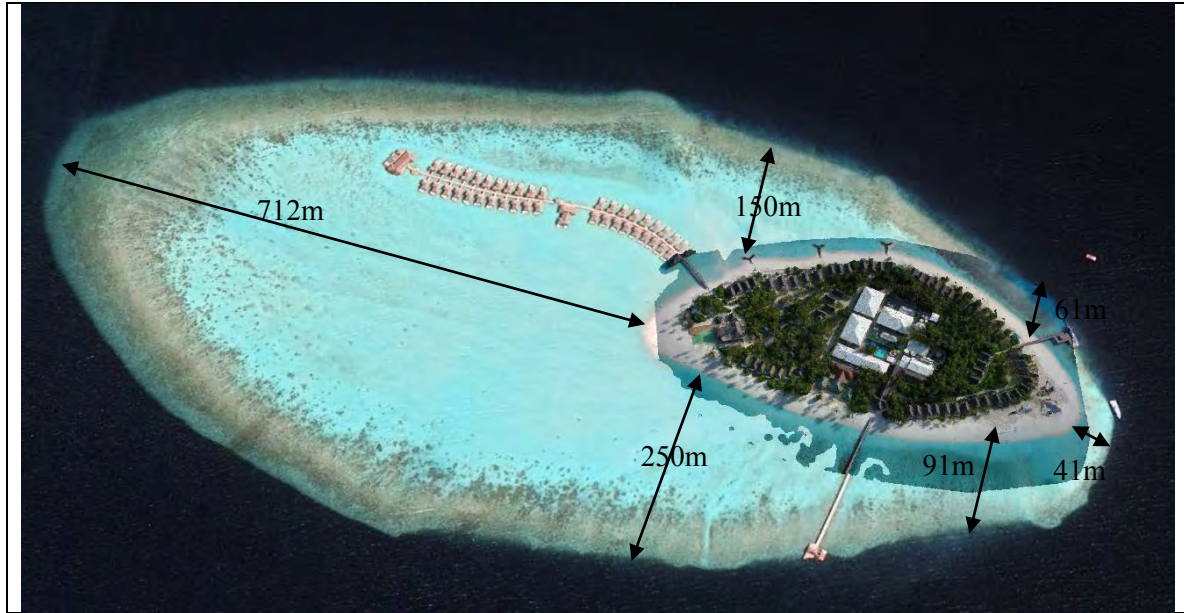
Figure 14: Reef-island distance (reef width) important for wave energy dissipation

Maagau the reef- island distance is smallest on the eastern side and gradually increases westwards. The reef-island distance on western side is measured to be 712m on the western tip 41m on the eastern tip and 150-61m on the northern side and 250-90 on the southern side of the island (Figure 14).

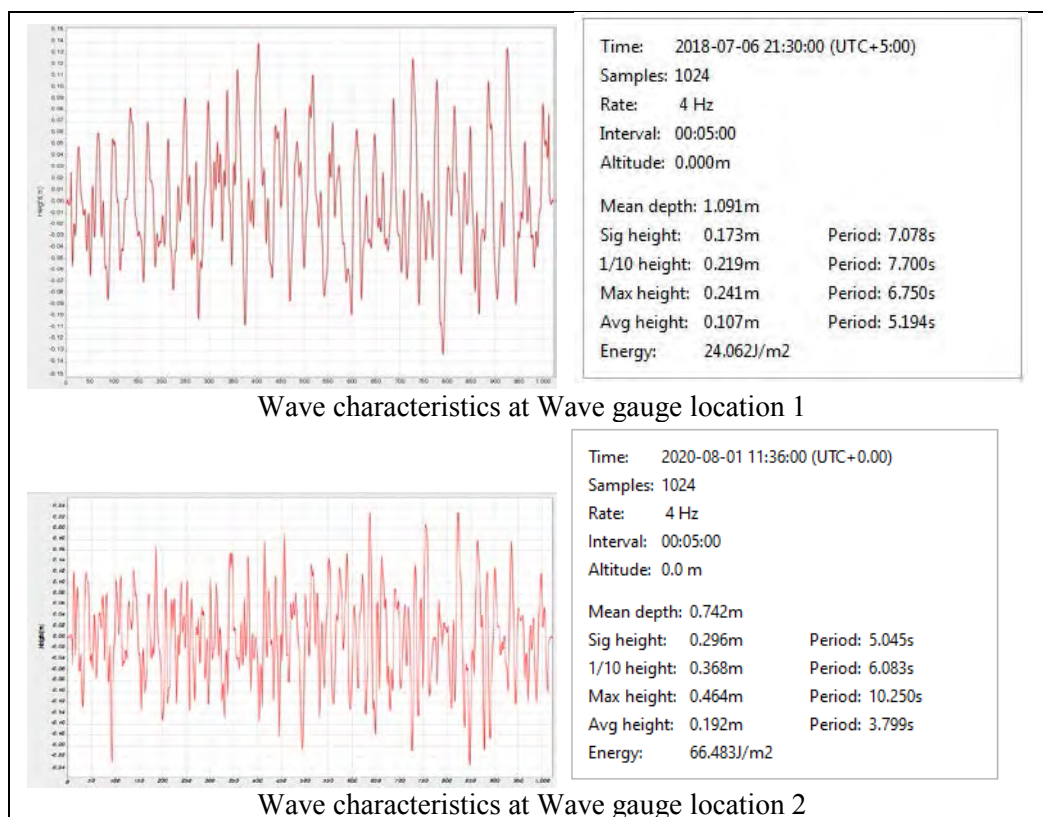
Figure 16: Local wave condition and characteristics at Maagau lagoon at two wave gauge records

Normal wind conditions during the NE monsoon period vary between 2 to 8 m/s winds. More extreme wind conditions are in the order of 11 m/s. considering fetch lengths of 25 to 30km within the atoll, local wave conditions can simply be estimated. However, several small islands are located within the atoll which limits the full growth of the wind waves. For this reason it is assumed wind waves will only grow up to 75% of the theoretical, full fetch length. This gives normal wave heights in the order of 0.2m to 0.45m. In more extreme situations wave heights of 0.8 to 0.9m can occur from the Easterly directions. Characteristics of the measured wave are shown in *Figure 16*

The sand spit on the north western part is exposed strong wave action from the north westerly direction which is in an angle /oblique to the shore line. Whereas southern part of the sand spit is exposed to wave action perpendicular to the shore therefore the sand is moved away from the shoreline. When the wave action is oblique to the shoreline sand movement is littoral (more or less parallel to the shoreline) see dominant wave direction and measured wave characteristics in the area (*Figure 16*).

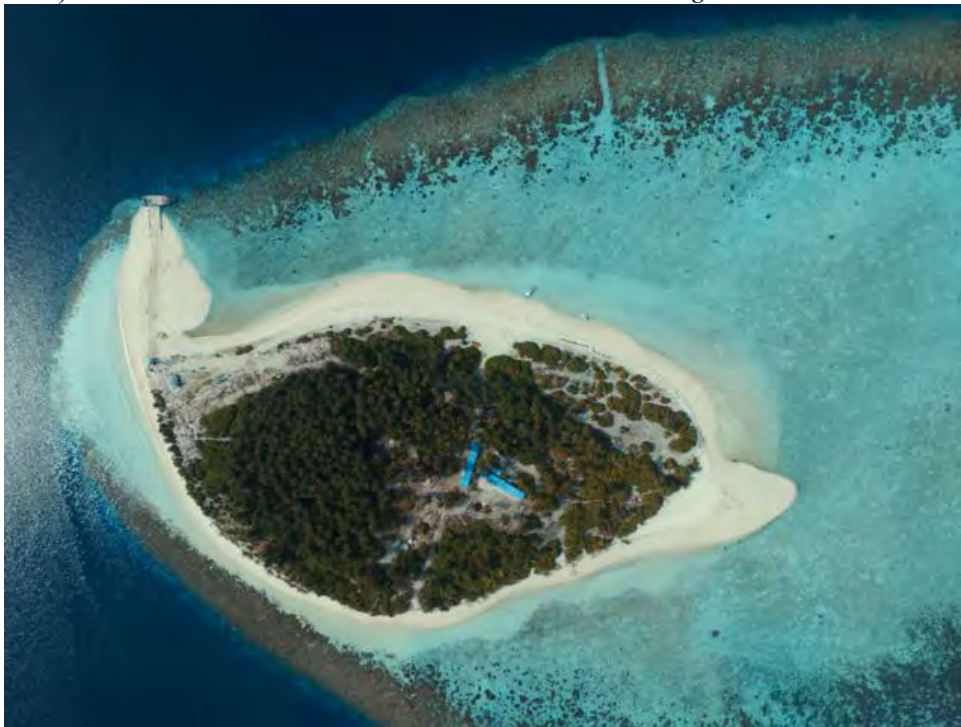
Figure 17: Drone photo taken in 2016 December showing seasonally shifting natural sand spits on the eastern and western end of Maagau and the temporary jetty constructed for loading and unloading material for construction.

Historical photographs show that naturally the island has seasonally shifting sand spits (Sand banks Thundi) at both eastern and western ends of the island *Figure 17*.

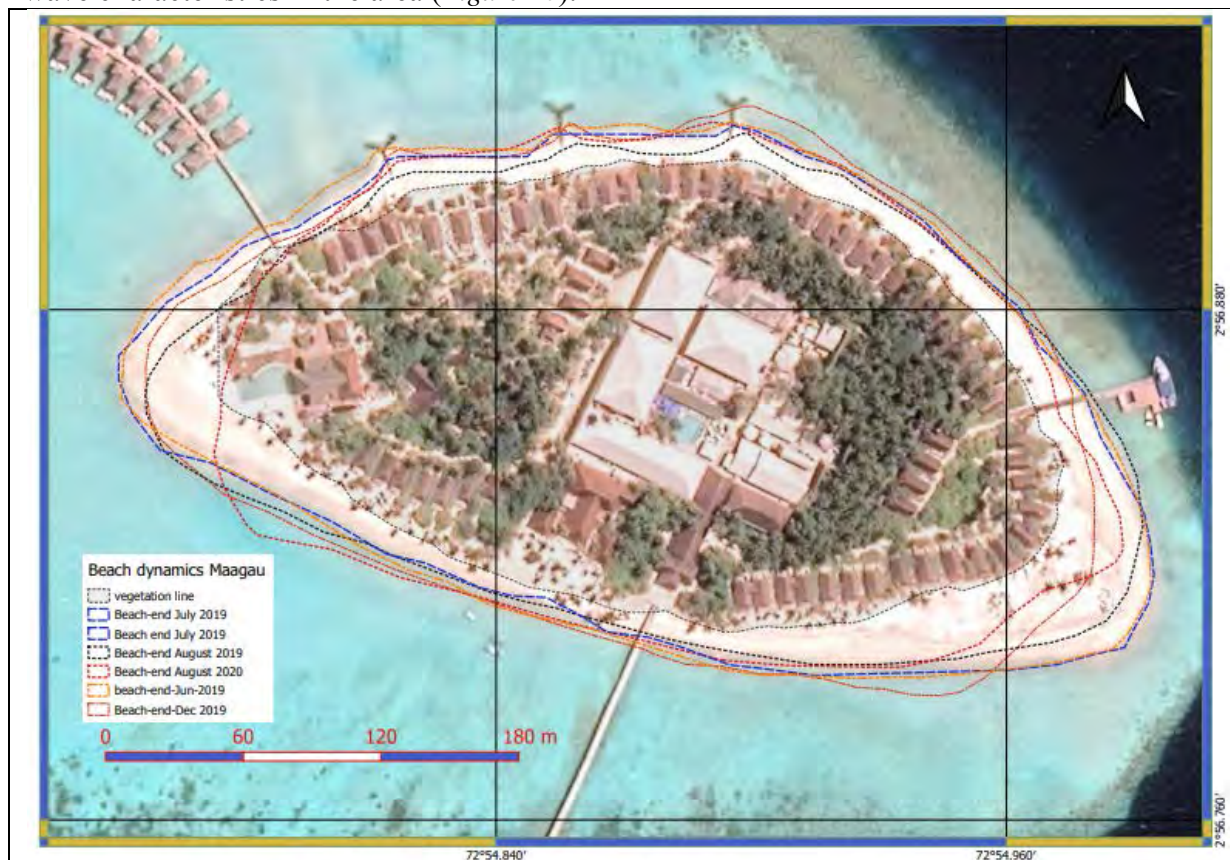
Figure 19: Coastal dynamics and changes in shoreline over laid on Google earth photo July 2019, Maagau

Coastal erosion observed on the western and eastern end of the island is largely seasonal. Construction of resort infrastructures in these dynamic locations are subjected to damage if left unprotected. This is because; a) the structures are constructed very close to the shoreline, without due consideration to the seasonal movement, b) W and E ends of the islands are the most dynamic areas of the island. Erosion and accretion (sand movement) pattern around the is shown in (*Figure 19 -Figure 21*)

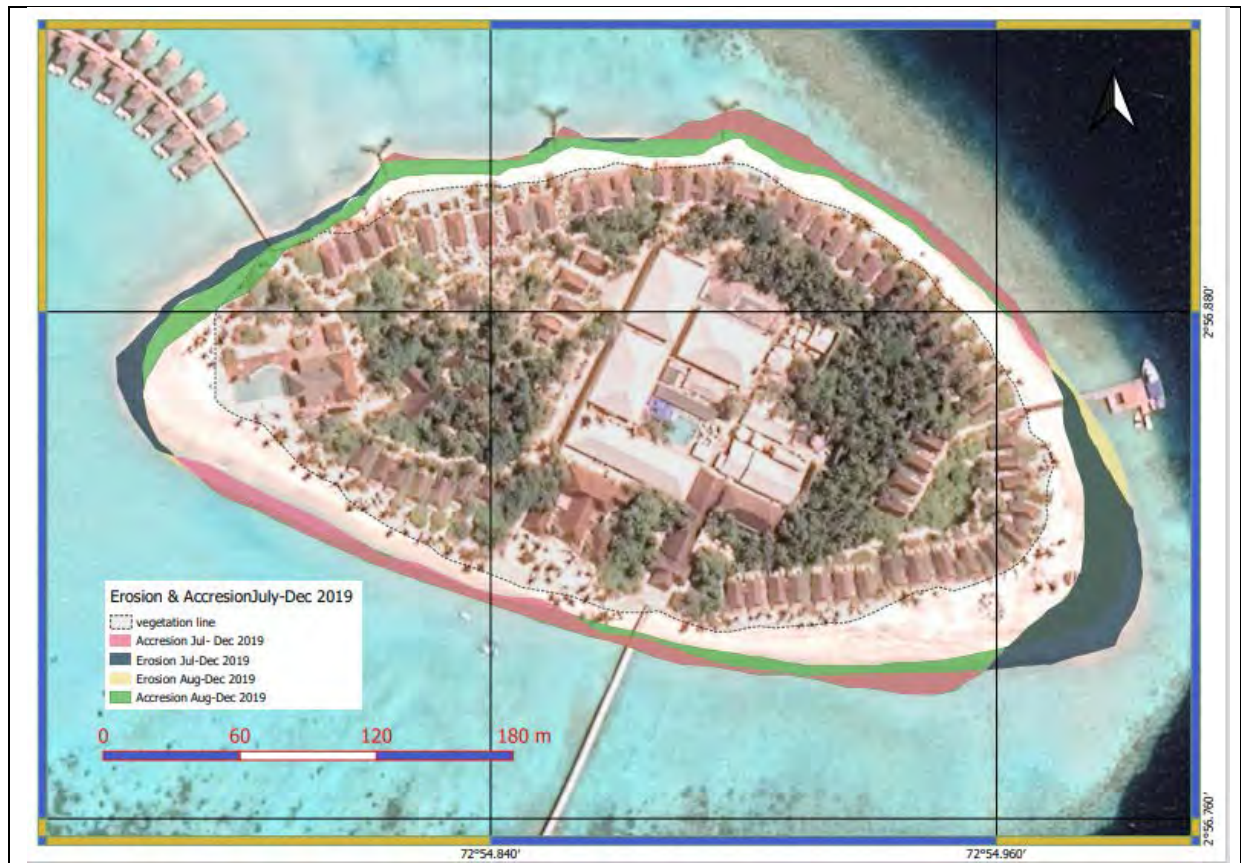
Figure 20: Coastal erosion and accretion pattern around Maagau Jul-Dec 2019

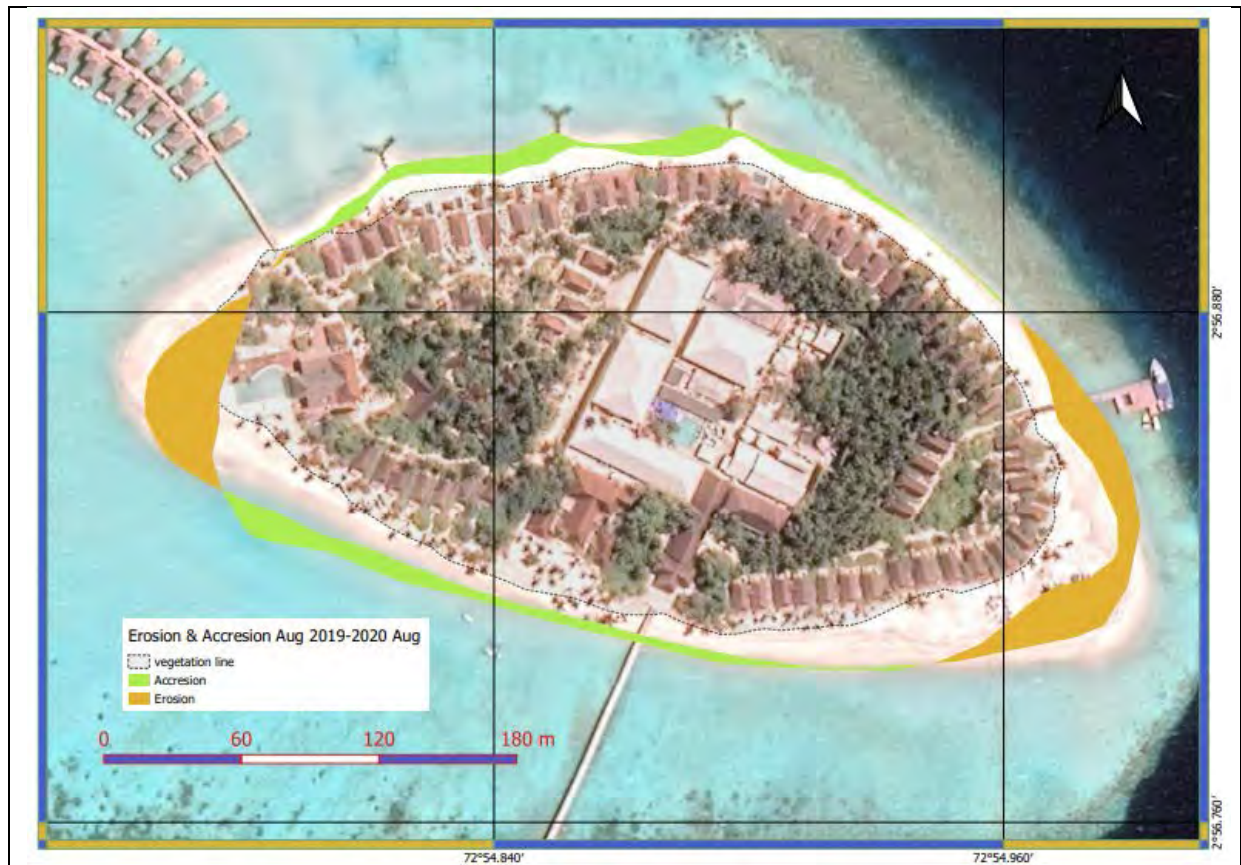
Figure 21: Coastal erosion and accretion Aug 2019- Aug 2020

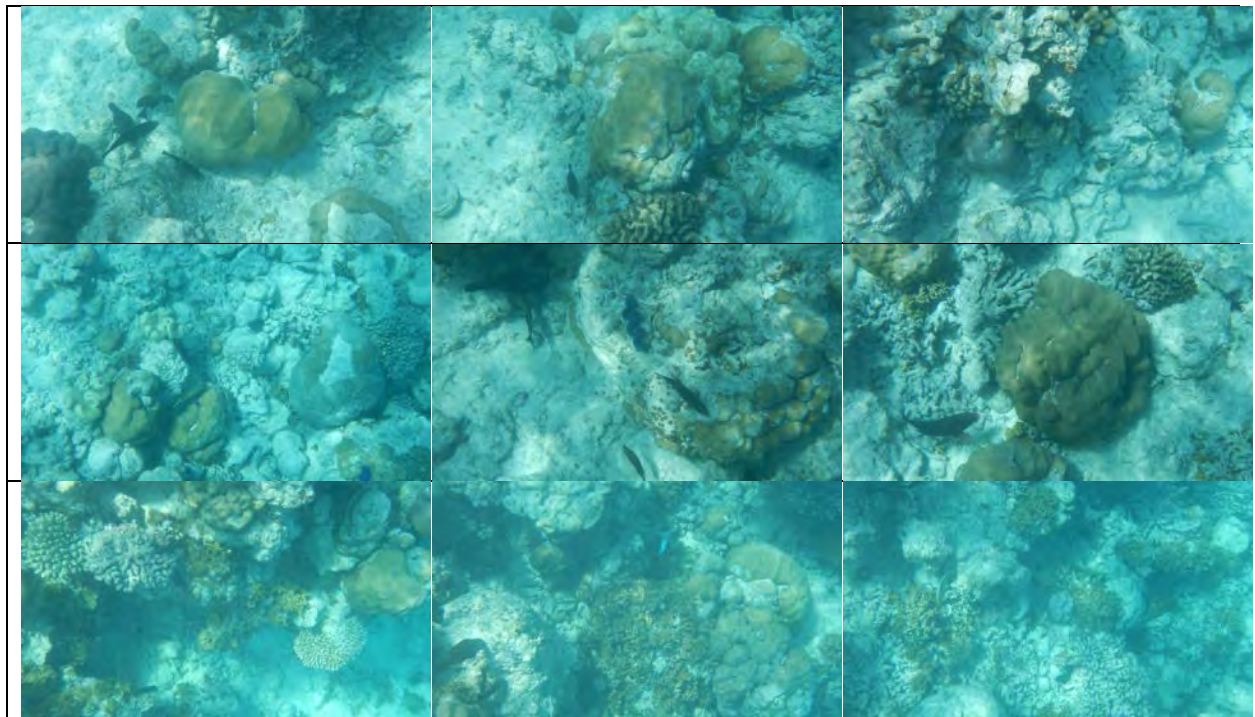
Figure 23: Photos from Transect #1

Rock hard coral and rubble dominated in transact one representing 37%, 28 and 15% cover respectively. In transact 2 rock and rubble is dominated covering close to 80% of the transact, roughly 39 rock and 40% rubble. Siltation and sedimentation is higher in transact two then transact one See (*Figure 23 & Figure 24*).

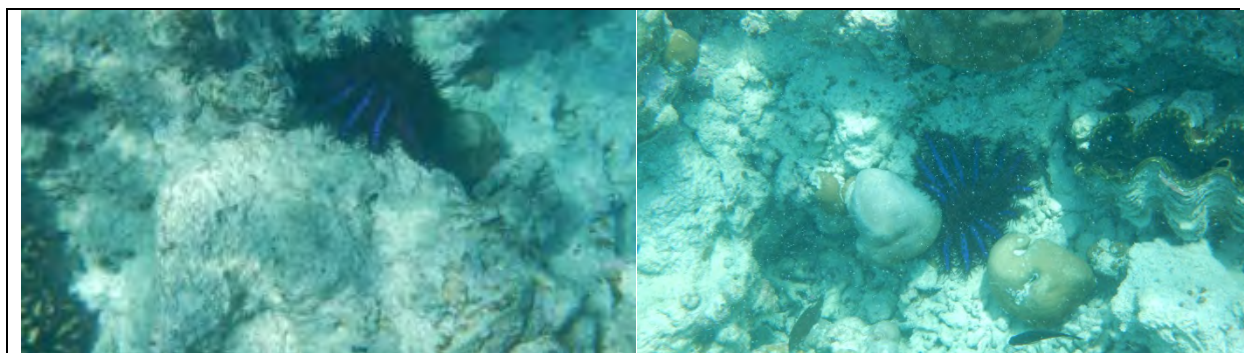
Figure 25: COTs recorded from the reef survey, the reef is infested with a large population of COTs

Fairly large number COTs were observed during the survey (*Figure 25*). 4 COTs were recorded along the transact 1 and 3 in transact 2.
