Addendum to

## ENVIRONMENTAL IMPACT ASSESSMENT

For the proposed Upgrading and Redevelopment in  
Athuruga resort, South Ari Atoll, Maldives

For Water Solutions Pvt. Ltd., Maldives

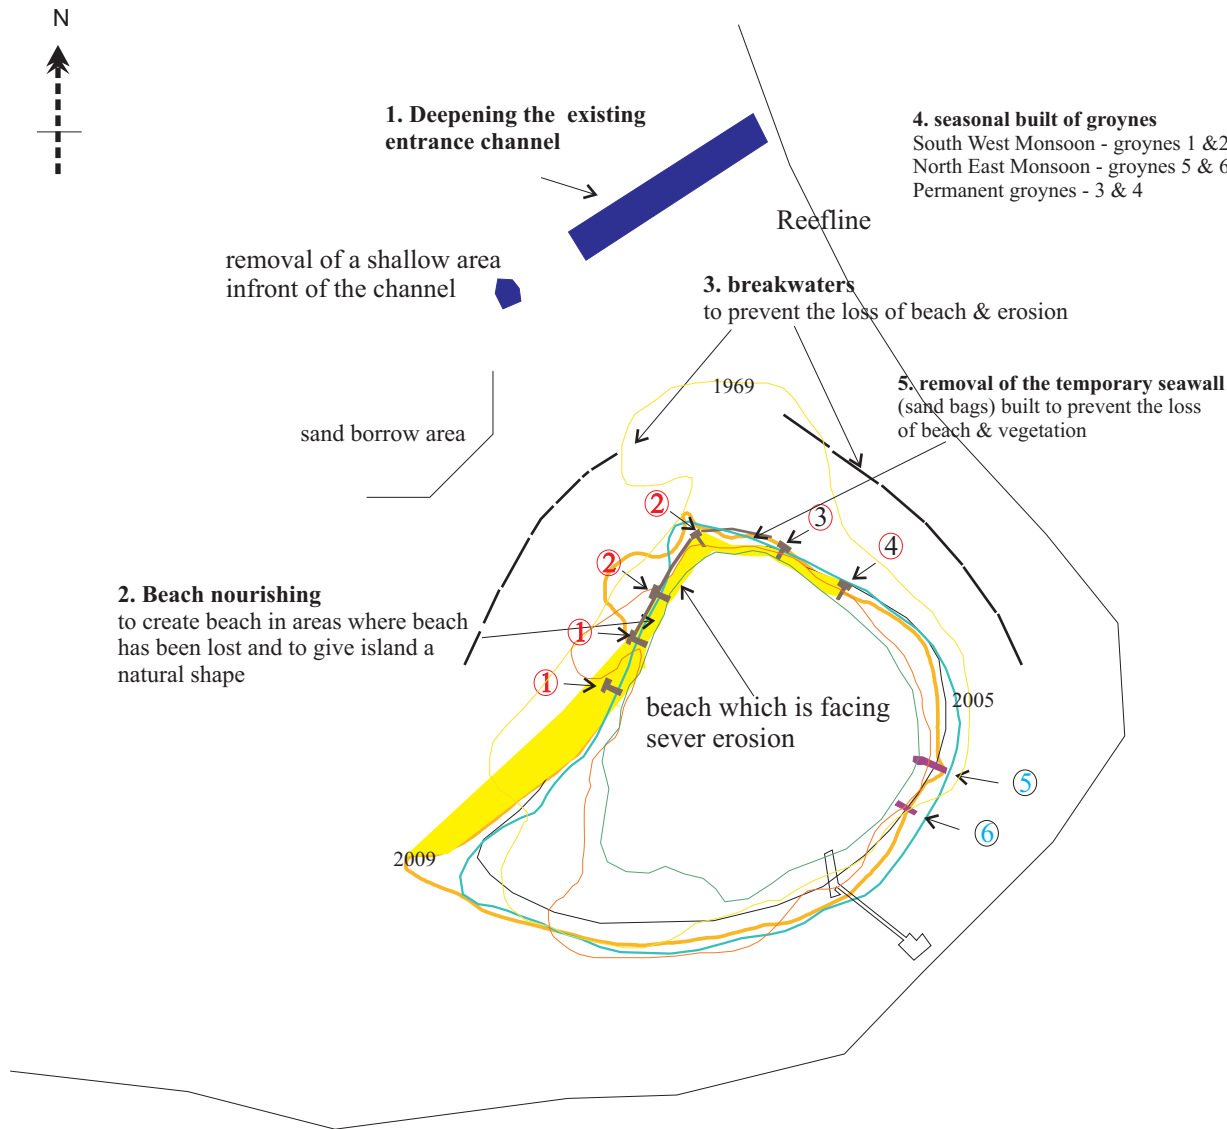
Figure 1 : Additional components bringing modification to the proposed redevelopment project at Athuruga

## Additional Coastal components of Athuruga Redevelopment Project

The design of the groynes is given in Figure 1. These design considerations take into account existing long-shore currents and wave overtopping. The crest of the groynes is based on the "significant wave height". However, under calmer conditions with low crested waves, as is the case in Athuruga, structures are designed to allow for overtopping. Overtopping often helps to minimize the effects of stagnation in the lee of the breakwater thereby improving water quality in the leeward side. In fact, a significant increase in strength of the crest can be achieved by careful placement of the armoured rocks to ensure good interlocking and by the use of gabion boxes or wire mesh in case of rubble structures.

The length of the new set of breakwaters is about 50m each and the gap between the breakwaters is about 2-5 m. Figure 1 shows the location of the submerged breakwaters and their possible orientation.

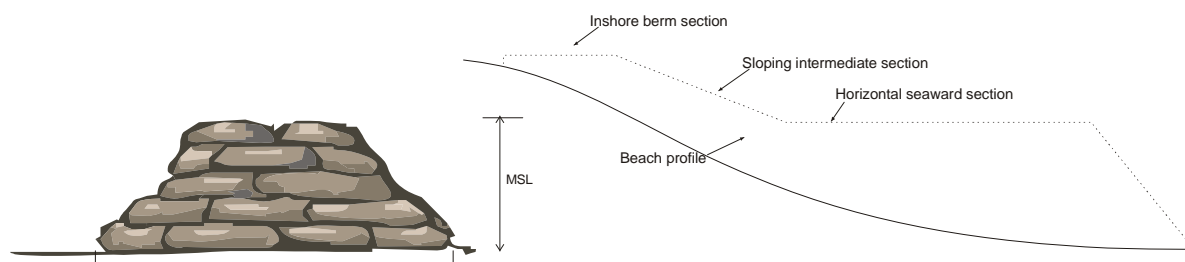
Figure 2: cross-sectional design of a groyne

The gap between groynes is usually about two or three groyne lengths, where groyne length is defined as the distance from the beach berm crest to the groyne's seaward end. Groyne spacing is often selected based on an analysis of desired shoreline alignment following groyne construction, which depends on the wave and long-shore transport at site. Shoreline alignment following groyne construction depends mainly on prevailing wind direction and subsequent incident waves. When incident wave crests are nearly parallel larger groyne spacing can be used; when incident wave crests make a larger angle with the shoreline, closer groyne spacing is required. In the case of Athuruga, the wave crests on the northern and western beaches shores are primarily parallel to the shoreline. Therefore, it is proposed to keep groynes as far away as possible given the short length that can be achieved. This has been observed to function in the past years. The effectiveness of the proposed groynes will be assessed in the monitoring programme.

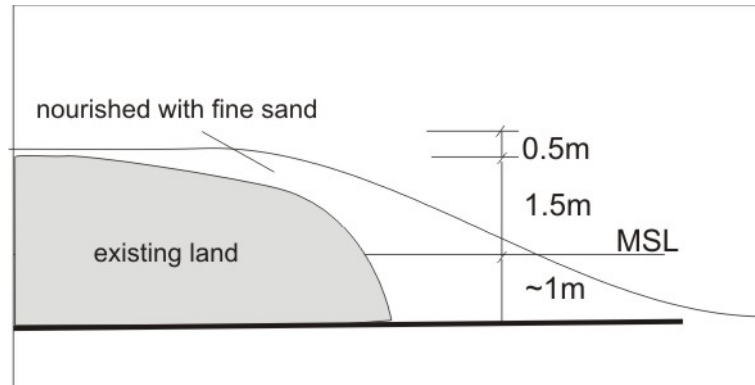
**Figure 3: fill profile for the nourished area**

The main problem with the beach face is that the beach face has not been nourished with fine sand to maintain the loss that had occurred due to erosion. Hence, it is proposed to replenish the beach with 6,900 m<sup>3</sup> of beach sand. The sand would be borrowed from the shallow lagoon west of the island. The replenishment would be carried out so that the berm at the replenished area would have a height of at least 0.5m. Fill profile for beaches around the nourished area on the north and western side of the island are shown in Figure 3.

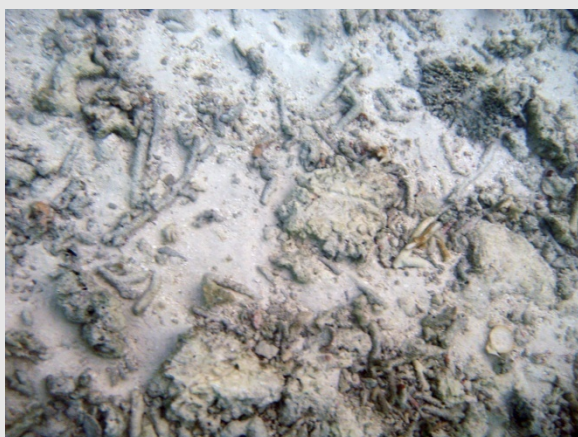
**Figure 5. Coral rubble on a sandy seafloor is the main benthic substrate in the entrance channel**

The existing channel which is located on the north western side of the island is the only channel that boats have to use frequently to get into the lagoon. The channel has become very shallow at less than 1.0 m at low tide making the boats difficult to access the island in low tide causing disruption to the supply to the island. Hence, it has been proposed to deepen the channel as to allow easy and safe access to the island by boats.

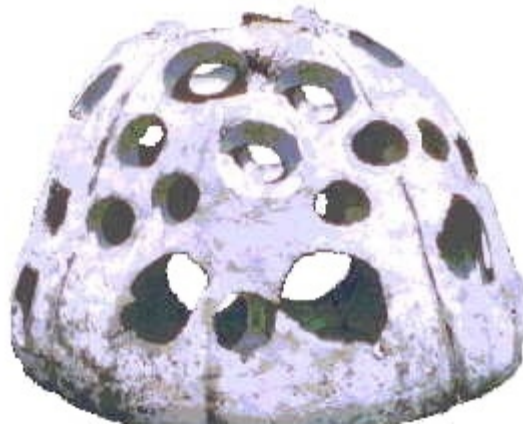
Figure 7: Mould of a reef ball structure - a habitable environment for marine organisms

Artificial reefs on the western, northern and eastern side would be similar to submerged breakwater in terms of design but with a greater base and lower crest. Since the western side is the sandy lagoon area, creating an artificial reef using submerged structures similar to “reef balls” or similar substrate may be useful. Once the reef balls are in place, coral growth will take place, if not, it can be induced by artificial coral transplantation that helps to populate the area with live corals.

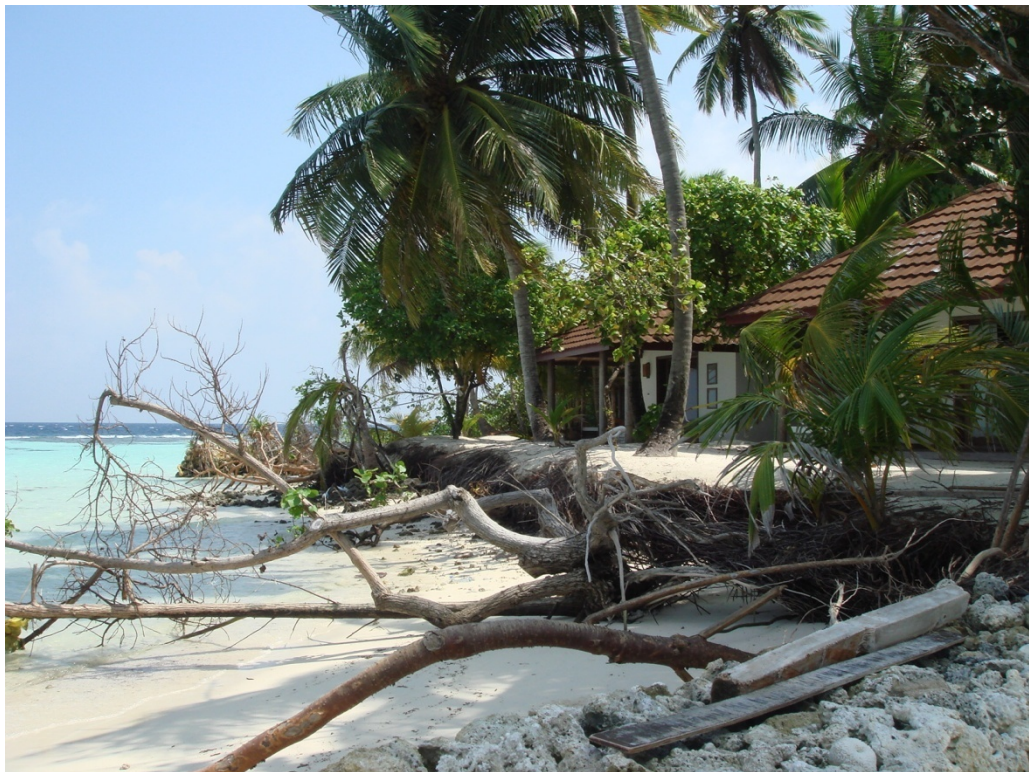
Plate 1: Erosion is causing severe damage to the terrestrial vegetation on western side of the island

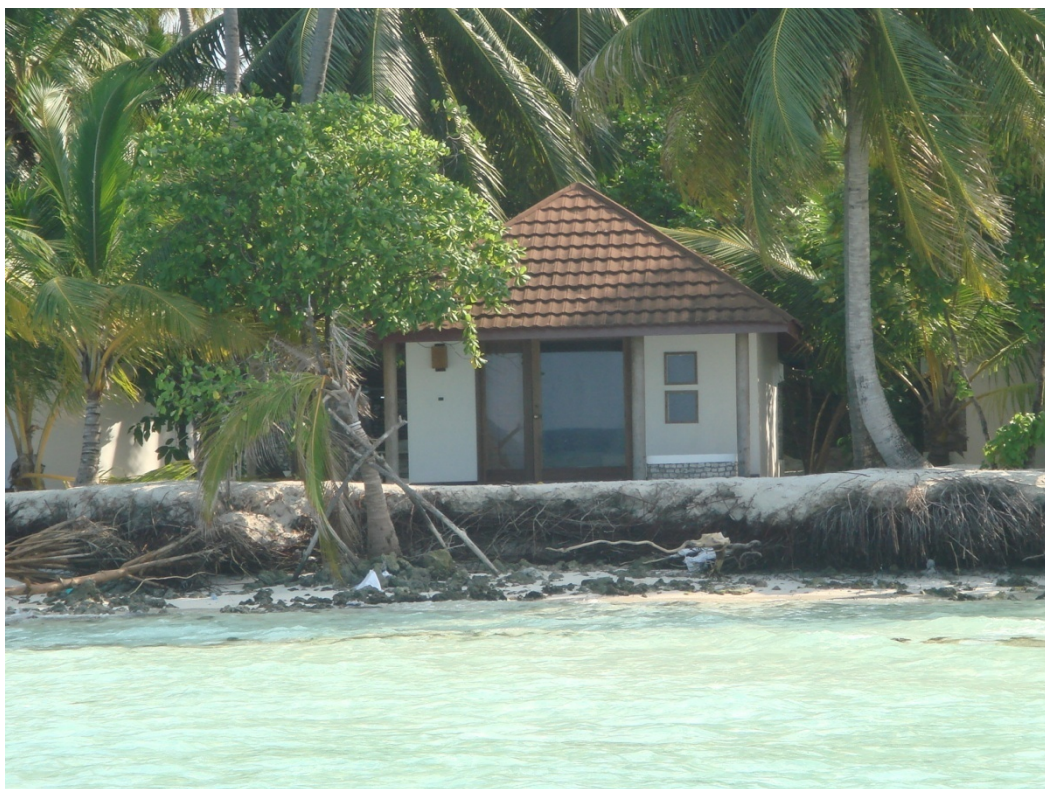
Plate 2: Erosion is treating the some of the beach bungalows on northern side of the island

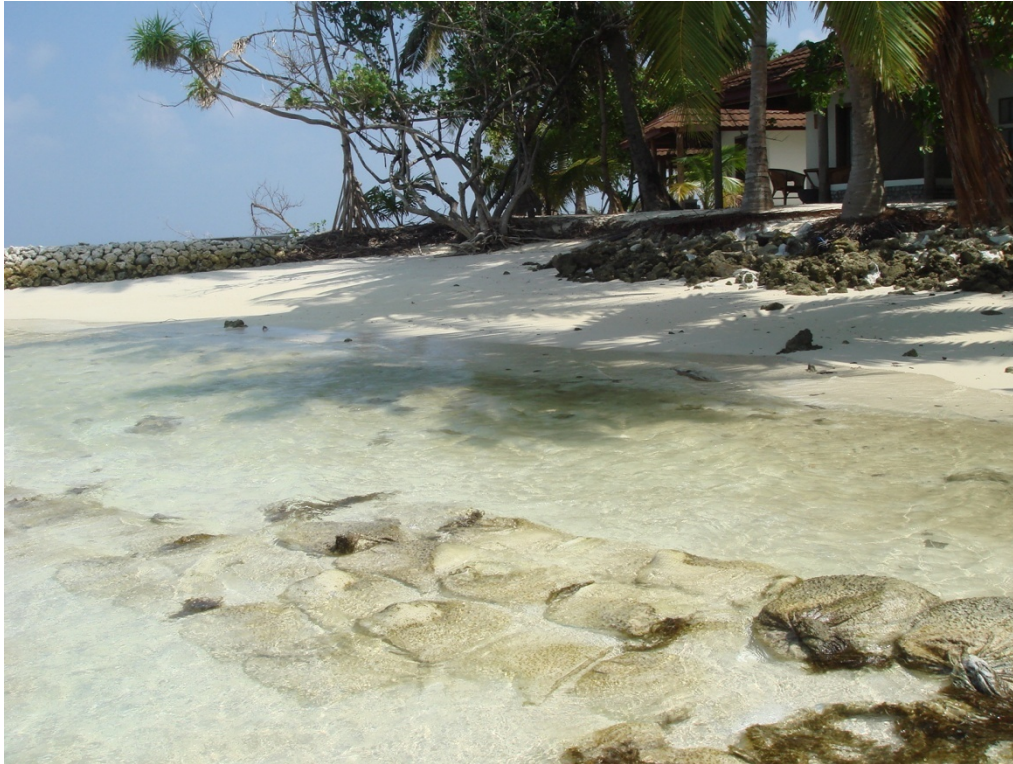
Plate 3: A groyne and sand cement bag near shore breakwater constructed to combat erosion

For the selection of construction materials, the existing materials which had been used to build the existing groynes will be re-used. According to the report compiled by EPA, the island had 4 new groynes and 4 old groynes that were built around the island. Additional materials, if required to finish the groyne fields, will be cement-sand bags. The purpose of using the existing corals is to reuse the existing corals that had been used. One of the principles of waste management is to recover what is usable and valuable in the waste stream and it would be a waste to dispose the corals which have been used to construct the existing groynes. Hence it is proposed to reuse these corals and to use additional sand-cement bags as additional materials to complete the groynes.

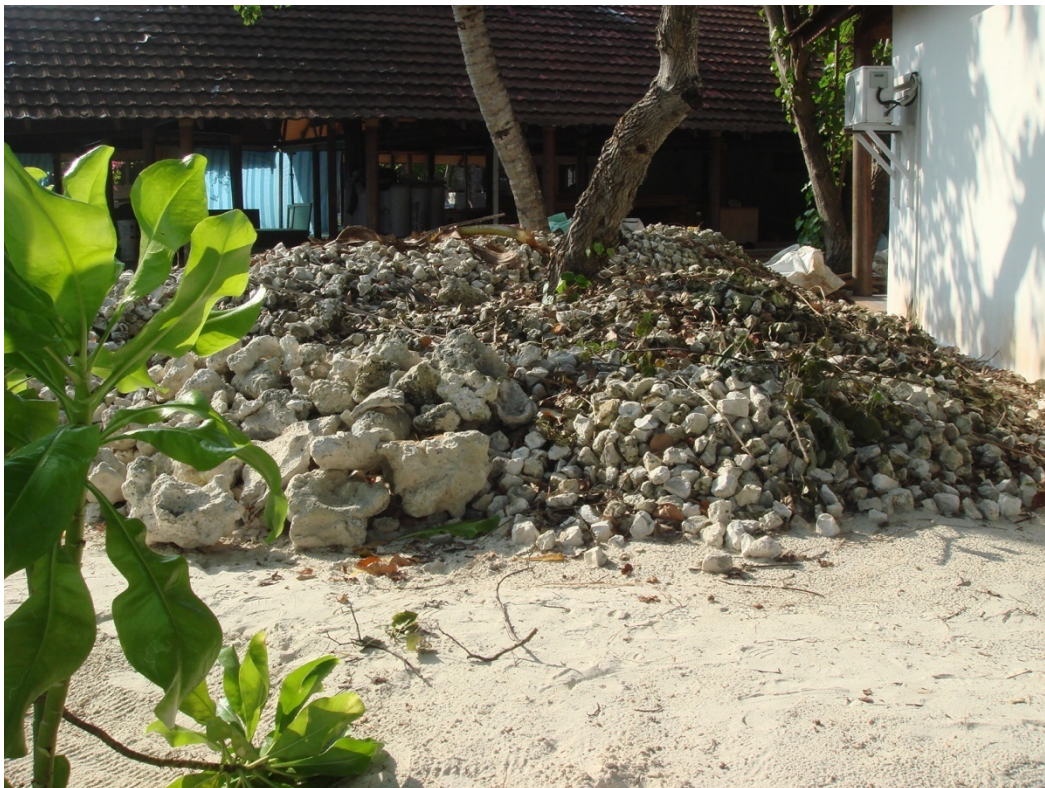
Plate 4: recovered corals from the demolition waste stream
