**ENVIRONMENTAL IMPACT ASSESSMENT
FOR THE DEEPENING WORKS RELATING TO A
FLOATING PONTOON JETTY AT COCOA ISLAND -
MAKUNUFUSHI – SOUTH MALÉ ATOLL**

MAY 2010

**ALYSEN SERVICES PVT. LTD.
MALÉ, MALDIVES**

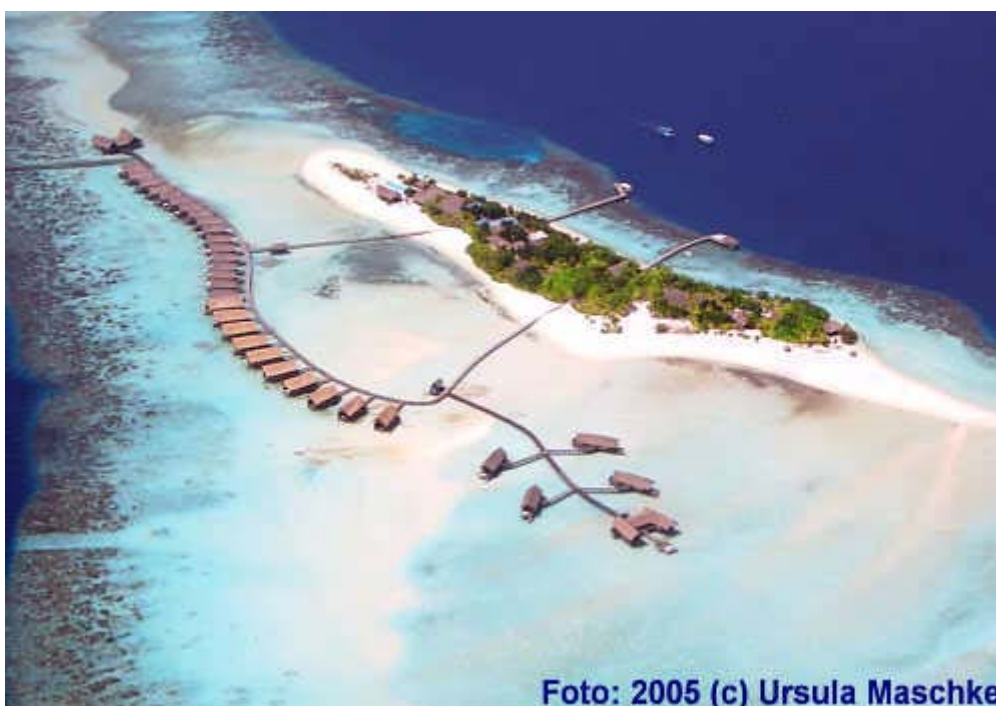
Figure 6: Birds eye view of the island and reef looking from south east towards to the north. The arrival area and the clearance in the east of the existing arrival jetty are clearly seen.

Fortunately the area has some clearance, presumably due to a channel used an earlier time. The area is clearly seen in Figure 6. Deepening will involve use of an excavator mounted on a shallow-bottomed flat top barge. The excavated material will be placed on the barge itself

The issues under this option are related to the requirement for the deepening of the reef flat adjacent to the pontoon. The activity is equivalent to creating a small channel on the reef. Presently the reef flat is about the 0.8 – 1.2 m. The proposed area for deepening also has a clearing which appear to have been used as an entrance channel sometime in the past (cf. Figure 6).

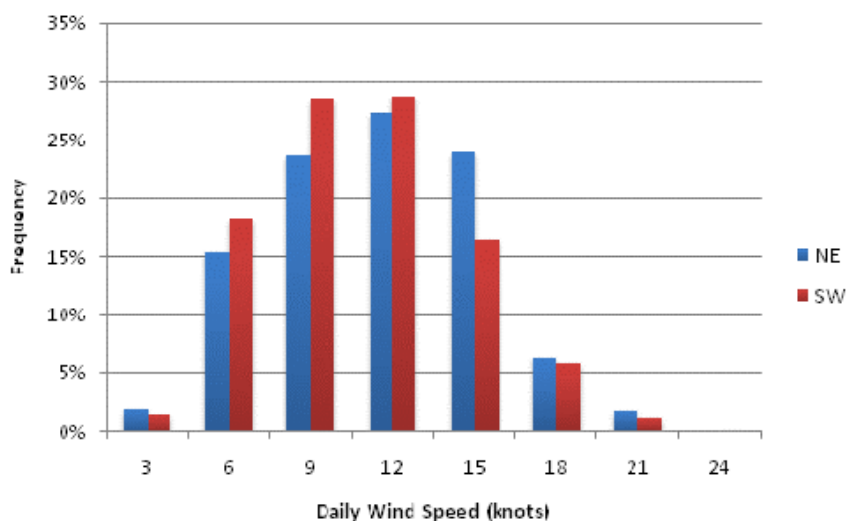
Figure 11: Comparison of the frequency distribution of wind speeds during the SW (May – Aug) and NE (Dec – Jan) monsoon season.

A comparison of wind speeds during the SW and NE monsoon is given Figure 11. The distribution of wind speeds during the north east monsoon has a distinct feature in that frequency of high speed winds (> 12.5 knots) are more frequent in during the NE monsoon. It is known that winds are unpredictable and gusts may reach to gale-force speeds during the *halha* period. Interesting this is the period when the resort finds most difficult to use the jetty.

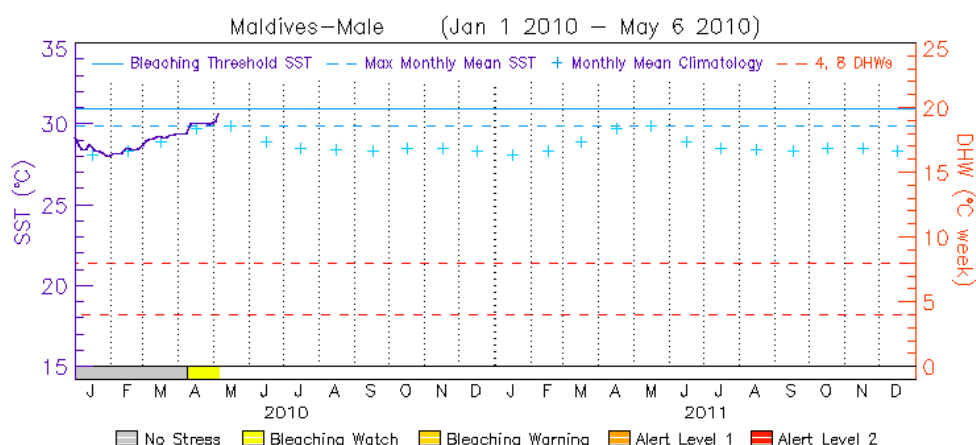
Figure 13: Sea surface temperate and degree heating week (DHW) indices for the Maldives area during 2010. DHW measure how long it has stayed above the threshold level (which is zero on this chart)

March / April in Maldives are generally warmer and often coincide with periods of the slack or no wind. It is these periods that coral bleaching is mostly likely to occur. The coral bleaching watch website of the NOAA (<http://coralreefwatch.noaa.gov/satellite/index.html>) showed that during April 2010, a ‘bleaching watch’ alert was assigned for the Maldives area (Figure 13)

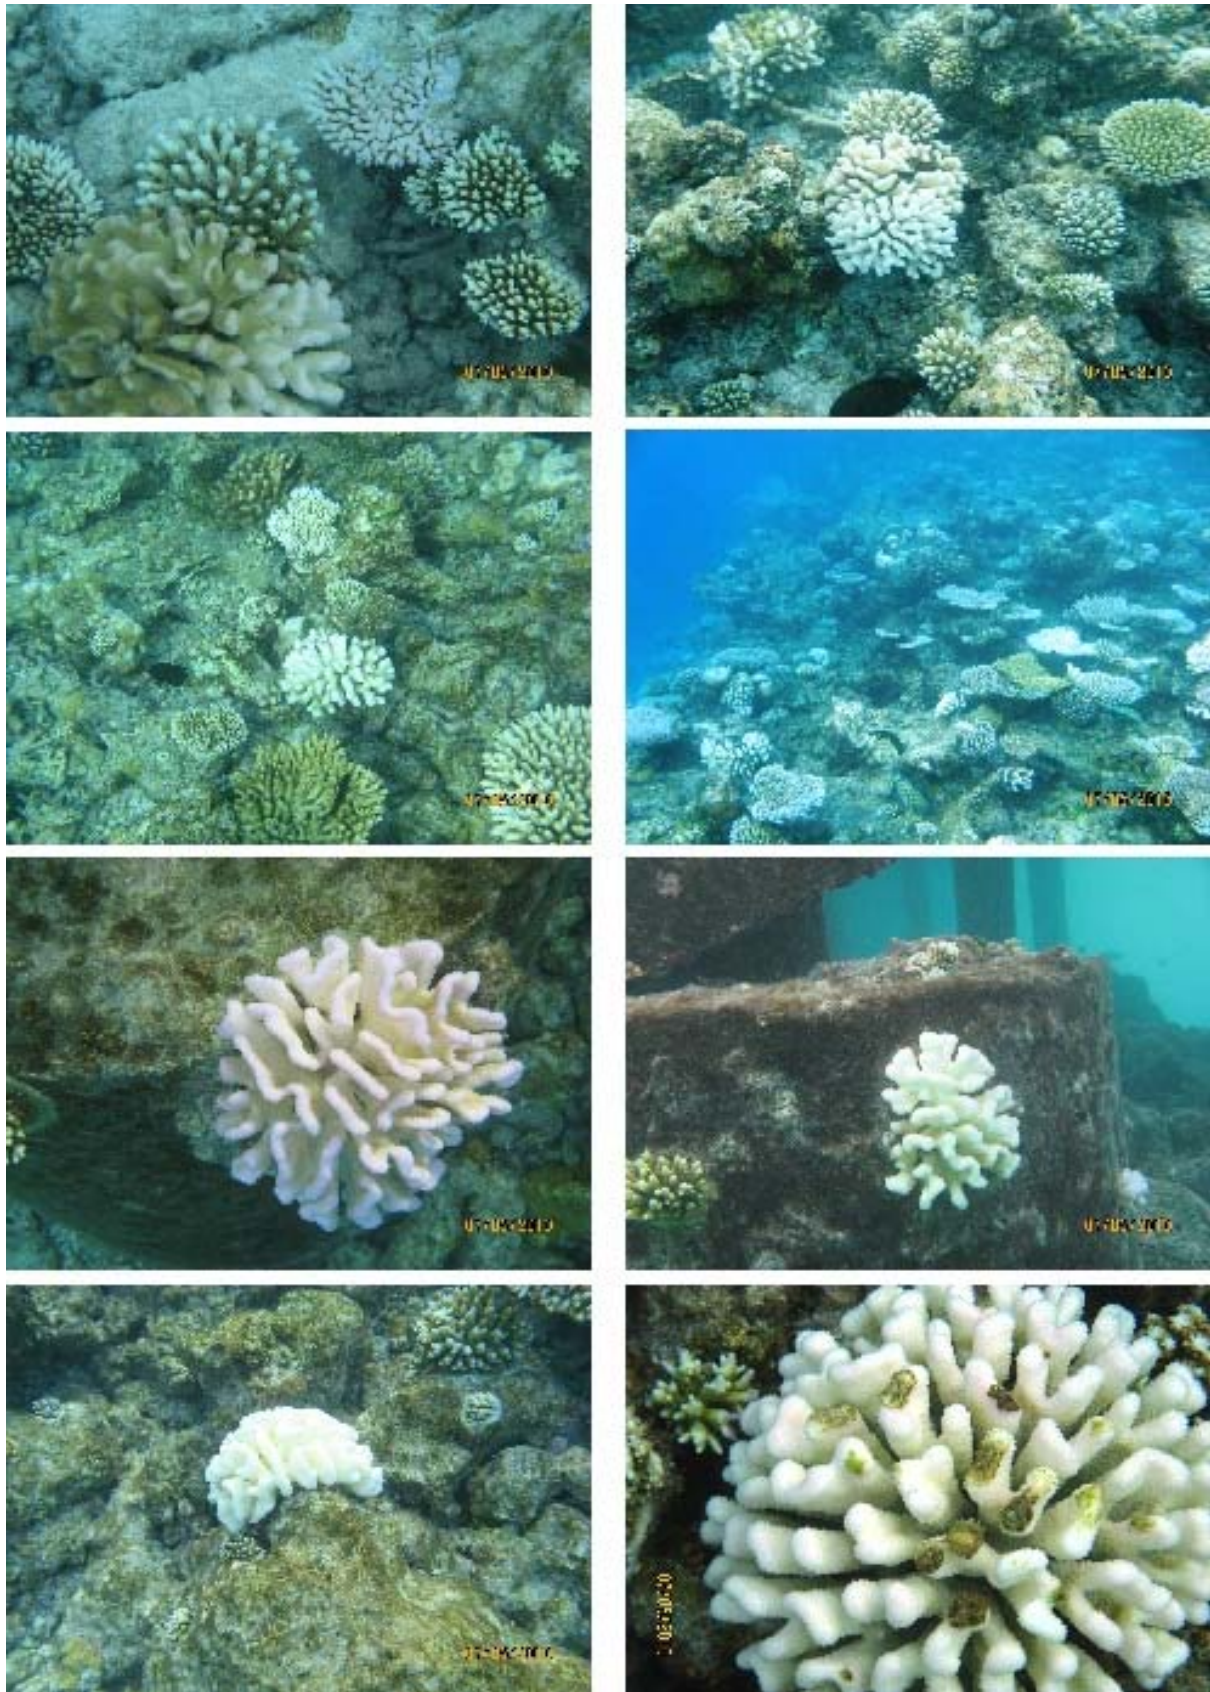
Figure 14: Photo-images of the coral reef area on east of the jetty. Most of the live coral have been affected by the warm weather in April 2010.

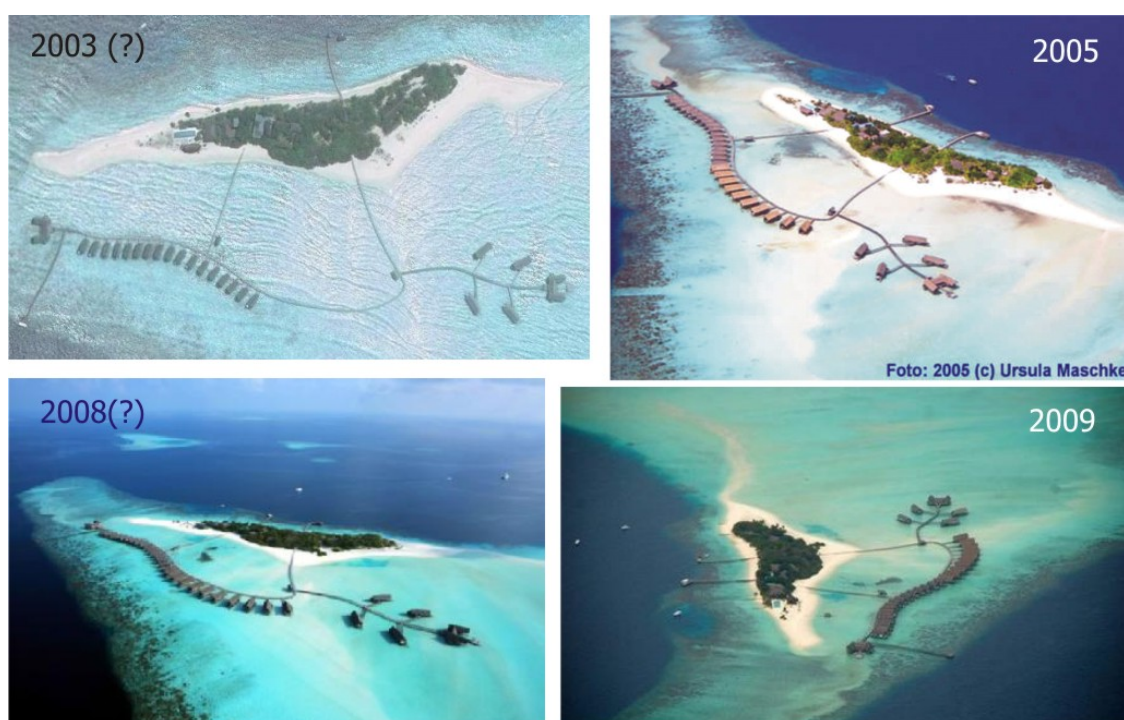
Figure 18: Cocoa Island at various time periods – Photos from Google Image Archives showing that southern beach has shifted westward and drawn along the jetty forming an acute angle.

It has been mentioned that shoreline of the Cocoa Island is quite dynamic. A major shift in sediment depositional pattern was observed following the re-development of 2002 (Figure 18). The requirement of active sand pumping to maintain beach of the northern side suggest that dynamics has not reached a long-term equilibrium. In equilibrium states the net accretion of inshore lines is presumed to be relatively small (Kench and Brander, 2006).
