1 Non Technical Summary

This report discusses the findings of an environmental impact assessment study undertaken by Water Solutions Pvt. Ltd. upon request from Male' Water and Sewerage Company Pvt. Ltd. (MWSC), hereafter referred to as 'client'.

The project involves the construction and implementation of an additional sewerage outfall and a pump station in Hulhumale' and is the first phase of a sewer network for the Industrial area in Hulhumale'. The only existing sewerage outfall currently available has reached its maximum capacity. After the location approval for the sewerage outfall, the rest of the sewerage network will be planned. This EIA has been prepared to assess the social and environmental impacts of the sewage outfall pipe and the pump station.

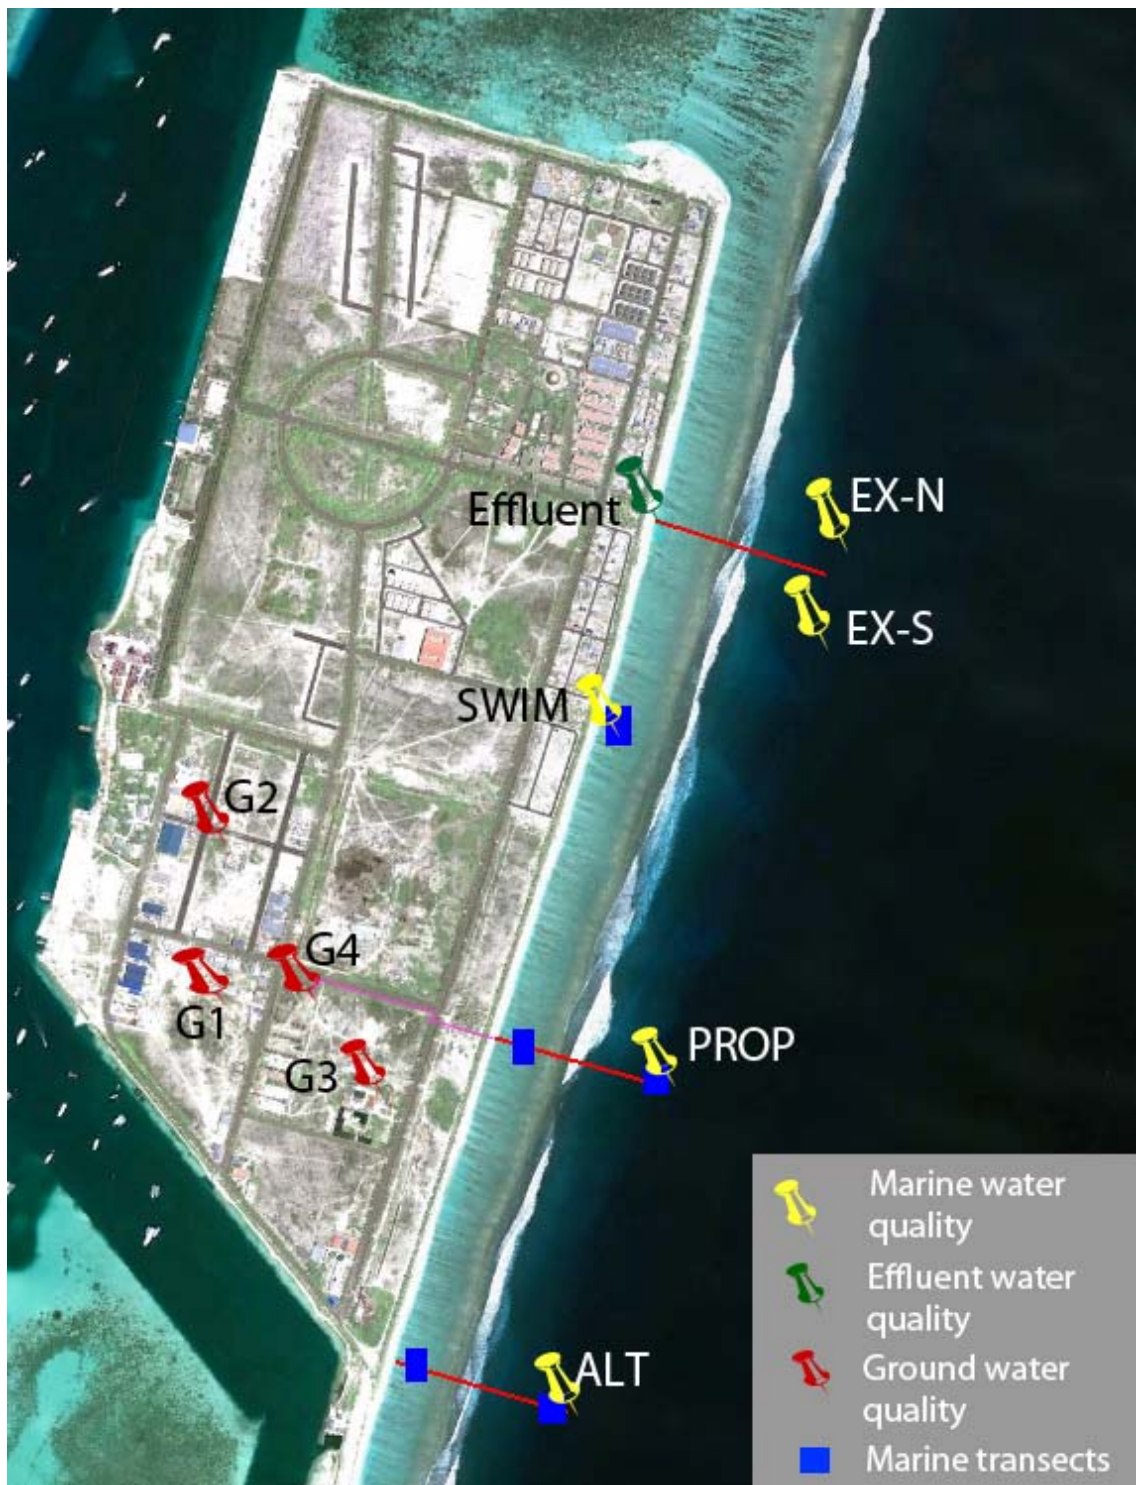
Figure 3. Survey locations for the present EIA study.

G1-G4 are groundwater quality sampling sites; ALT ... Alternative Site, PROP ... Proposed site for outfall, EX-N and EX-S ... North and South of the existing sewage outfall. Marine benthos survey sites are marked in blue quadrats.

Several locations on and around the island such as groundwater and seawater sampling points were recorded using a Trimble Geo GPS. Water quality sampling sites and the location of the reef survey are outlined in Figure 3.

Groundwater sampling for baseline data was conducted in 4 areas of the southern side of Hulhumale' (Table 2, Figure 3) as discussed in the scoping meeting on 12th August 2010.

The quality of seawater was assessed in five areas on the eastern side of the island (Table 3, Figure 3): North and South of the existing sewage outfall (350 m from shore), at the proposed and alternative outfall site (350m from shore) and at the shallow area where the swimming track is planned.

A quantitative study was undertaken at the proposed outfall site (PROP) and the alternative site (ALT). Since the client planned to discharge sewage approximately 350m from shore, this distance was calculated and the survey was conducted in 21m (ALT) and 15m (PROP) depth (Figure 3).

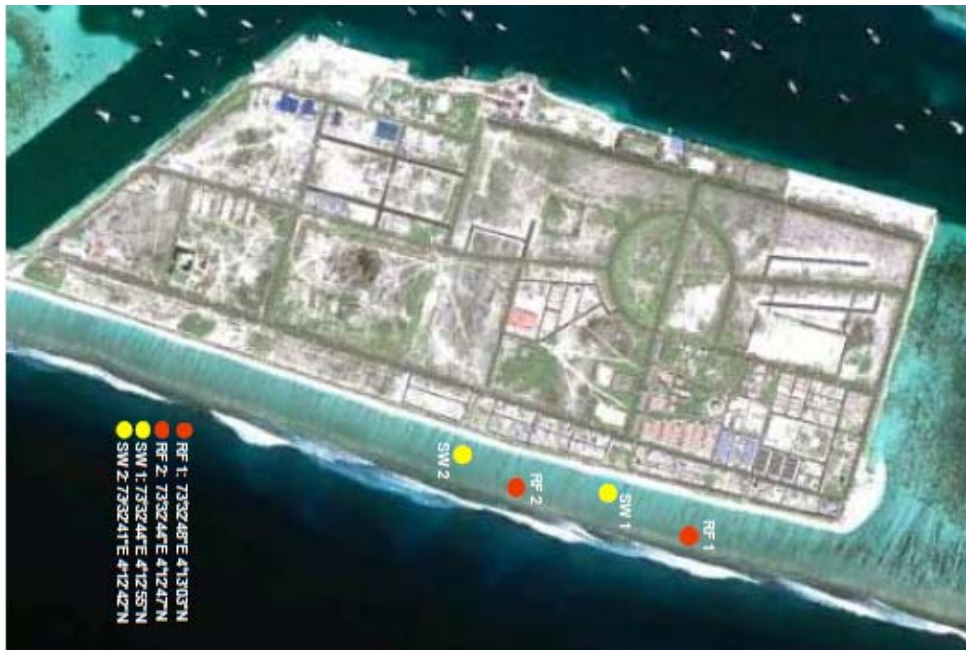
In addition to the parameters that we collected for this EIA, some information about the seawater quality at two more sites were available to us from the EIA of the proposed swimming track (LaMer 2010): from the shallow area where the swimming track has originally been proposed (Site “SW 1” at 4°12’55”N, 73°32’44”E), and at the alternative site, where the track is eventually planned (Site “SW 2” at 4°12’42”N, 73°32’41”E). The seawater sampling sites are indicated with a yellow dot in Figure 4:

Figure 4. Seawater quality sampling sites (SW1 and SW2, yellow dots) from the EIA for a swimming track (LaMer 2010)

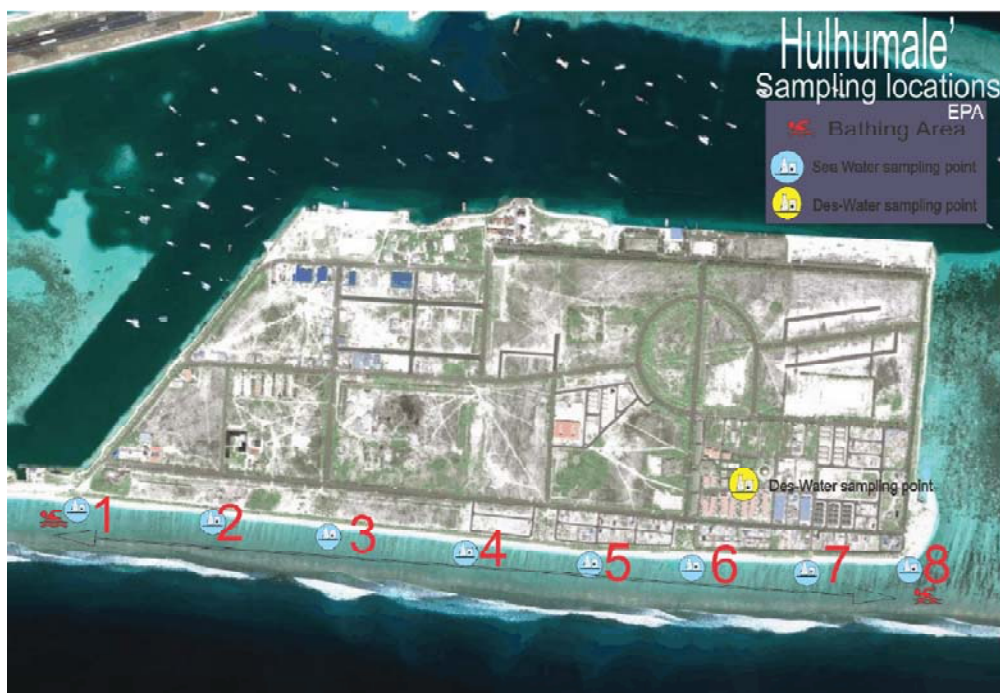
In addition, the EPA (Environmental Protection Agency) has performed water quality tests in Hulhumale’ at locations shown in Figure 5. Site “6” is closest to the existing sewer outfall, whereas the swimming track will be made between Site “4” and “5”. The proposed outfall is closest to “3”, and the alternative location would be close to “1”.

Figure 5. Water quality sampling sites “1” to “8” along the eastern shore of Hulhumale’. Graphic: EPA

Results that we received from the EPA are shown in Table 7. Sites “1” to “8” are shown on a satellite photo in Figure 5 in the Methodology section.

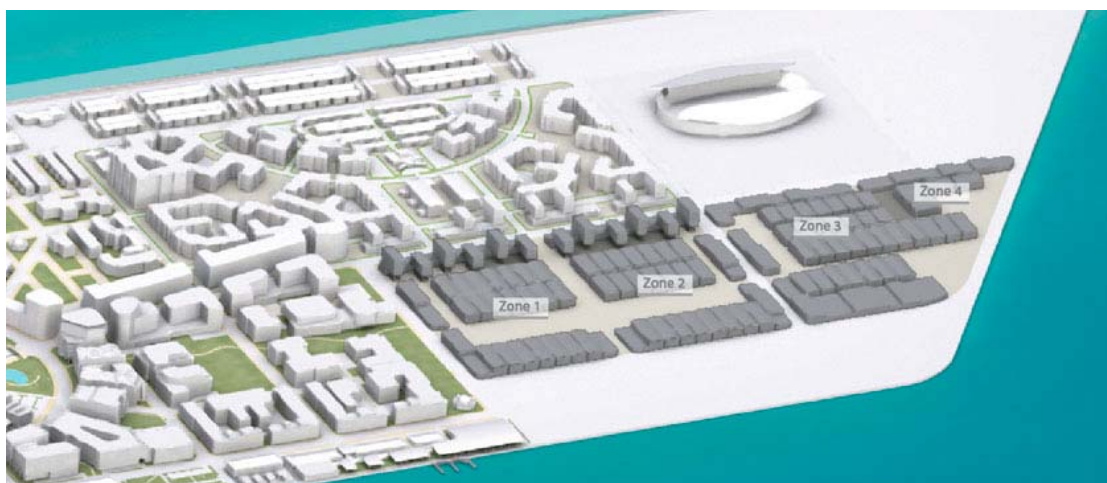
As per information from HDC, the Industrial Zone, for which a sewer network is planned and for which the proposed outfall will be constructed, will consist of 4 Zones (Figure 7):

- Zone 1 – Fish, Food and related services
- Zone 2 – Warehouse and other light industries
- Zone 3 – Workshop, Carpentry and similar activities
- Zone 4 – Nuisance Industrial activities

Figure 7. Plan for the industrial zone in Hulhumale'. Graphic by HDC.

This project proposes a pump station and a deep sea sewage outfall that will receive sewage from the so-called "Industrial area" of Hulhumale' (see Figure 7). The contents of industrial waste waters will differ significantly, depending on the nature of the industry. Waste water from metal/mechanical industries tends to have much higher metal and inorganic salts than human waste. Food processing industries such as the tuna industry tend to have high bacterial content, very high nitrogen and phosphorous concentrations, as well as organic components that will deplete oxygen rapidly during the natural break-down process. Human waste, on the other hand, consists mainly of human excreta. The urine is referred to as 'yellow waste', faeces are referred to as 'black waste' and human wash water, laundry and kitchen water are referred to as 'grey water'. The domestic waste water is therefore higher in bacterial / virus / pathogen – concentrations and lower in metal concentration than industrial waste.

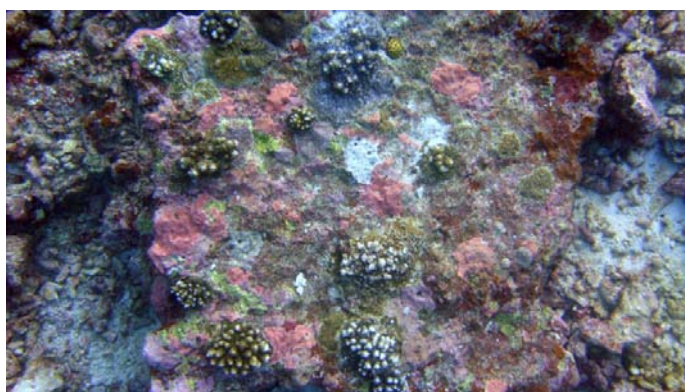
The benthic reef composition at both sites is similar with a high amount of coral rock and rubble covered in coralline algae as typical for outer atoll environments. The scarcity of marine life from the reef flat ends in about 8 to 12 meters, where corals and other benthic communities take hold at the underlying rock and flourish in from about 12-15 meters below. Corals found at both sites are generally young, with the exception of a few large *Porites* boulders (example in Figure 14) in the shallow area, which are only partly alive. Generally, the chances for coral recruitment are high in both areas since there is enough proper hard substrate to settle. Apparently, a concrete block was disposed at the proposed site at 12m depth which can now be seen completely covered in young corals as shown in Figure 20.

Figure 20. Concrete block covered in at least ten species of coral and coralline algae (PROP), 12m depth

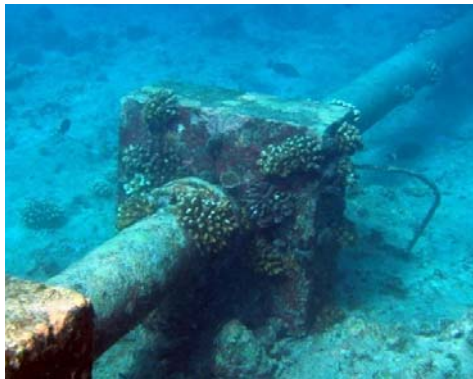
During normal operation of the sewage system, the pipe itself does not pose any environmental hazard to the surrounding reef; instead it may act as a settling ground for new coral larvae, just like the existing sewage outfall (see Figure 21).

Figure 21. Existing sewage outfall in Hulhumale' with young corals using it as a settling ground
