ENVIRONMENTAL IMPACT ASSESSMENT

For the proposed Upgrade and Redevelopment in
Thudufushi Resort, South Ari Atoll, Maldives

Seagull Group Pvt Ltd

Ahmed Jameel

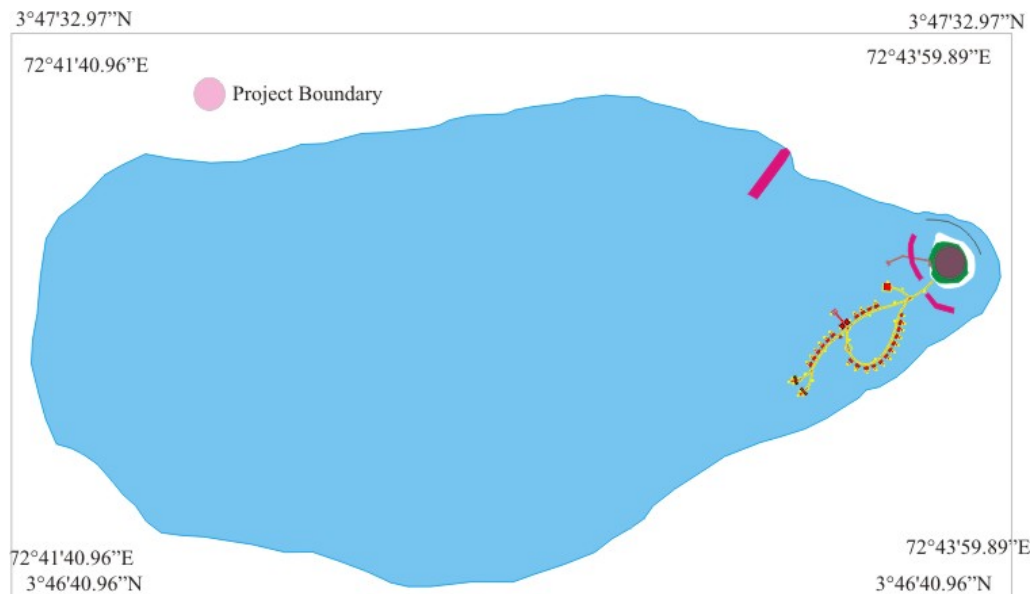
Figure 2: Project boundary

This project is limited to Thudufushi. The project boundary is illustrated below.

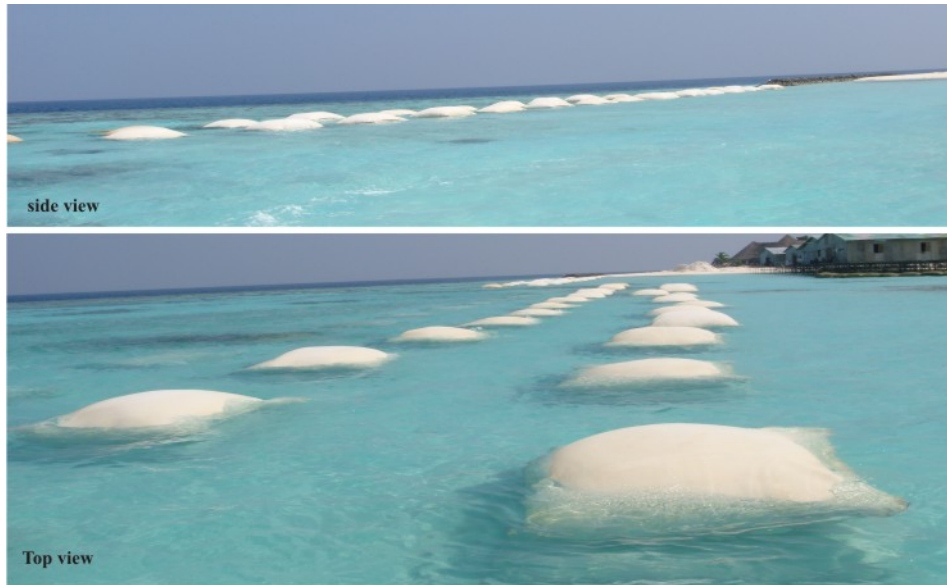
Figure 4: cross-section of a breakwater made from geotextile bag

The breakwater has been designed to create an artificial reef using geotextile bags. The geotextile bags will be filled with sand and placed in three rows. The distance between rows would be 5 meters. A row is made of discrete geotextile bags. The distance between bags in a row is about 4 – 5 meters.

The length of the new breakwater on western side of the island is about 150m and southern side is 120m and the breakwater on northern side of the island would be 200m. The gap between the geobags is about 2-5 m. Figure 4 shows the location of the submerged breakwaters and their possible orientation.

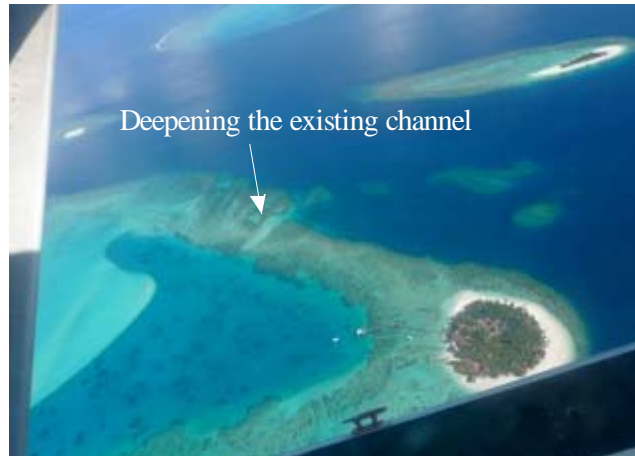
The existing channel which is located on the north western side of the island can be used on high tide by boats. The proposed development would block the existing channel which is located on southwestern side of the island. Even this channel has become very shallow at less than 1.0 m at low tide making the boats difficult to access the island in low tide causing disruption to the supply to the island. Hence, it has been proposed to deepen the channel which is located on north western side of the island as to allow easy and safe access to the island by boats.

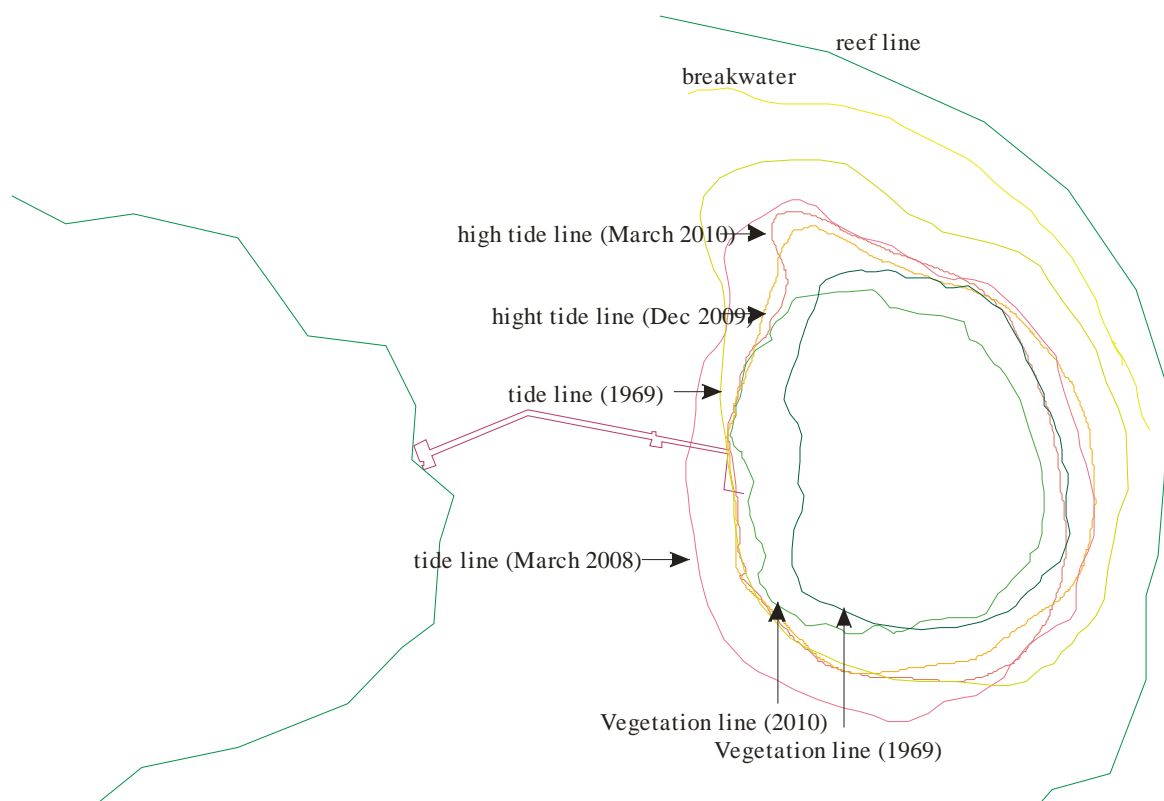
Figure 6: Comparison of Thudufushi vegetation and beach lines in 1969, 2008 , 2009 & 2010

There have been dynamic changes to the vegetation and shorelines of Thudufushi over the past. These changes are mainly due to natural evolution of the island but have also been affected to a great extent by the different changes that have been made in the name of coastal protection in the past.

According to the geological formation, vegetation and soil characteristics of the island the island is young and growing from a nodal point in the east corner of the reef system. The dynamic nature of the island can be seen from Figure 5, especially the shift in coastal vegetation.

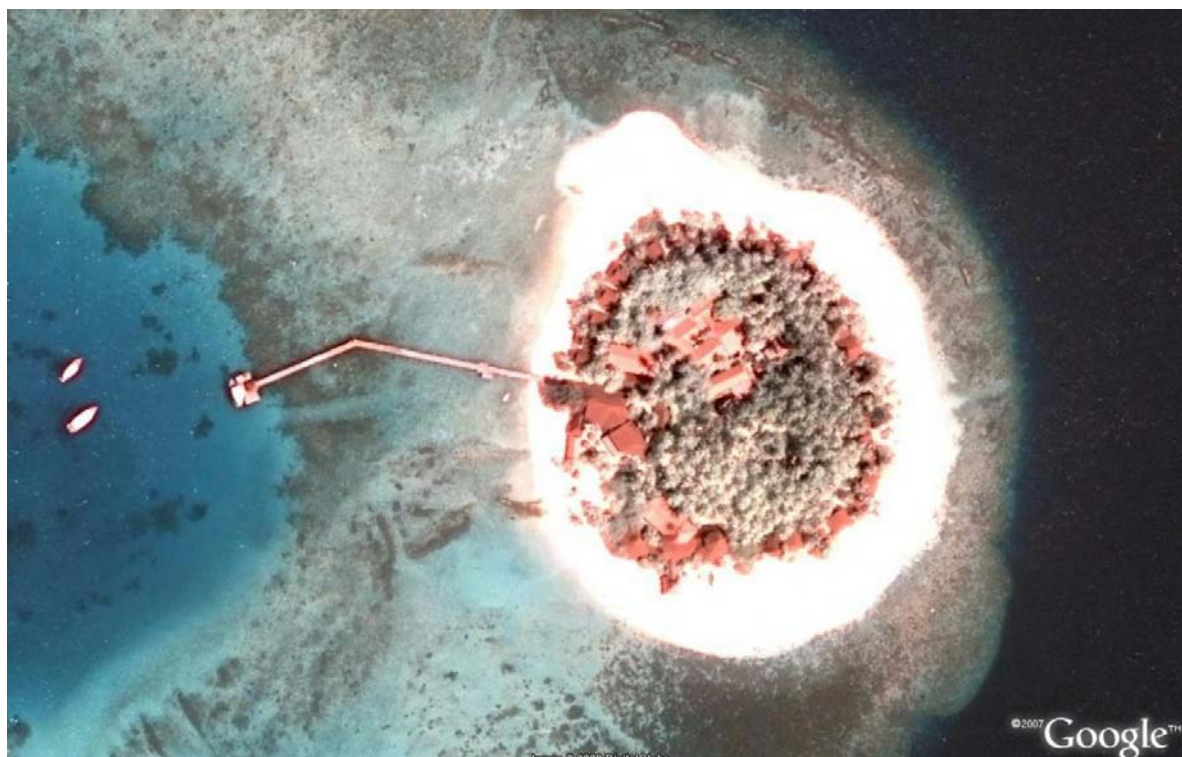
Figure 7: Satellite photo (March 2008) from Google Earth

The eastern reef extent is much smaller than the western reef extent. The western side lagoon gradually slopes into a deeper vilu which is about 150m from the beach. The vilu area is about 53 hectares. This vilu has been used for seaplane platform and vessels are moored to buoys in the area.

From Figure 5 as well as the aerial photo shown in Figure 7 it can be depicted that the island appears to grow in the westerly direction with the island building occurring mainly during the northeast monsoon. However, there is very little sediment deposition during this period compared to the sediment deposition potential during the southwest monsoon. This is because the submerged breakwater on northern side of the island had created a calmer condition as such the movement of the beach had been restricted than it used to be.

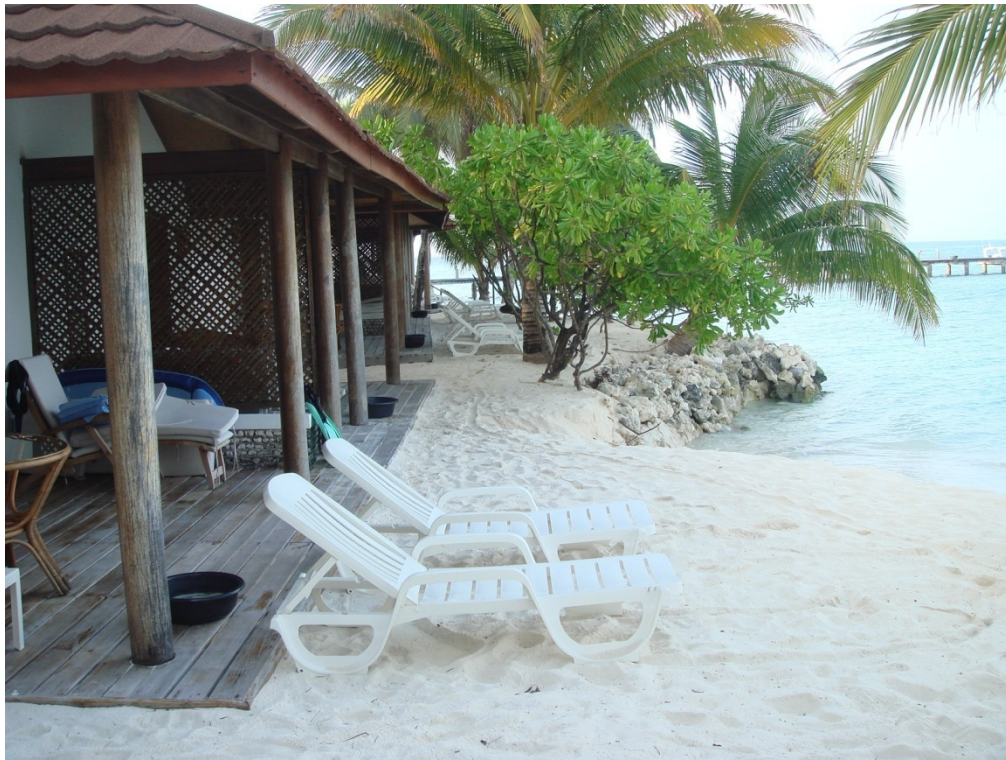
There is a 200 m submerged breakwater on northern side of the island. This breakwater has been constructed when the island faced severe erosion on northern side of the island during the NE monsoon. After the breakwater, the beach on this side of the island has become stabled.

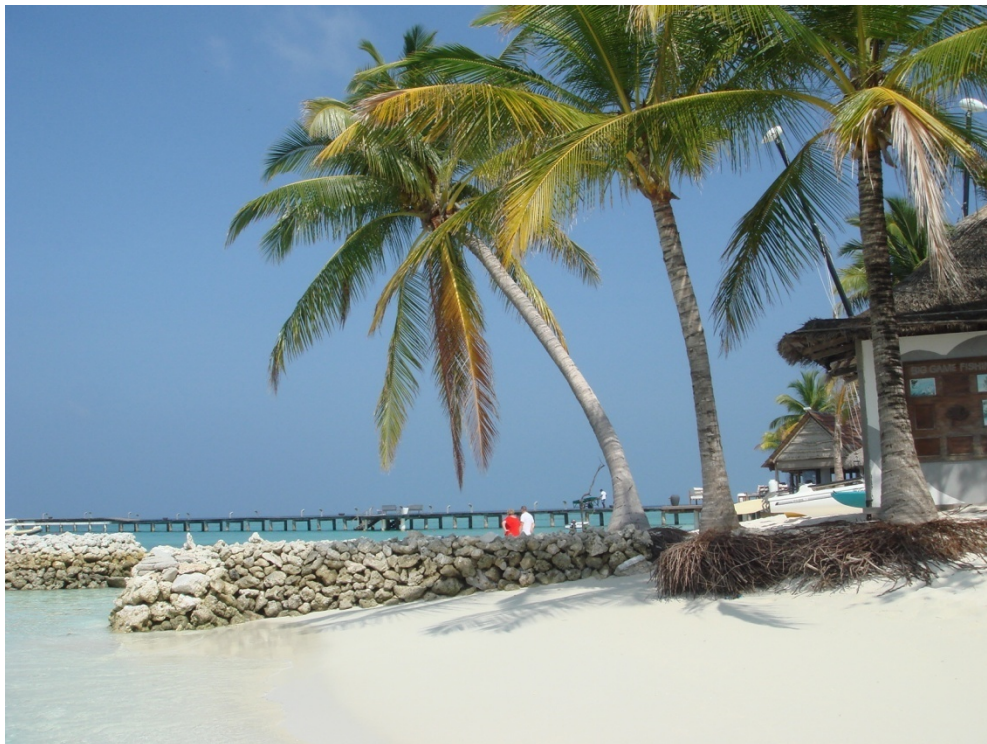
Plate 2: Two groynes which had been constructed using coral on western side of the island

The west side shows severe erosion as a result of southwest monsoon weather. This area sees most erosion as a result of which the area has three rubble-mound groynes and seawall on the

western side of the island. These groynes, however, do not seem to serve the purpose, since it is due to wave scour that the sediment moves mainly.

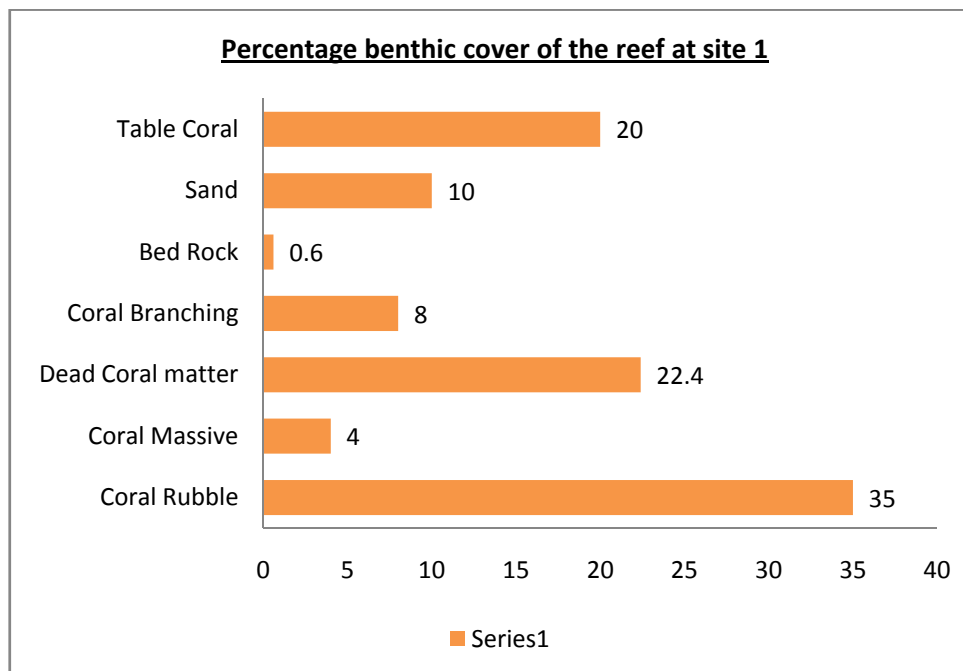
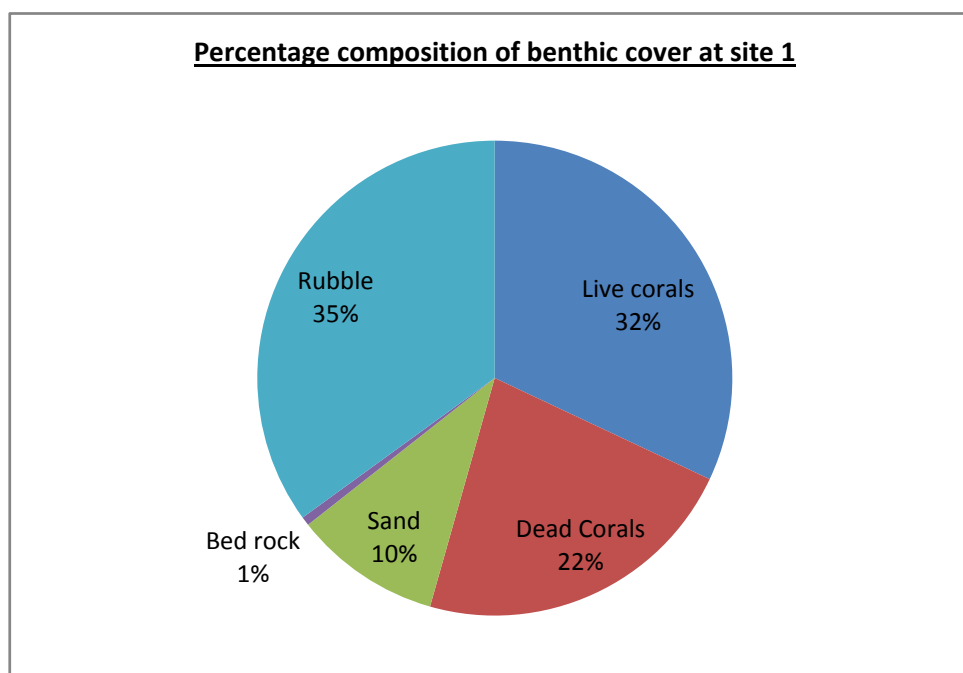
Marine survey location 1**Figure 12: Percentage benthic cover of the reef at Site 1**

The survey showed that the coral reef at site 1 had 32% live coral cover consisting of corals mainly belonging to the *Acropora* group. Other composition include 20 % *Acropora* Tabular, 10% sand, 0.6 % bed rock, 8% *Acropora* Branching, 22 % dead corals, 4 % massive corals, and 35 % coral rubble. This area is dominated by coral rubble and the live coral cover is quite high. Standard error for these estimates is within $\pm 10\%$.

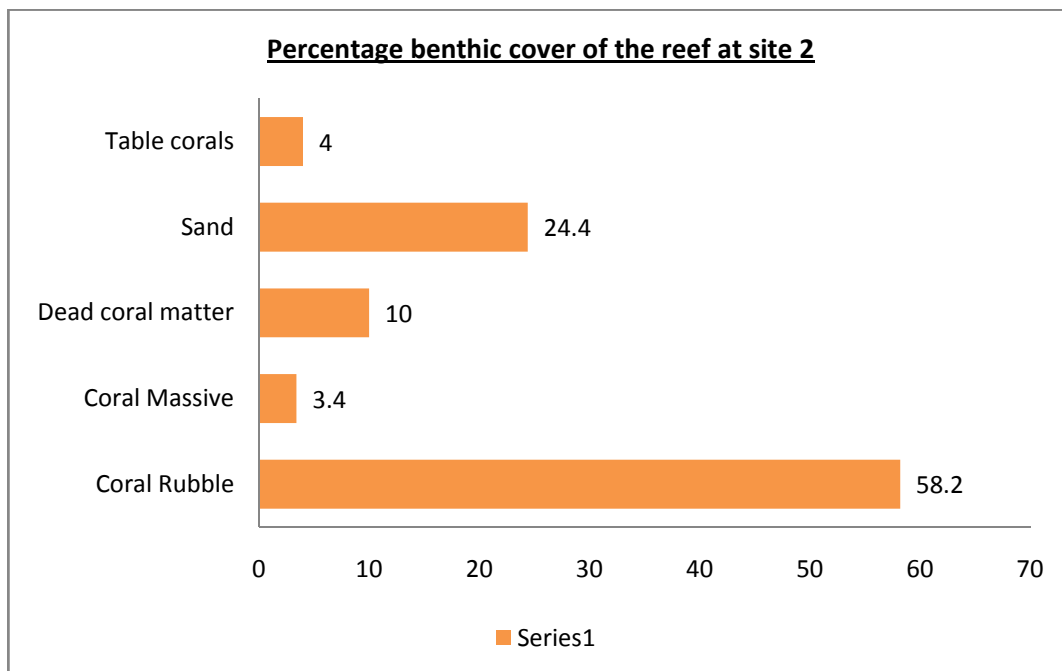
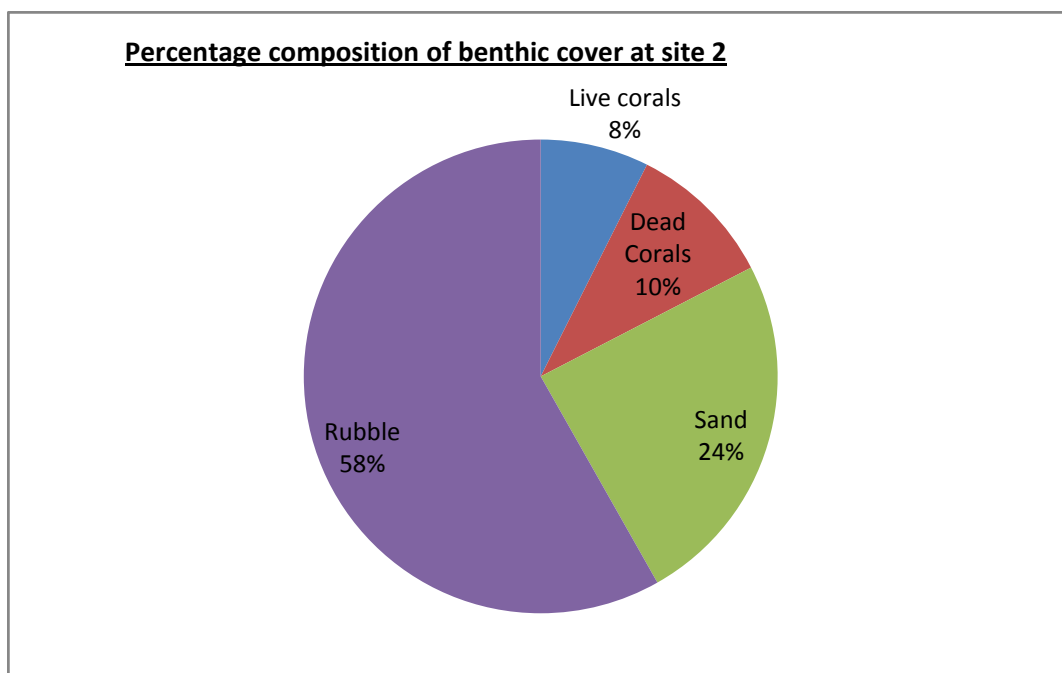
Marine survey location 2**Figure 13: Percentage benthic cover of the reef at Site 2**

The reef survey conducted showed that the coral reef at site 2 had 8% live coral cover. The most abundant types of coral were table corals. The survey showed that site 2 consisted of 3.4 % massive corals, 4 % table corals, 24.4% sand, 10% dead coral matter and 58% coral rubble. This area is dominated by coral rubble. Standard error for these estimates is within $\pm 10\%$.

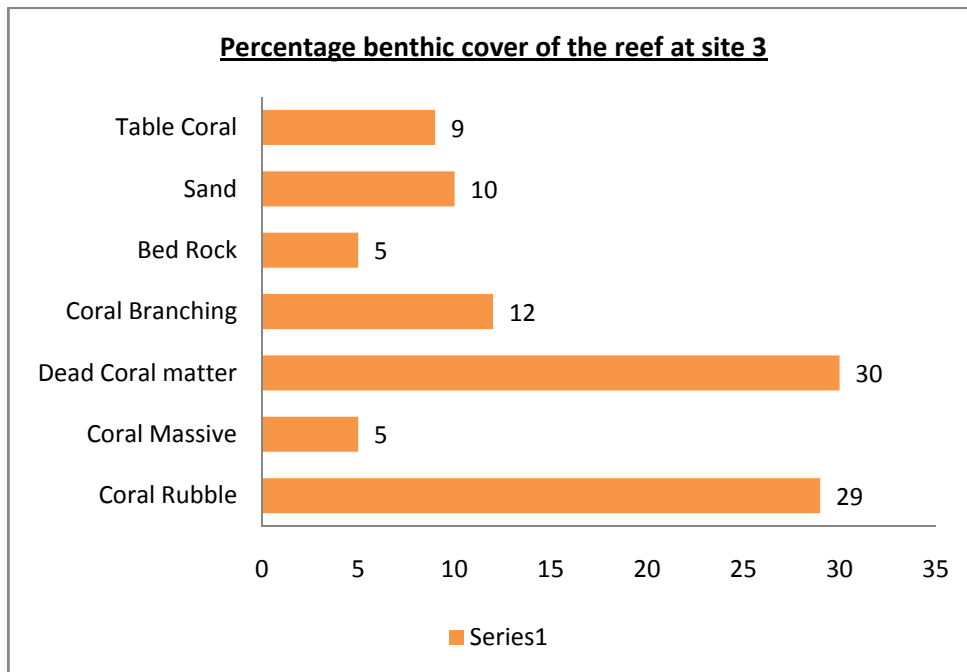
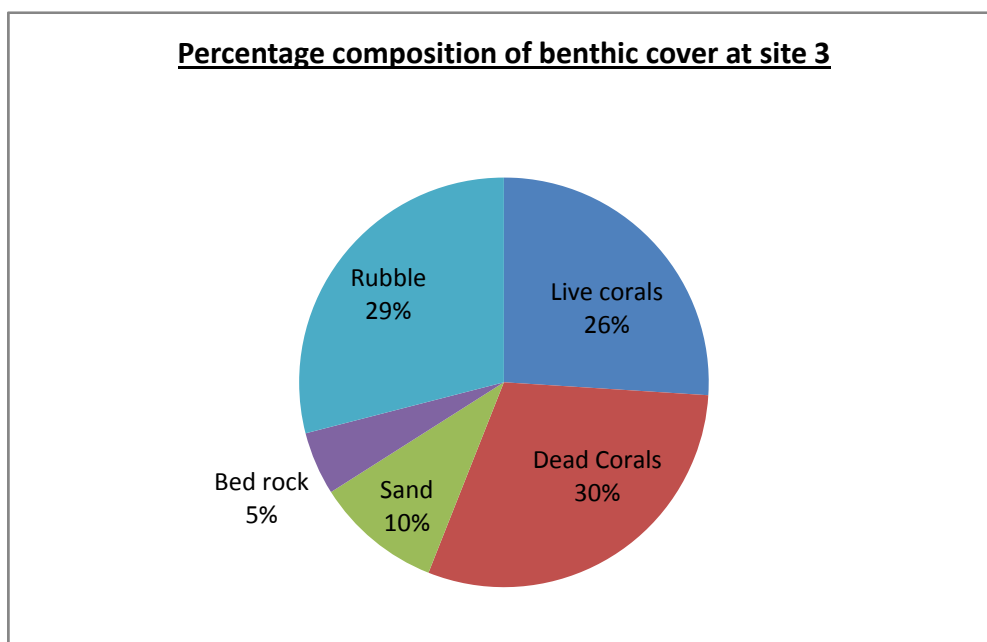
Marine survey location 3**Figure 14: Percentage benthic cover of the reef at Site 3**

The reef survey conducted showed that the coral reef at site 3 had nearly 26% live coral cover. The most abundant types of coral were coral branching. The survey showed that site 3 consisted of 9% table corals, 5% bed rock, 30% dead coral matter and 5% coral massives. This area is dominated by dead coral. Standard error for these estimates is within $\pm 10\%$.

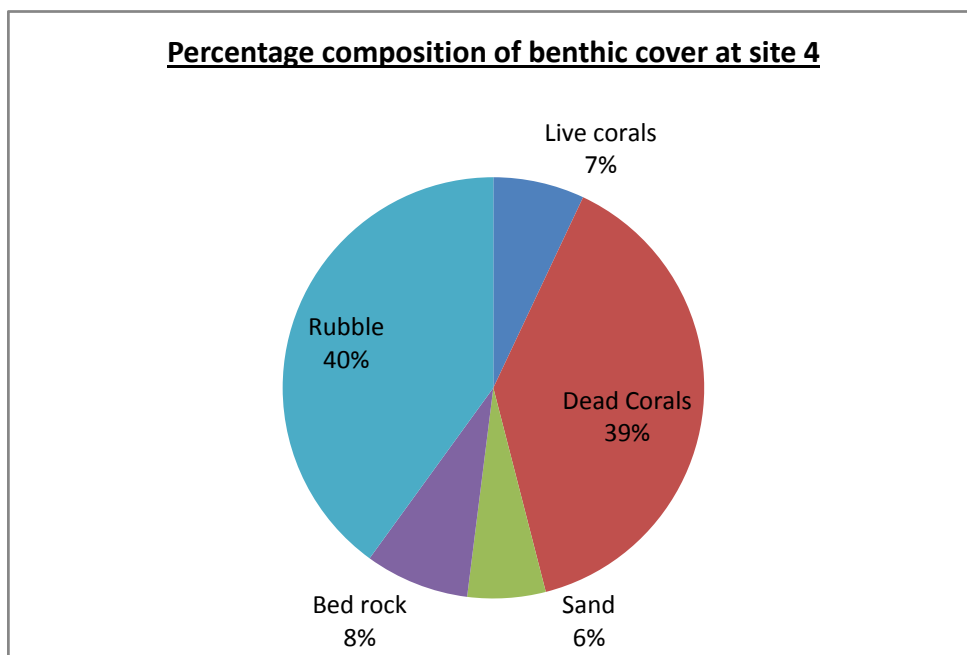
Marine survey location 4**Figure 15: Percentage benthic cover of the reef at Site 4**

The reef survey conducted showed that the coral reef at site 4 had nearly 7% live coral cover. The most abundant types of coral were coral branching and table corals. The survey showed that site 4 consisted of 3% table corals, 8% bed rock, 39% dead coral matter and 1% coral massives. This area is dominated by coral rubble. Standard error for these estimates is within $\pm 10\%$.

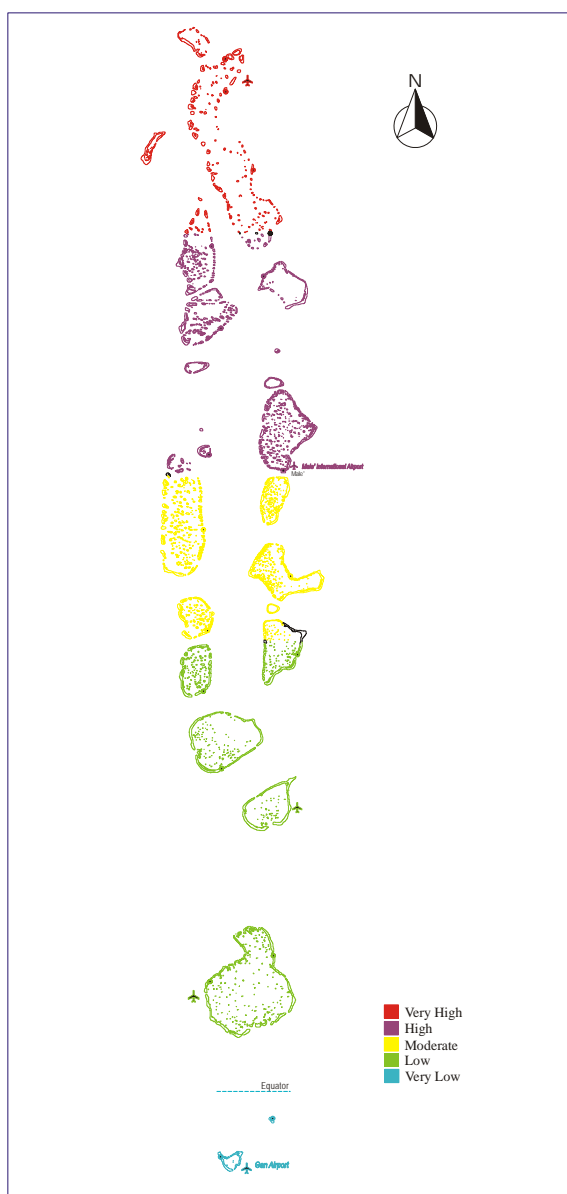
Map 1: Cyclonic Wind Hazard Map (source: UNDP, 2006)

The northern atolls have a greater risk of cyclonic winds and storm surges. This reduces gradually to very low hazard risk in the southern atolls (see Map 1). The maximum probable wind speed in Zone 5 is 96.8 knots (180 kilometers per hour) and the cyclonic storm category is a lower Category

3 on Suffir-Simpson scale. At this speed, high damage is expected from wind, rain and storm surge hazards (UNDP, 2006).

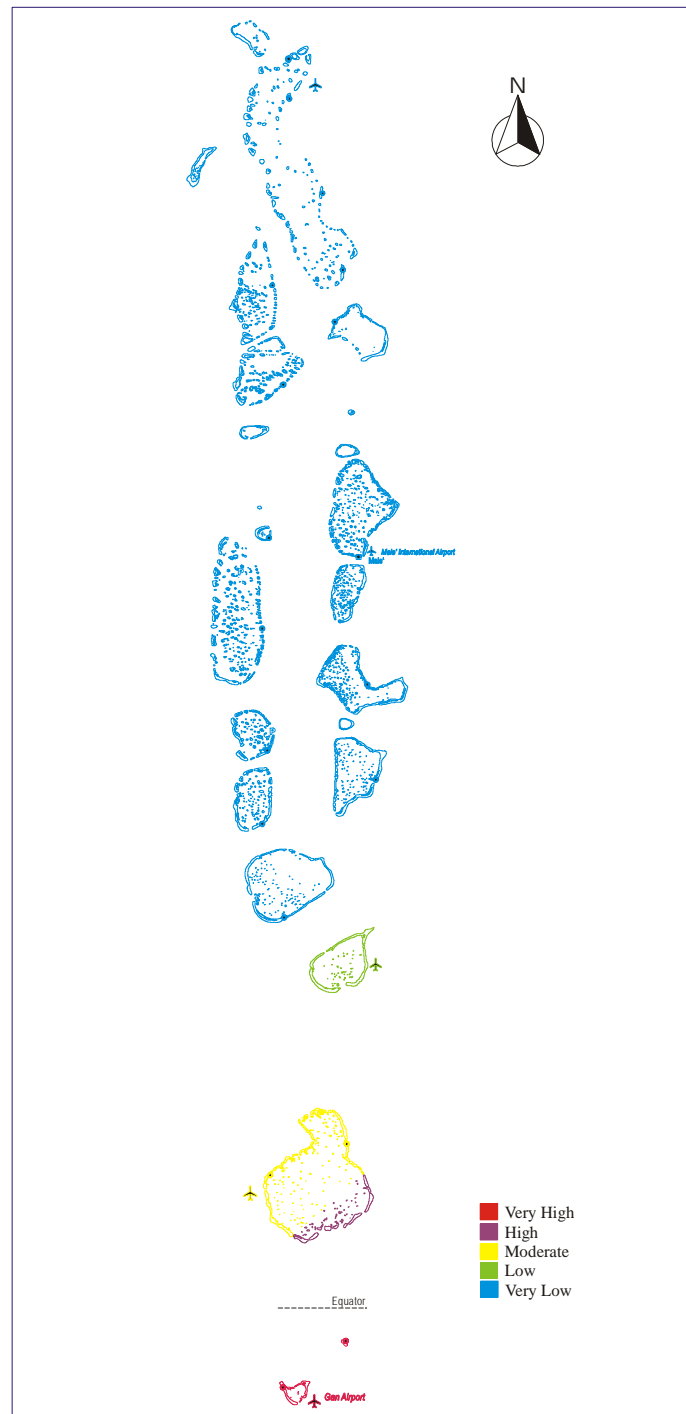
Map 2: Earthquake Hazard Zone (source: UNDP, 2006)

UNDP (2006) identified that hazard risk from earthquake is low for the Maldives and considered as a disaster risk for only islands located in the south of the country. See Map 2.

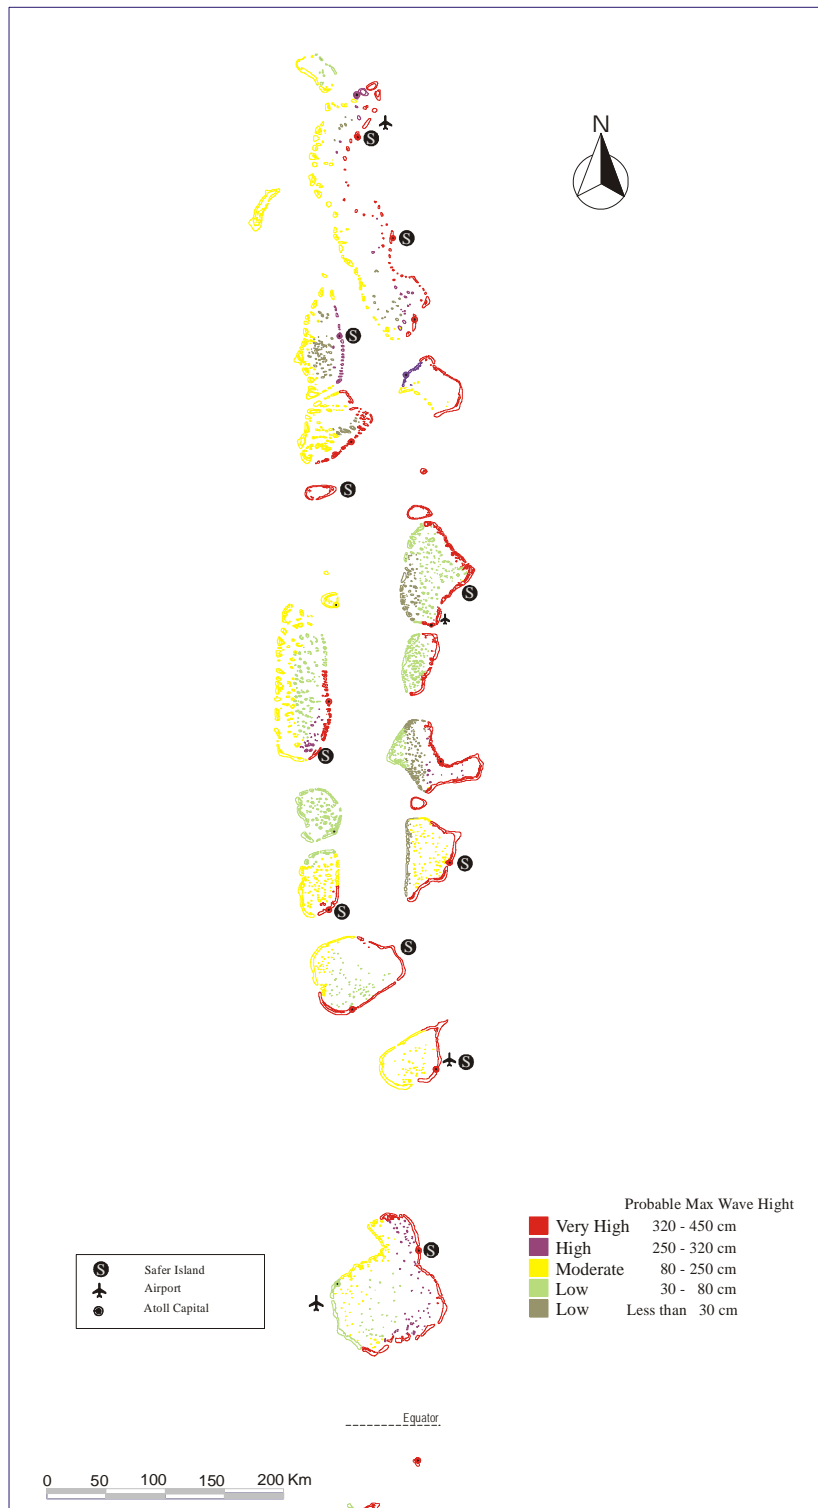
Figure 17: Tsunami Hazard Zones (adopted from UNDP, 2006)

Maldives faces tsunami threat largely from the east, and lower threat from the north and south. Islands along the eastern fringe of the atolls are more prone to tsunami hazard than those along the northern and southern fringes. Islands along the western fringe experience a relatively low tsunami hazard. Historically, Maldives has been affected by three earthquakes which had their sources in the Indian Ocean. Of the 85 tsunamis generated since 1816, 67 originated from the Sumatra Subduction zone in the east and 13 from the Makran Coast Zone in the north and Carlsburg Transform Fault Zone in the south. The probable maximum tsunami wave height is estimated at 4.5 metres.
