Project	: Dredging, Land Reclamation and Revetment Works at Gulhifalhu	Document number	: 462.10062-WQR-21
Contract number	: AGR(471)-PIDS2/PRIV/2019/194	Contractor	: Boskalis Westminster Contracting Ltd
Project number [MIAS]	: 462.10042	Client	: Ministry of National Planning and Infrastructure
		Attention	: shaana.farooq@planning.gov.mv

WATER QUALITY REPORT

Dredging, Land Reclamation and Revetment Works at Gulhifalhu

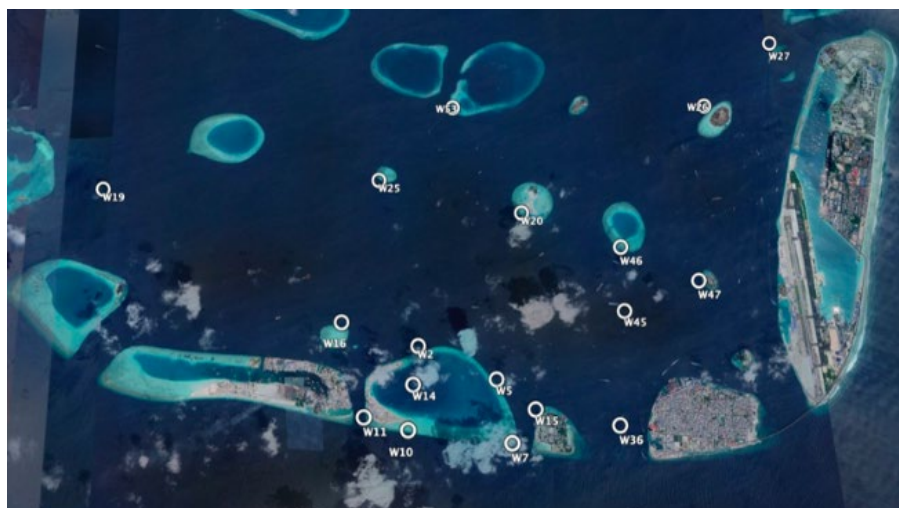
Locations

Location ID	Description
W2	Reclamation
W5	
W7	
W10	
W11	
W14	
W15	Villigili
W16	Reclamation
W19	Background
W20	Borrow area
W25	
W26	
W27	Background
W36	Borrow area
W45	
W46	
W47	
W51
